# Technical Service Bulletin

| SUBJECT: | | | No: | TSB-12-13-006 |
| <b>ECM REPROGRAMMING FOR ENGINE SYSTEM<br/>SERVICE REQUIRED ILLUMINATED – REVISED</b> | | | DATE: | November, 2012 |

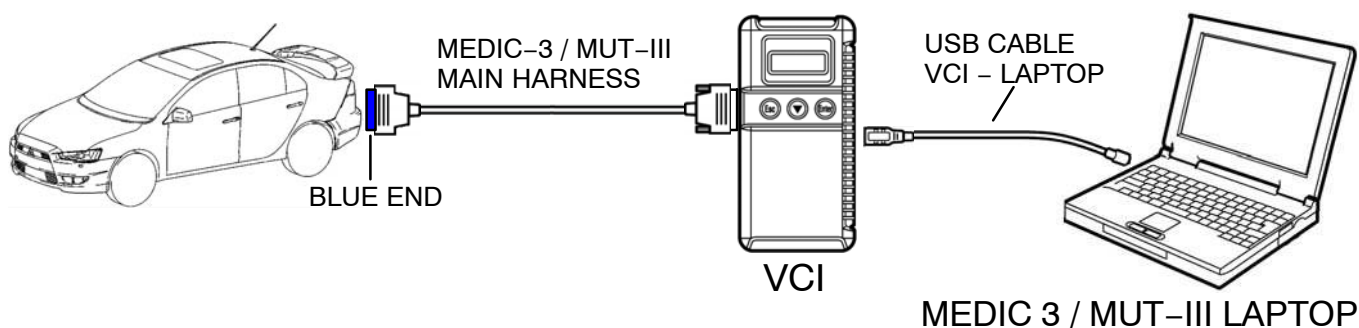
**Connect the equipment as follows:**

- Turn the laptop computer on. If you're running on battery power and the charge indicator in the lower right hand corner of the screen does not show a full charge, it is recommended that either the laptop battery be charged prior to beginning, or that reprogramming be completed with the A/C power adaptor connected to the laptop.
- Connect the USB cable to the VCI.
- When the laptop displays the MUT-III main screen, connect the USB cable to the laptop.
- Connect the MUT-III main harness with the blue DLC connection to the VCI.
- Connect the blue connector of the MUT-III main harness to the vehicle's data link connector.
- Turn the VCI power switch ON. Verify that the indicator lamp in the upper right corner of the screen is green.
