# Audio Head Unit Software Update (Denso-Ten)

**Service****Category** Audio/Visual/Telematics**Section**

Navigation/Multi Info Display

## **Audio Head Unit Software Update (Denso-Ten)**

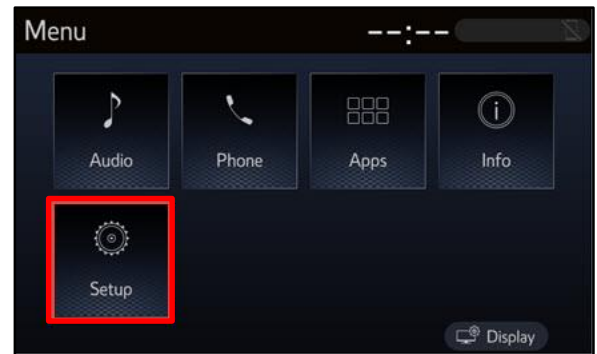
**Figure 1.**

1. Turn the ignition ON.
2. Press the Menu button on the radio faceplate, then select Setup.

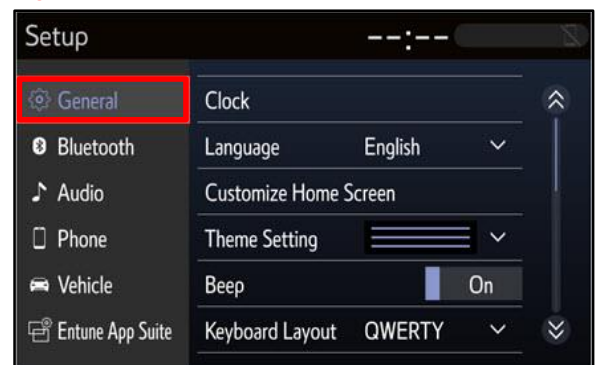
**Figure 2.**

3. Select General on the Setup screen.

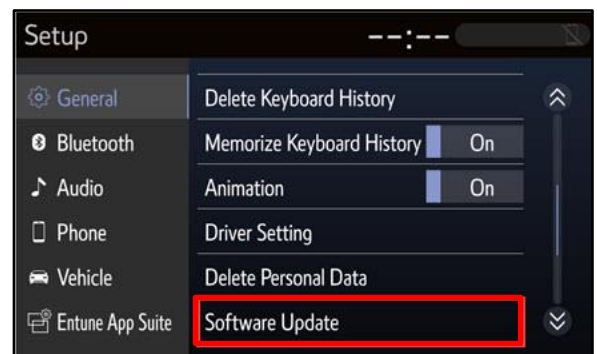
**Figure 3.**

4. Scroll down and select Software Update.

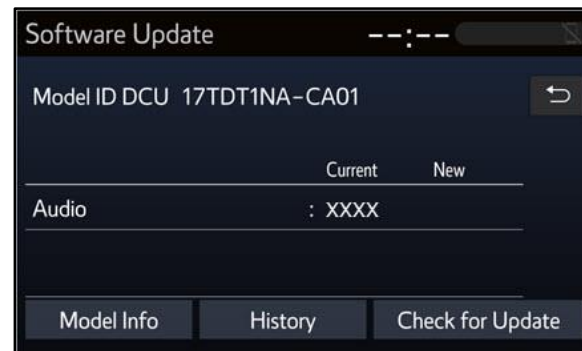
**Figure 4.**

5. Verify that the software version is the same or earlier than indicated in the Introduction.

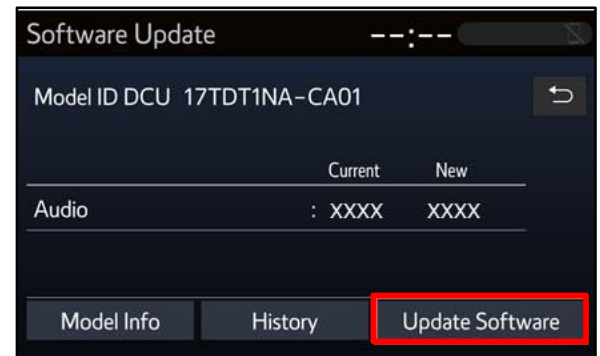
**Figure 5.**

9. Select the Update Software button in the lower right-hand corner.

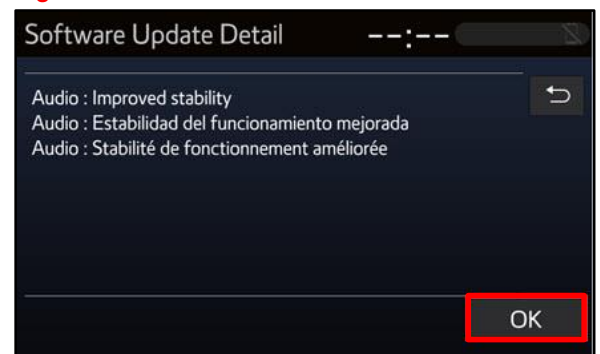
**Figure 6.**

10. Select OK on the Software Update Detail screen.

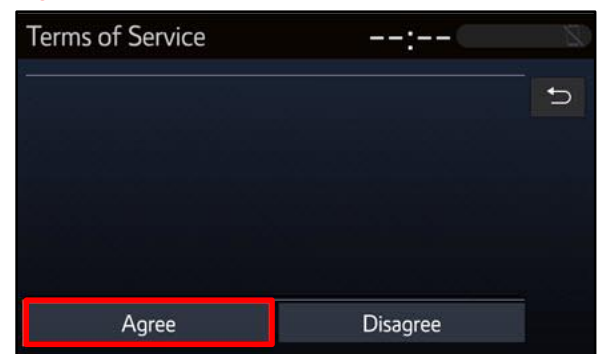
**Figure 7.**

11. Select Agree on the Terms of Service screen.

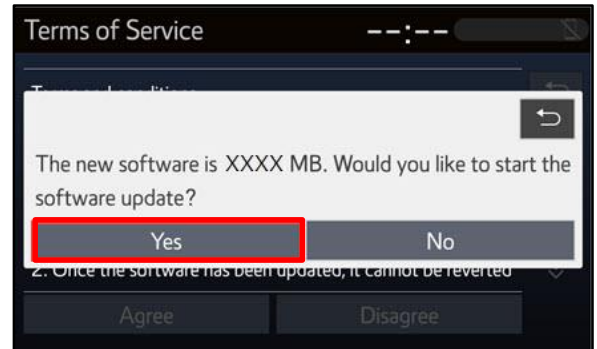
Figure 8.

12. Select Yes on the “Would you like to start the software update?” pop-up.

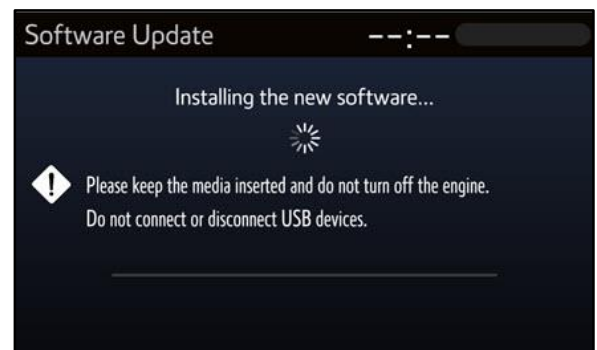
Figure 9.

13. Once the head unit begins installation, the update will take approximately 10 minutes.

- Do NOT turn OFF the ignition or ACC BEFORE the software is ready for updating.
- Do NOT remove the USB flash drive until instructed in step 17.

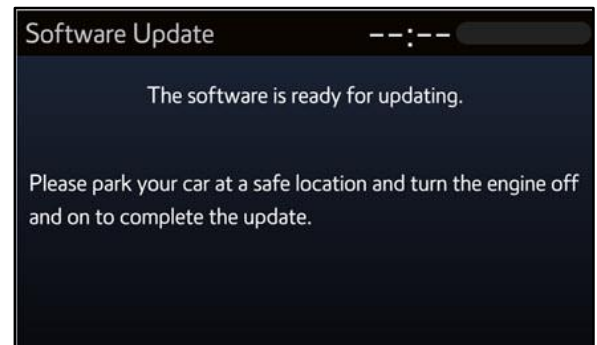
Figure 10.

14. When the “The software is ready for updating” screen appears, turn OFF the ignition.

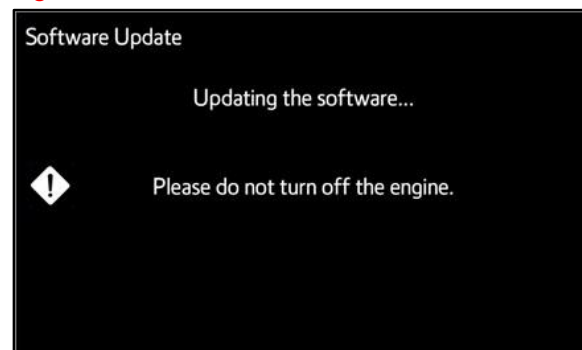
**Figure 11.**

16. AFTER turning the ignition ON, the Software Update screen will appear. Do NOT turn OFF the ignition or remove the USB flash drive. The head unit will reboot during this time.

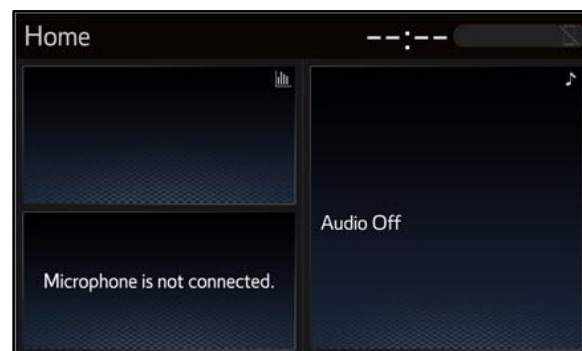
**Figure 12.**

17. Once the software update is complete and the Home screen appears, remove the USB flash drive.

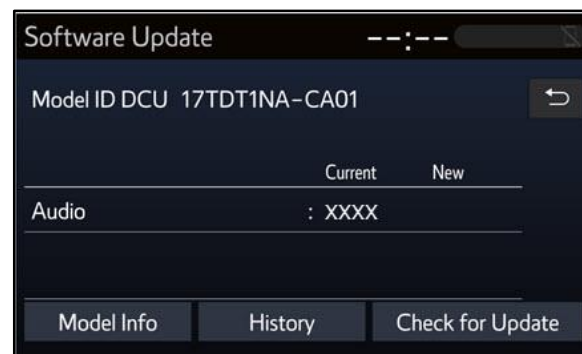
**Figure 13.**

18. Perform steps 3 – 6 to verify the software version matches the current software version information table below.
