# Technical Service Bulletin

| <b>SUBJECT:</b><br><b>ECM REPROGRAMMING FOR MIL ILLUMINATES,<br/> DTC P1235 OR P0068 STORED IN ECM</b> | | | No: <b>TSB-13-13-009</b> |

This TSB provides field fix procedures to reprogram the ECM with new software to address false MIL illumination with boost/air flow plausibility monitor DTCs P1235 (2008–2010 models) or P0068 (2011–2014 models) stored in memory.

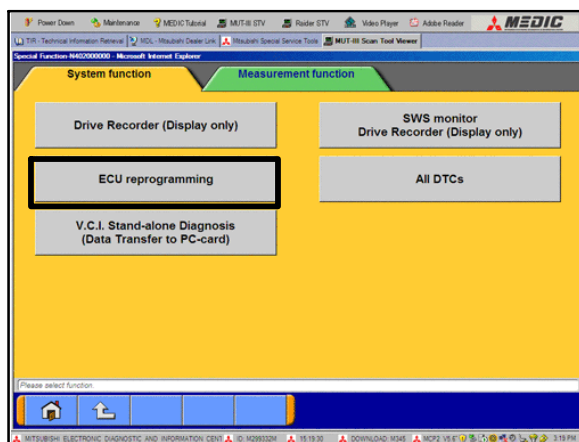
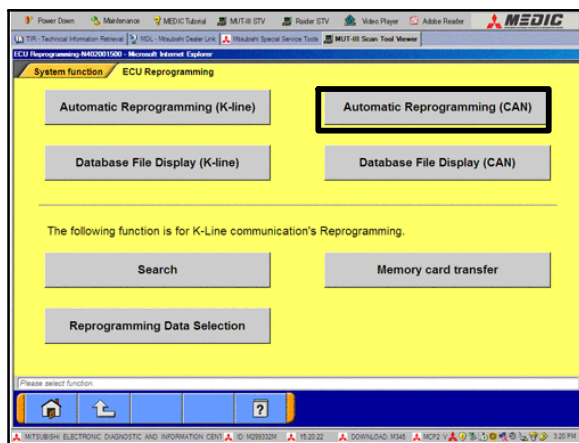
1. Conduct the following steps to reprogram the ECM.
  - a. Turn the ignition switch to the ON position. If the vehicle is equipped with the F.A.S.T. System, the transmitter must remain in the vehicle for the entire procedure.
  - b. If using MEDIC 3, from the main page, click the MUT-III STV icon at the top center of the screen.
  - c. From the MUT-III Main Menu, select "Special Function."
  - d. Select "ECU Reprogramming."

- e. Select "Automatic Reprogramming (CAN)."

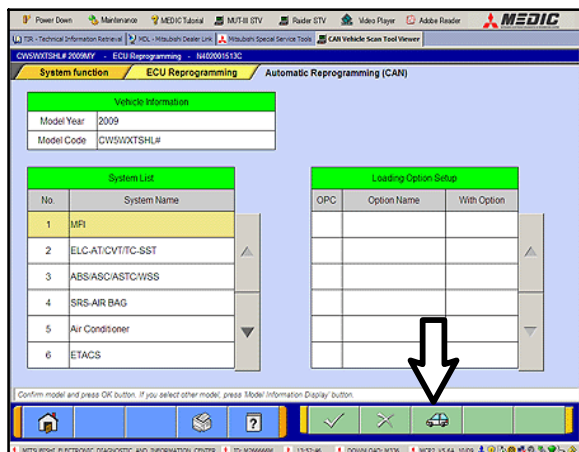
f. Click on the car icon at the bottom of the page.

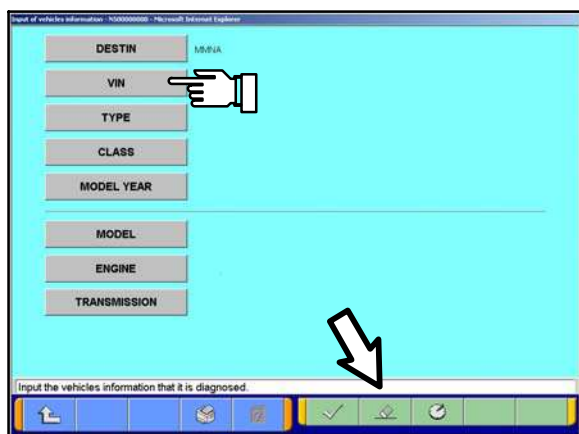
g. If the VIN or vehicle description displayed does not match the vehicle you are working on, click on the eraser icon at the bottom of the page to erase vehicle data.

Then click on the VIN button.

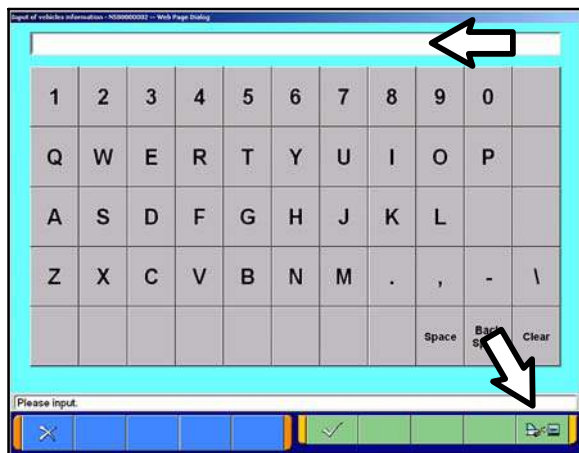
h. Click the icon in the lower RH corner of the screen to have MUT-III automatically read the VIN. If a message appears saying the VIN cannot be input automatically, manually type the 17 digit VIN into the VIN field at the top of the page.

Make sure the VIN is correct and click on the check mark.

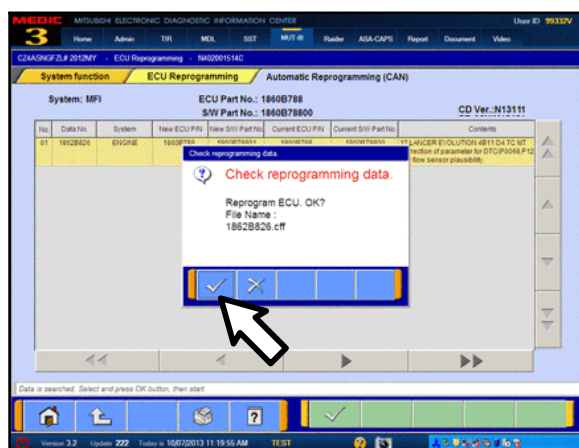
- m. A message will ask you to “Check reprogramming data.”
- n. Click the check mark to begin reprogramming.

Reprogramming will take up to 5 minutes to complete.

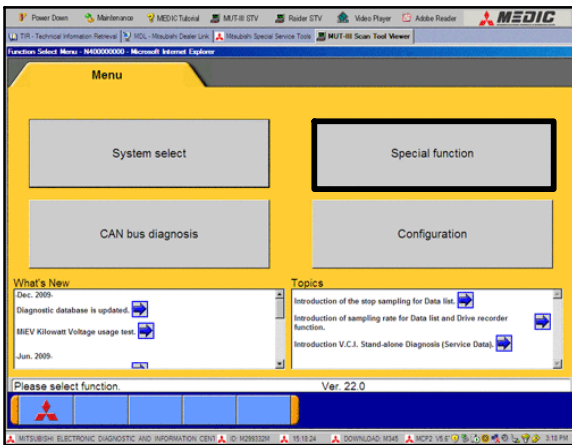
3. Using MUT-III, check and erase ALL DTCs from all systems as follows.

a. Select “Special Function.”

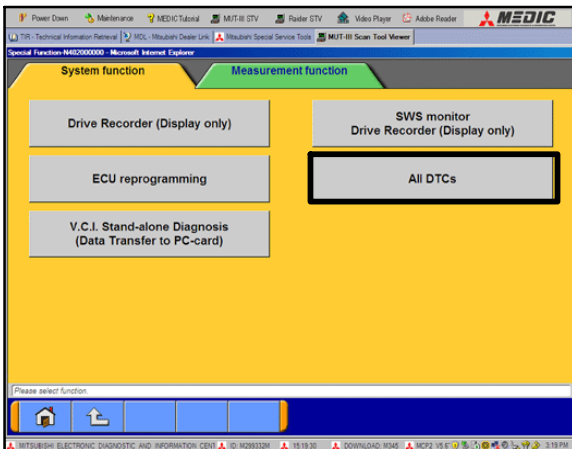
b. Select “All DTCs,” then select “ERASE AND READ ALL DTCS.”

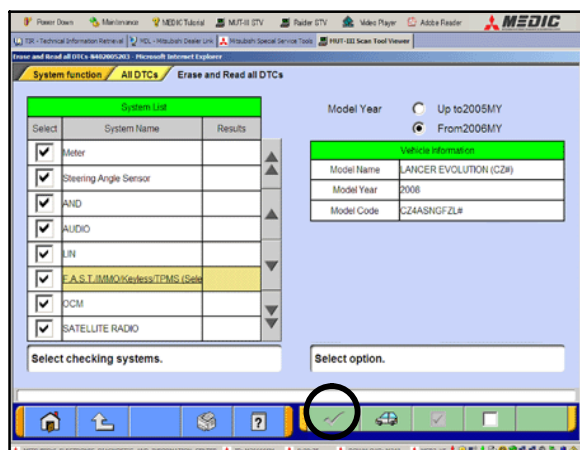
- c. The "System List" on the left side of the screen will have all selections checked. Do not change these selections. DTCs may be set if the vehicle is equipped with options that are unchecked.
- d. If the check mark at the bottom of the screen is highlighted, click it and proceed to step 4. If not, proceed to step e.

**NOTE:** A "Loading Options Setup" list on the RH side of the screen must be completed for Lancer based models. For those models, the check mark at the bottom of the page is not highlighted (inactive) at this time. It will activate when step e is completed.

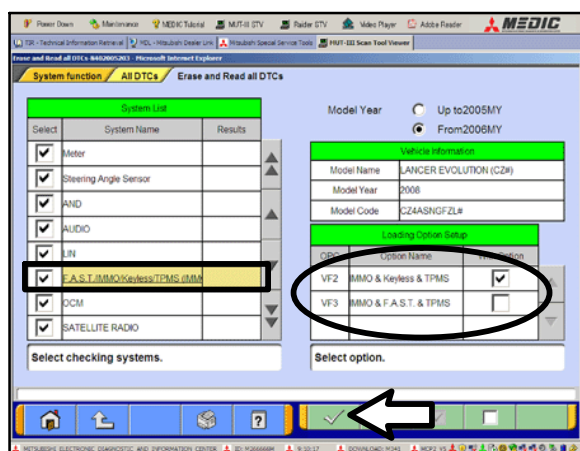
- e. In the left column, scroll to and click FAST/IMMOB/KEYLESS/TPMS. In the right column, check the correct option code (VF#) from the Loading Options Setup list. This will activate the check mark at the bottom of the page.
  - Vehicles with regular keyless entry (buttons on a multi-function key), select VF2.
  - Vehicles with F.A.S.T. Key, select VF3.
- f. In the left column, scroll to and select METER. A window will display. Check the correct display type for the vehicle.

Click the check mark to continue.

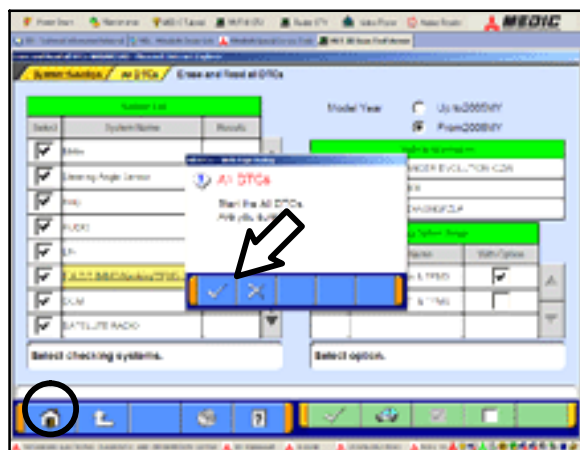
4. A window will pop up asking you to confirm DTC erasing. Click the check mark for DTC erasing and reading to begin.
5. When DTC erasing is completed, a window will display.
  - a. If DTCs return after reprogramming, click the check mark to clear the window. Diagnose and repair per the Service Manual.
  - b. If DTCs do not return, click the check mark to clear the window, then click the home icon at the lower left of the screen to return to the main menu.
6. Turn off the ignition switch and disconnect the MUT-III. Turn off and disconnect the battery charger.
