| | GROUP<br><b>ELE</b> | MODEL<br><b>2021MY<br/>Seltos (SP2)</b> |
| <b>TECHNICAL SERVICE BULLETIN</b> | | |
| <b>SUBJECT: SERVICE ACTION: BCW SOFTWARE UPDATE (SA422)</b> | | |

This bulletin provides the procedure to update the logic of the Blind Spot Collision Warning (BCW) on some 2021MY Seltos (SP2) vehicles, produced from November 20, 2019 through March 27, 2020, which may exhibit MIL ON with DTC(s) C2702 – C2703. To correct this concern, apply the improved logic to the BCW using the KDS ECU Upgrade function as described in this bulletin. For confirmation that the latest reflash has been applied to a vehicle you are working on, verify the ROM ID using the table on page 2 of this bulletin. Before conducting the procedure, verify the vehicle is included in the list of affected VINs.

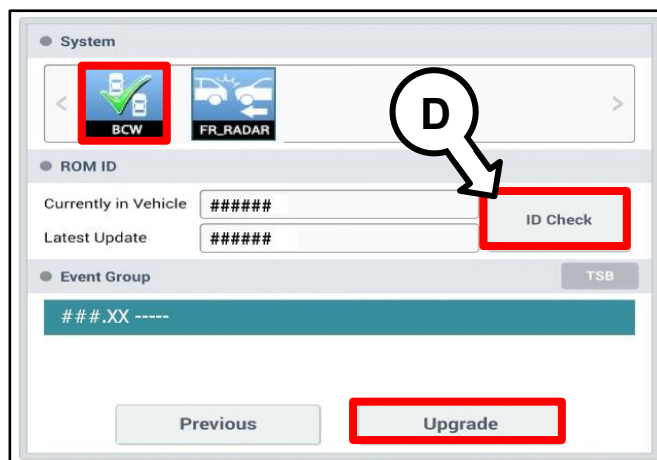
8. The ECU upgrade will begin and the progress of the upgrade will appear on the bar graph. Upgrade part (1/2) (E) will download the upgrade event to the VCI-II. Upgrade part (2/2) (F) will upgrade the ECU.

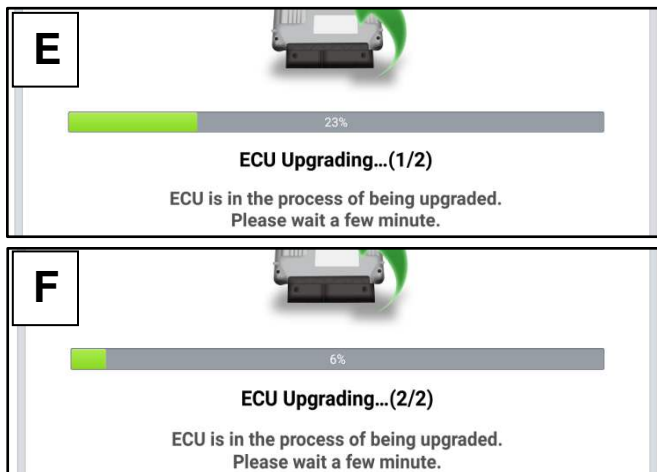
9. If a “Communication Fail” screen appears, verify that the VCI-II and KDS are communicating properly. Touch **OK** and restart the procedure from step 4.

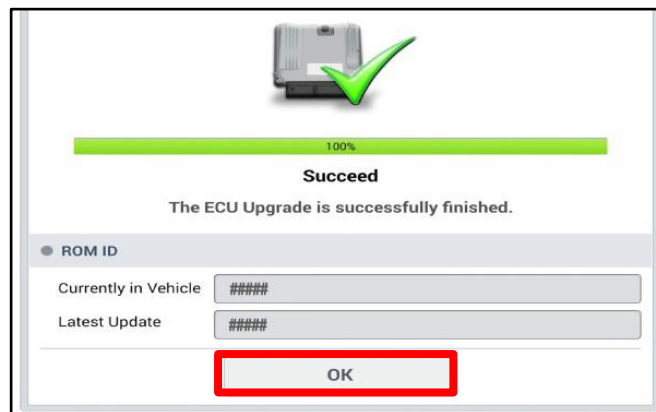
12. When prompted, select **YES** to check for Diagnostic Trouble Codes (DTC) and erase any DTCs stored such as EPS, ESC, and TPMS that may have been set during the upgrade.

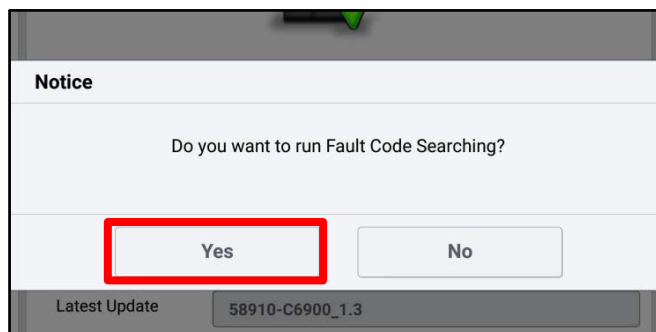
13. Using the KDS, perform the '**BCW (BSD) Variant Coding**' in the 'S/W Management'.
