| | GROUP<br><b>Product Improvement</b> | MODEL<br><b>See Model List on Page 1</b> |
| | NUMBER<br><b>PI1803Y/Z (Rev 3, 07/01/2020)</b> | DATE<br><b>March 2020</b> |
| <b>SUBJECT: ENGINE REPLACEMENT INSTRUCTIONS<br/>FOR DTC P1326 (PI1803Y/Z)</b> | | |

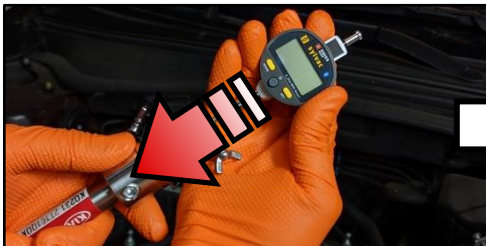
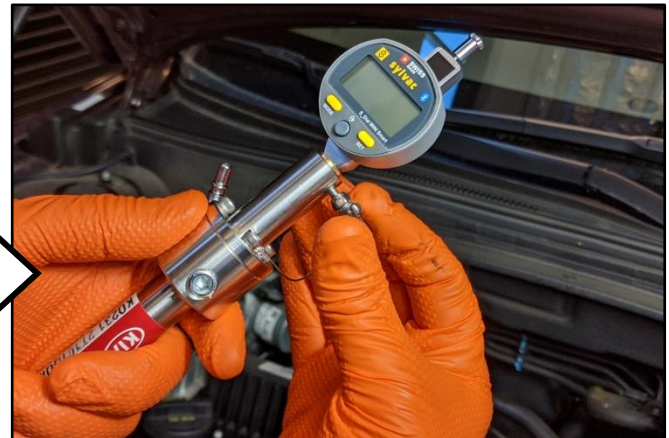
7. Install the Dial Gauge fully into the Probe Rod and secure together by hand tightening the locking wingnut.

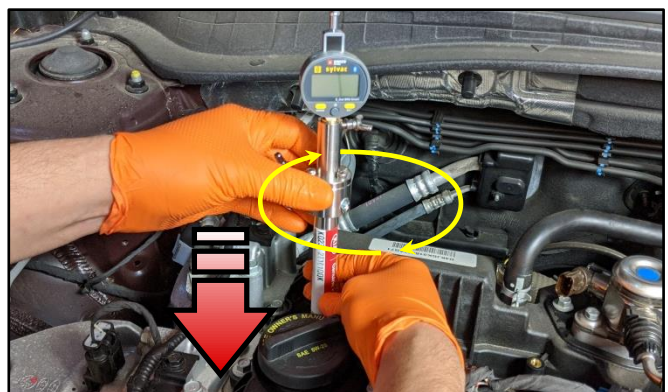
8. **Carefully**, insert the assembled SST Probe Rod and Dial Gauge into the Cylinder 1 spark plug hole and **carefully** turn the SST Crankshaft Rotator **by hand** clockwise until hand tight.

**Damage to cylinder head can occur if spark plug hole is cross-threaded. DO NOT use a wrench to tighten the SST rod.**

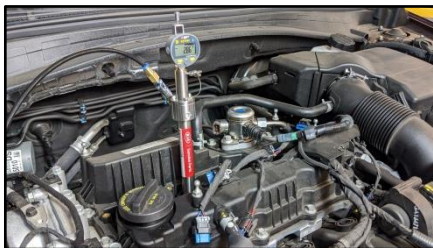
23. Once Cylinder 1 test is completed, the KDS will prompt to take a picture of the tested cylinder. Select **'Take a picture'**.

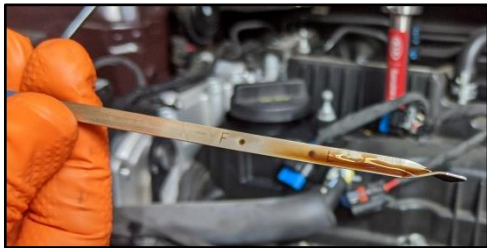
27. After completing the test of all four (4) cylinders, the KDS will prompt to check the crankcase oil level and to select the appropriate check box on the screen.

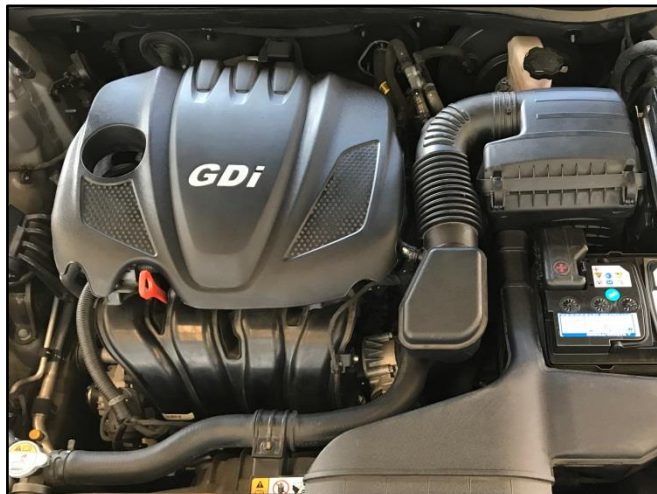
1. Remove the engine assembly by referring to the “Engine And Transmission (Transaxle) Assembly → Engine And Transmission (Transaxle) Assembly → Repair procedures” chapter in the applicable Shop Manual on KGIS.

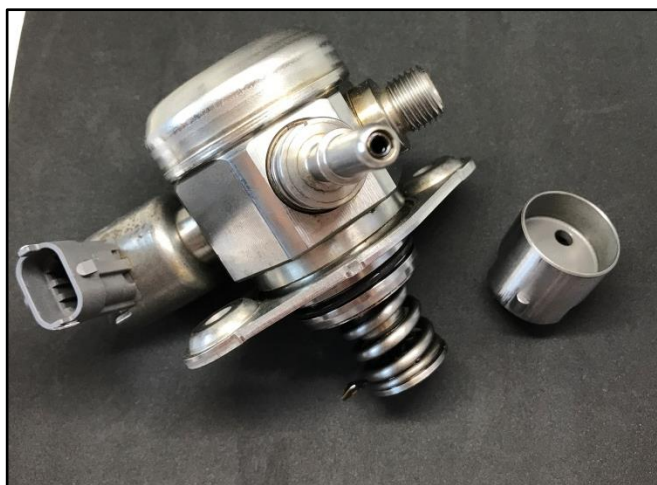
### Tightening torques of pipe flare nut:

19.5 – 23.9 lb.ft (26.5 – 32.4 N.m,  
2.7 – 3.3 kgf.m)

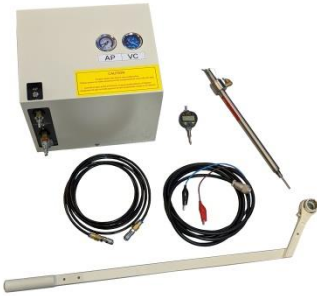
| Tool Name | Tool Part No. | Figure | Comments |
|---|---|---|---|
| Bearing Clearance Tester Kit | KQ231 2T110QQK | | Auto-shipped to Dealers<br><b>For troubleshooting assistance contact the GITA Support Line at: (888) 542-4371.</b><br><br><b>For replacement parts, contact Snap-On Tools at: (888) 542-1011.</b> |

If DTC P1326 is present, first perform the bearing clearance inspection with the Engine Bearing Clearance Tester device (SST KQ231-2T110QQK). This device checks the rod bearing clearance by placing air and vacuum into the cylinder block. Measure the bearing clearance and follow the instructions in this bulletin. Refer to the flow chart found on page 2, then follow the appropriate procedure as outlined in this bulletin.
