| | GROUP<br><b>ENG</b> | MODEL<br><b>2020MY<br/>Niro (DE P/HEV)</b> |
| | NUMBER<br><b>221</b> | DATE<br><b>August 2020</b> |
| <b>SUBJECT: SERVICE ACTION: ACTIVE AIR FLAP (AAF)<br/>MIL ON JUDGMENT LOGIC IMPROVEMENT (SA429)</b> | | |

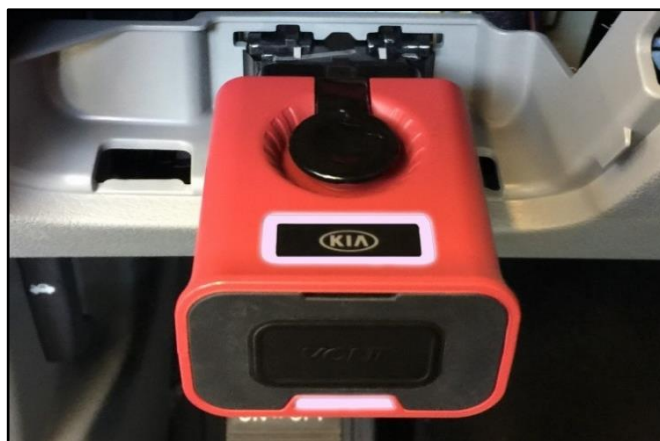
1. Connect the VCI-II to the OBD-II connector, located under the driver's side of the instrument panel.

The ECU upgrade function on KDS operates wirelessly. It is not necessary to perform the upgrade via USB cable.

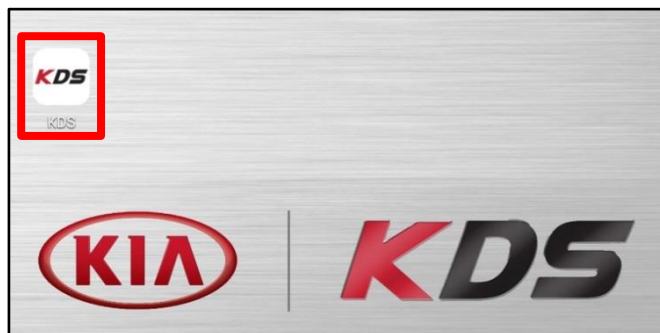
2. With the ignition ON, turn ON the KDS tablet. Select **KDS** from the home screen.

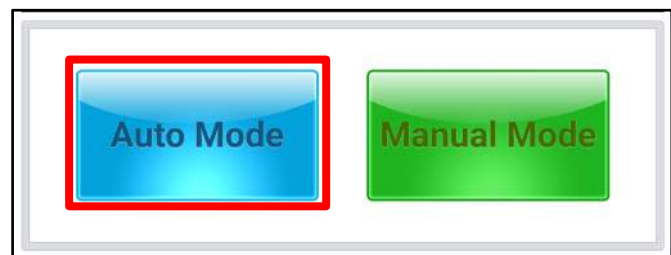
6. Select **Auto Mode**.

Do NOT attempt to perform a Manual Mode upgrade UNLESS Auto Mode fails. Always follow the instructions given on the KDS in either Auto or Manual mode.
