# DCM Reset and Firmware Update (LG)

**Service Category** Audio/Visual/Telematics

**Section** Cellular Communication

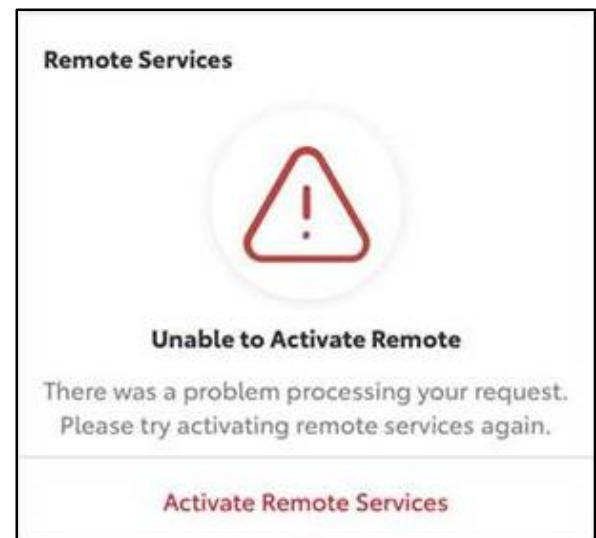
**Figure 8.**

15. Using Techstream, perform a Health Check and clear ALL DTCs that may have occurred during the update process.
16. In the customer's Toyota app, perform steps 17 – 19 for customers with the "Unable to Activate Remote" message.

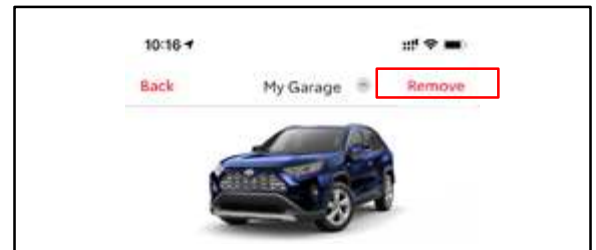
**Figure 10.**

18. Click on REMOVE.

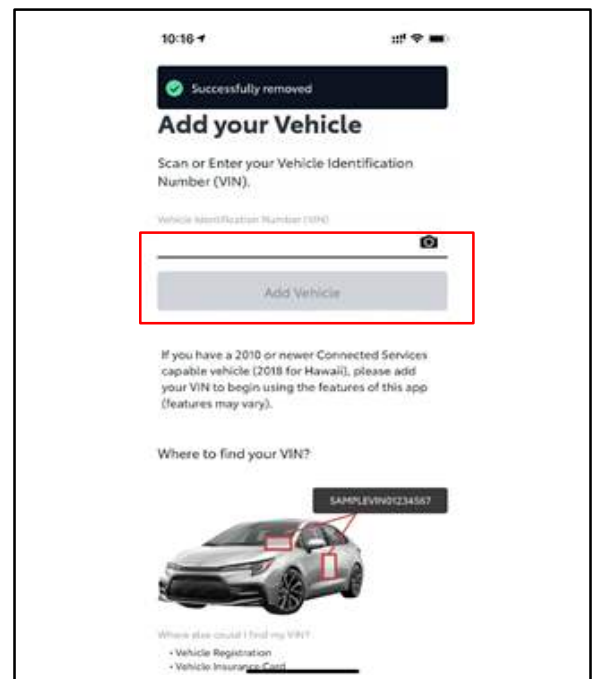
**Figure 11.**

19. Click on Add Vehicle to perform the enrollment again.
