GROUP  
Product Improvement

NUMBER  
PI1802Y/Z (Rev 4, 11/12/2020)

### ENGINE REPLACEMENT INSTRUCTIONS FOR DTC P1326 (PI1802Y/Z)

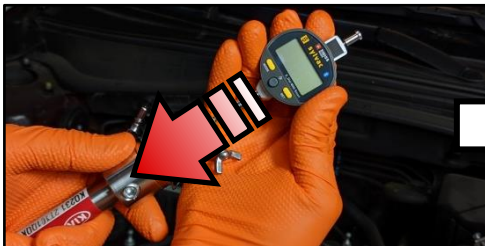
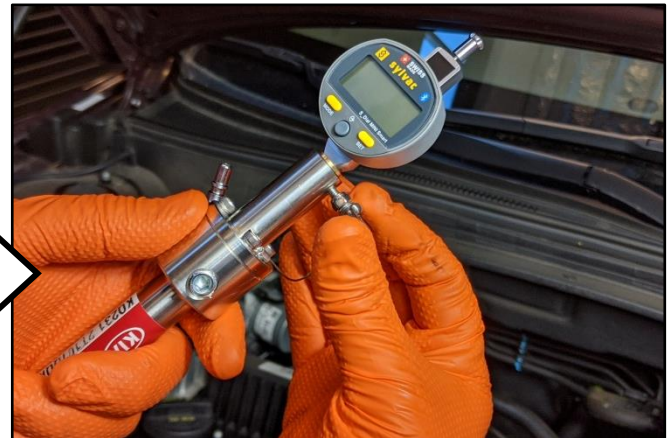
7. Install the Dial Gauge fully into the Probe Rod and secure together by hand tightening the locking wingnut.

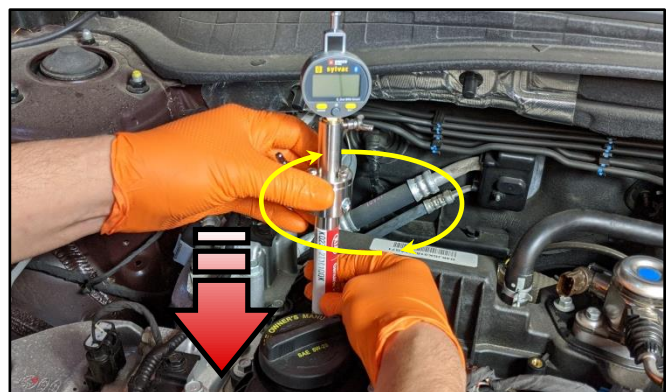
8. **Carefully**, insert the assembled SST Probe Rod and Dial Gauge into the Cylinder 1 spark plug hole and **carefully** turn the SST Crankshaft Rotator **by hand** clockwise until hand tight.

**Damage to cylinder head can occur if spark plug hole is cross-threaded. DO NOT use a wrench to tighten the SST rod.**

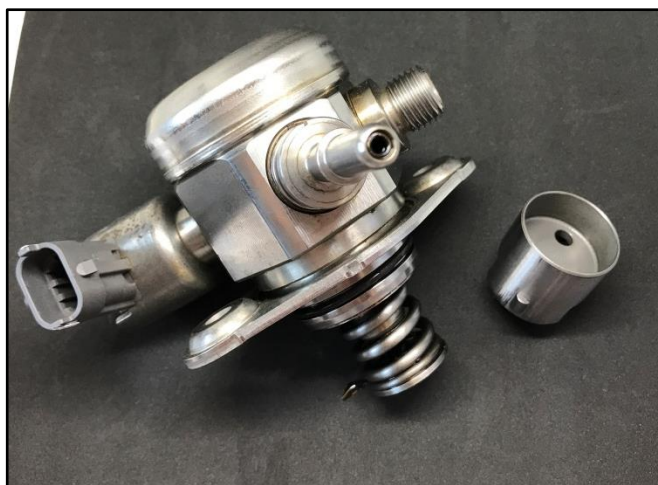
High Pressure Pump & Roller Tappet:

- Refer to [TSB ENG083](#) for special attention and handling procedures of GDI-specific components.
- When installing the high pressure pump and roller tappet onto the new engine, apply engine oil to the roller tappet, and O-rings of the high pressure pump.

### Tightening torques of pipe flare nut:

19.5 – 23.9 lb.ft (26.5 – 32.4 N.m,  
2.7 – 3.3 kgf.m)

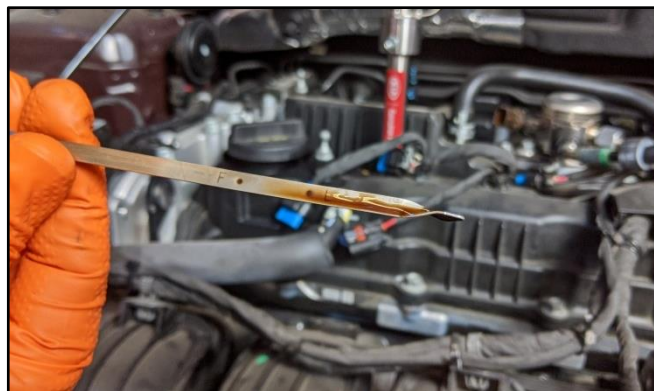
### Oil Level Check: (Applies to all Flowcharts B and C)

1. Measure and record oil dip stick level.
2. Note oil dip stick reading on the RO.

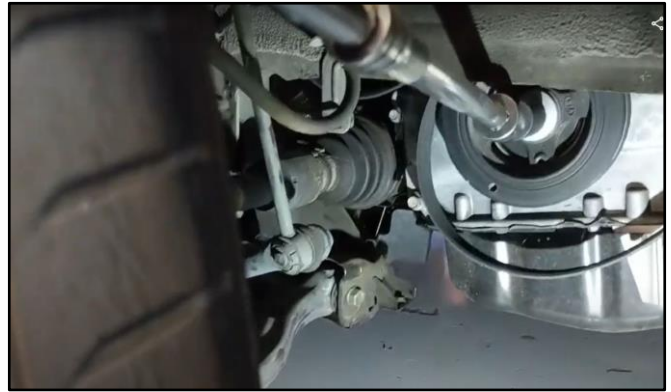
5. Show the removed drive belt and attached torque wrench to crank bolt.

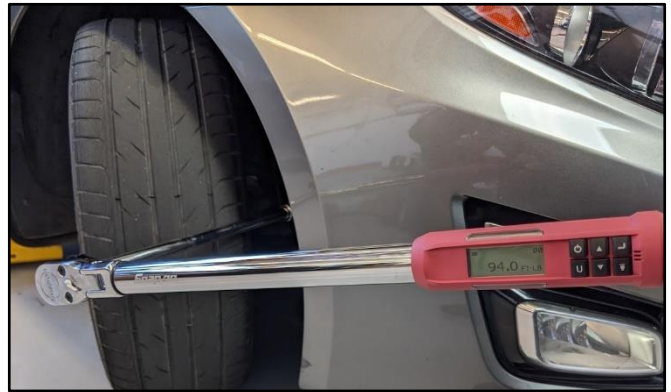
6. Show the engine being cranked and torque specification exceeding 94 lb.ft. torque.

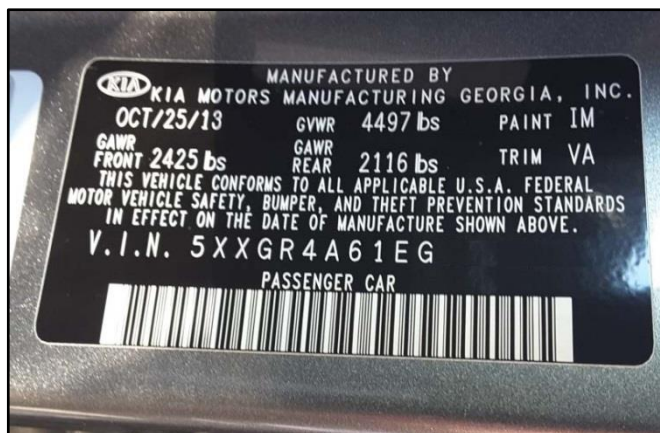
6. Start by recording the VIN. Ensure sun glare is not reflecting off windows or other objects.

Without stopping the recording, capture the area of the vehicle displaying the issue. i.e.;

- Engine Noise – record the engine.
- Hole In Block – record the side of the engine with the damage.
- Seized Engine – record a technician trying to turn the engine over with a breaker bar.

**NOTE: Ensure the video size is set to “Limit to email”. Only record the VIN and the engine exhibiting the concern.** Any additional information will increase the size of the video and make it difficult to upload or download.
