NUMBER  
**PI1803Y/Z (Rev 4, 11/12/2020)**

### ENGINE REPLACEMENT INSTRUCTIONS FOR DTC P1326 (PI1803Y/Z)

This bulletin provides information related to the Technical Service Bulletin previously published in July 2018 (PI1803, Rev 10, 03/16/2020) titled "Knock Sensor Detection System - ECU Logic Improvement" equipped w/THETA II engine. Specifically, this bulletin provides instructions on which procedures to follow if, after installation of the KSDS, any one of the subject vehicles below returns to the dealer with Diagnostic Trouble Code (DTC) P1326 (Knock Signal Range/Performance).

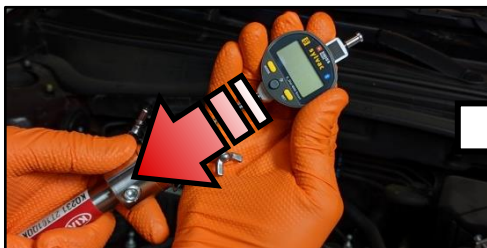
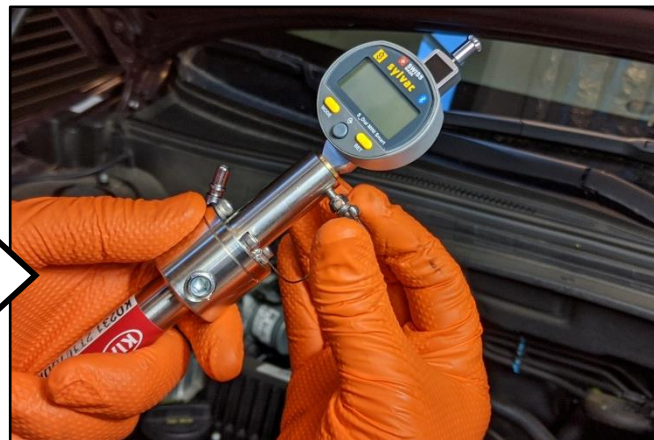
7. Install the Dial Gauge fully into the Probe Rod and secure together by hand tightening the locking wingnut.

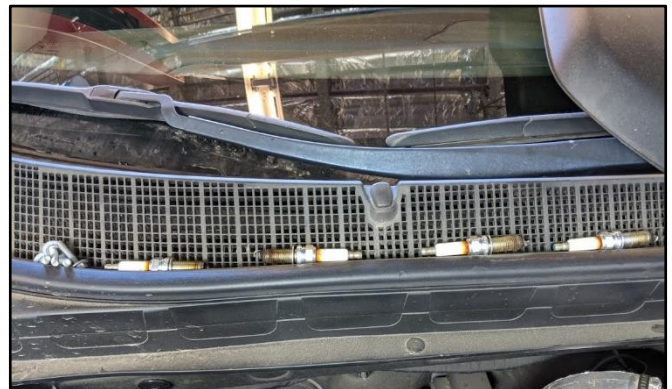
3. Show the removed spark plugs.

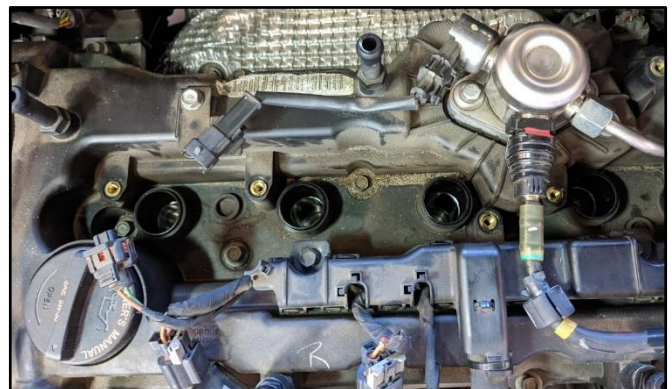
4. Show the empty spark plug holes from the engine.

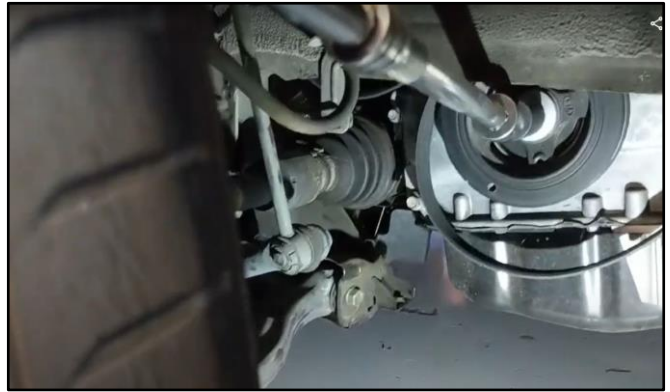
5. Show the removed drive belt and attached torque wrench to crank bolt.

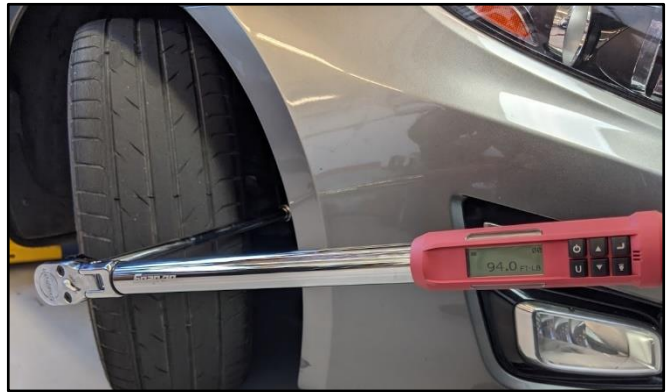
6. Show the engine being cranked and torque specification exceeding 94 lb.ft. torque.

**Prepare the vehicle prior to the video by removing the spark plugs and drive belt as well as setting the torque wrench to 94 lb.ft.**

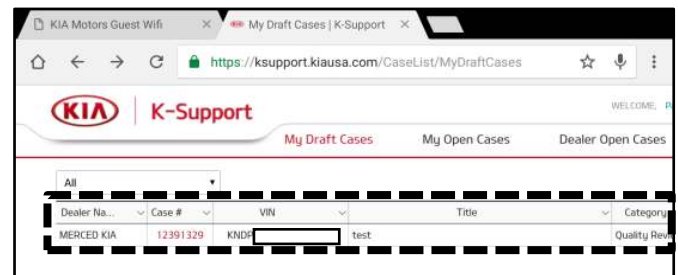
2. Open your existing Techline case for the vehicle requiring a video capture by selecting the case number.

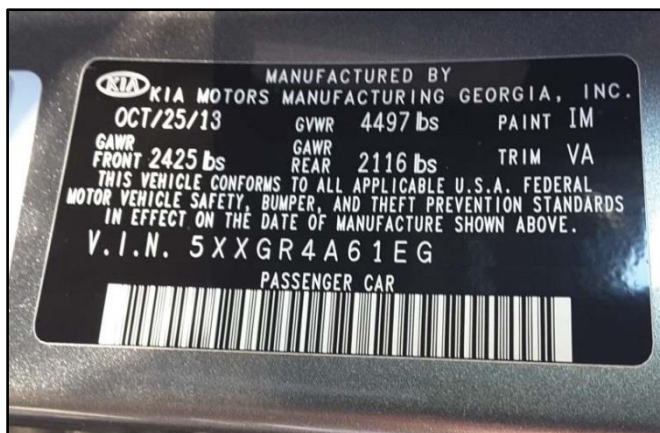
6. Start by recording the VIN. Ensure sun glare is not reflecting off windows or other objects.

Without stopping the recording, capture the area of the vehicle displaying the issue. i.e.;

- Engine Noise – record the engine.
- Hole In Block – record the side of the engine with the damage.
- Seized Engine – record a technician trying to turn the engine over with a breaker bar.

**NOTE: Ensure the video size is set to “Limit to email”. Only record the VIN and the engine exhibiting the concern.** Any additional information will increase the size of the video and make it difficult to upload or download.
