| | GROUP<br><b>TRA</b> | MODEL<br><b>2021MY<br/>Seltos (SP2)<br/>1.6L T-GDI w/7DCT</b> |
| <b>SUBJECT: SERVICE ACTION: DUAL CLUTCH TRANSMISSION (DCT)<br/>DTC P060194 LOGIC IMPROVEMENT (SA454)</b> | | |

This bulletin provides the procedure to improve the logic of the Dual Clutch Transmission (DCT) on some 2021MY Seltos (SP2) vehicles, produced from November 20, 2019 through October 14, 2020, equipped with Gamma 1.6L T-GDI engine and 7-speed DCT. These vehicles may experience limp-home mode driving with a check engine light (DTC P060194) due to limited gear shifting. To prevent this concern, apply the improved logic to the A/T system using the KDS ECU Upgrade function as described in this bulletin. For confirmation that the latest reflash has been applied to a vehicle you are working on, verify the ROM ID using the table on page 3 of this bulletin. Before conducting the procedure, verify that the vehicle is included in the list of affected VINs.

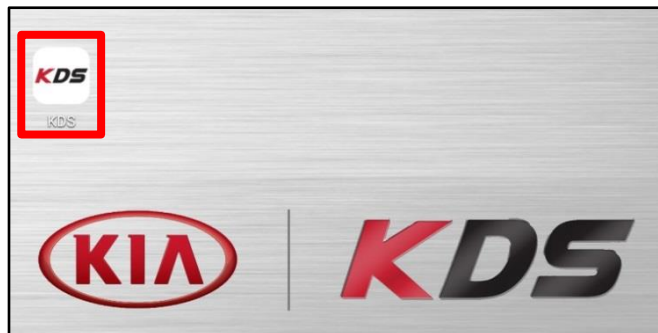
2. With the ignition ON, turn ON the KDS tablet. Select **KDS** from the home screen.

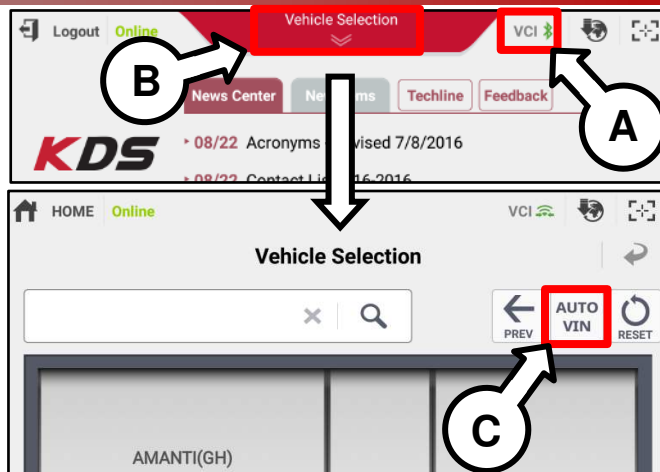
3. Confirm communication with VCI (A) and then configure the vehicle (B) using the **AUTO VIN** (C) feature.

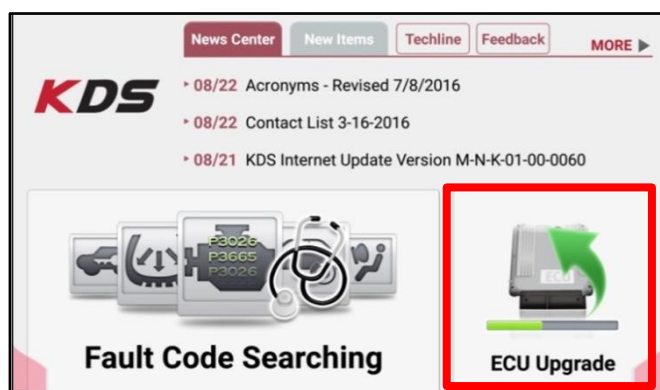
4. Select **ECU Upgrade**.

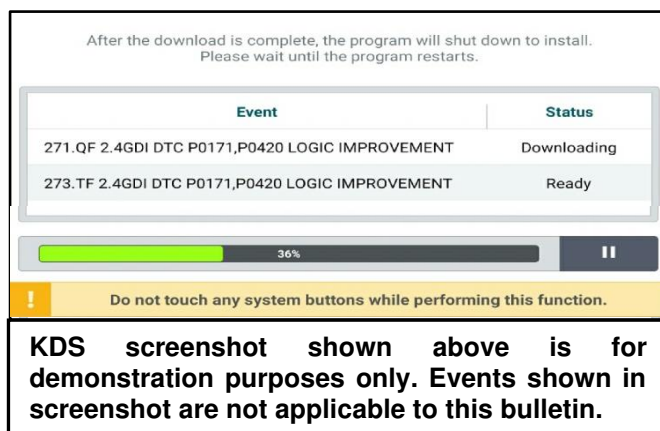
5. The KDS will check the server for recently uploaded Events and then automatically download **Upgrade Event #513**.

The vehicle must be identified in Vehicle Selection to download an Event for that vehicle.

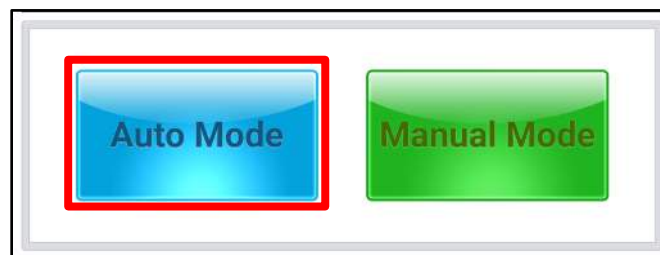
6. Select **Auto Mode**.

Do NOT attempt to perform a Manual Mode upgrade UNLESS Auto Mode fails. Always follow the instructions given on the KDS in either Auto or Manual mode.

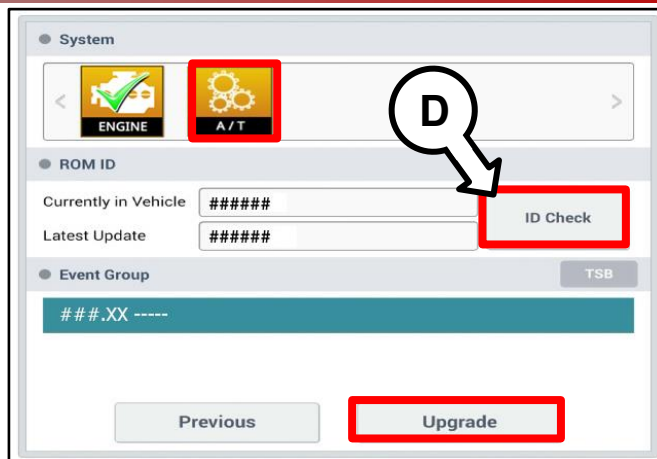
7. Select the **A/T** system under the System selection menu.

Touch **ID Check** (D) and confirm that the latest update is available.

Select **Upgrade Event #513** and select **Upgrade** to continue.

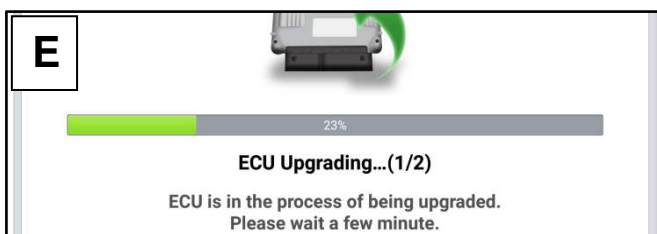
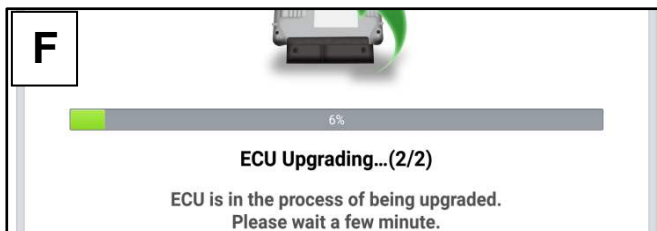
8. The ECU upgrade will begin and the progress of the upgrade will appear on the bar graph. Upgrade part (1/2) (E) will download the upgrade event to the VCI-II. Upgrade part (2/2) (F) will upgrade the ECU.

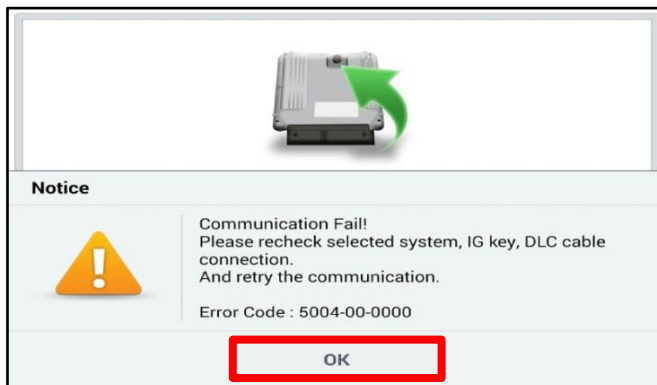
9. If a "Communication Fail" screen appears, verify that the VCI-II and KDS are communicating properly. Touch **OK** and restart the procedure from step 4.

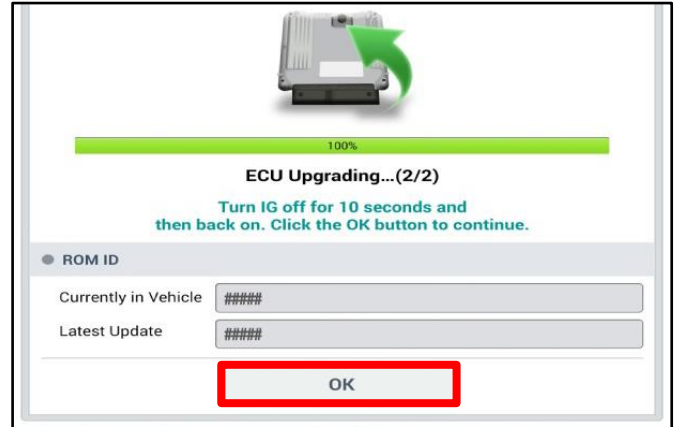
10. When instructed on the KDS, turn the ignition **OFF** for ten (10) seconds then back on. Touch **OK** to continue.

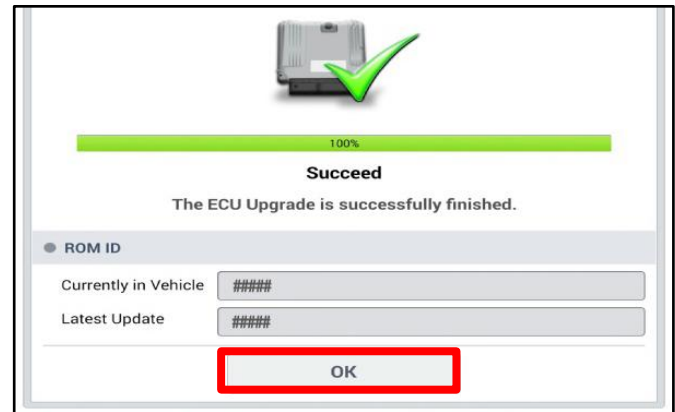
11. Once the upgrade is complete, touch **OK** to finalize the procedure.

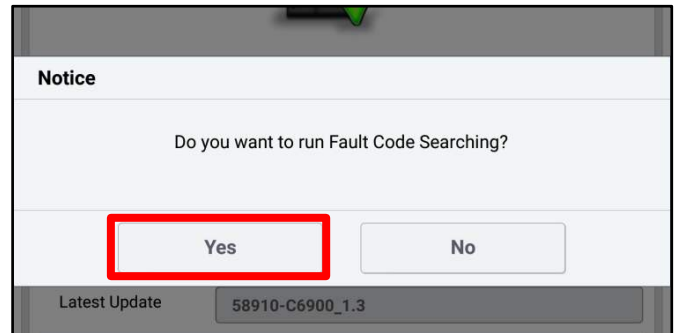
12. When prompted, select **YES** to check for Diagnostic Trouble Codes (DTC) and erase any DTCs stored such as EPS, ESC, and TPMS that may have been set during the upgrade.
