# SERVICE BULLETIN

DA21-003A

## 2021 ROGUE; DTCS B2740-87, B2744-87, AND/OR B274D-87 STORED

**APPLIED VEHICLE:** 2021 Rogue (T33)

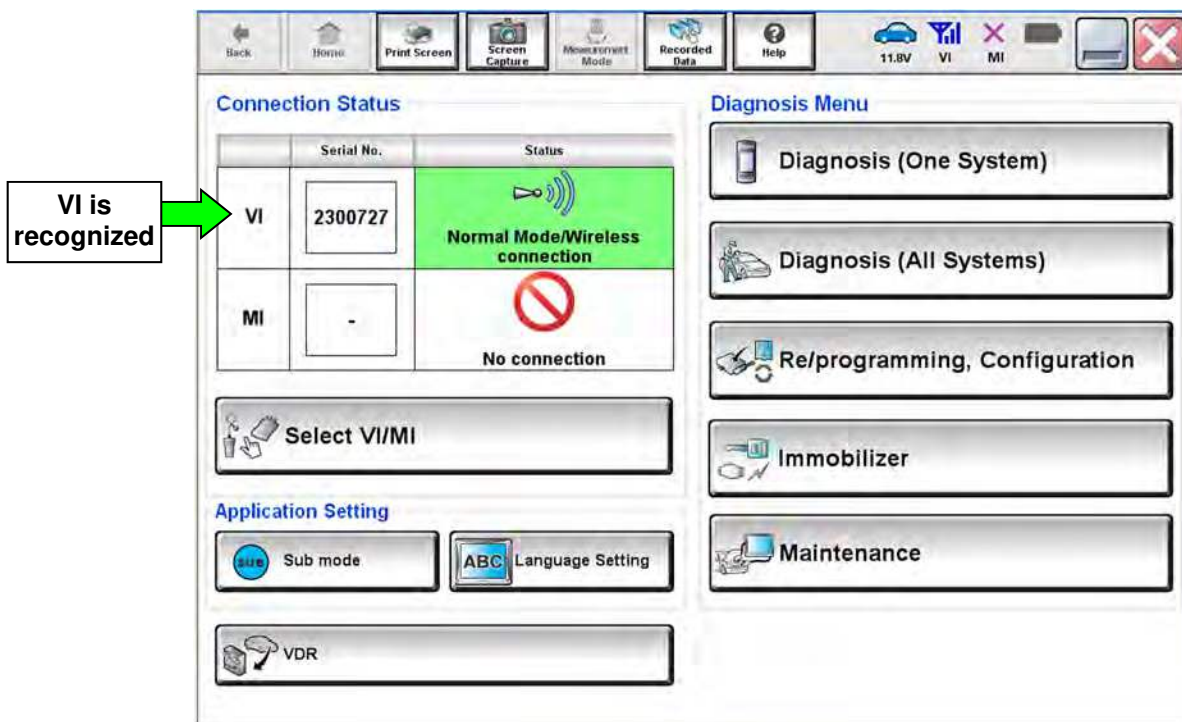
Figure 1

6. Turn OFF all vehicle electrical loads such as exterior lights, interior lights, HVAC, blower, rear defogger, audio, NAVI, seat heater, steering wheel heater, etc.
7. Turn ON the hazard warning lamps.
8. Turn ON the CONSULT PC.
9. Start C-III plus.
  - The serial number will display when the VI is recognized.

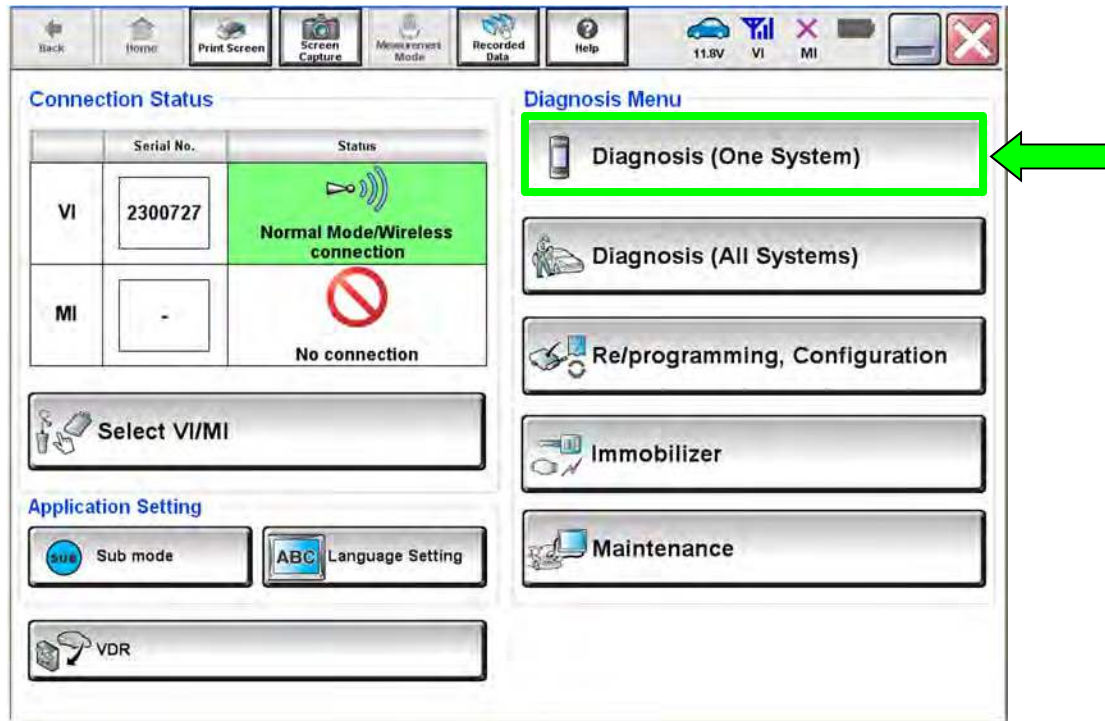
Figure 2

10. Select **Diagnosis (One System)**.

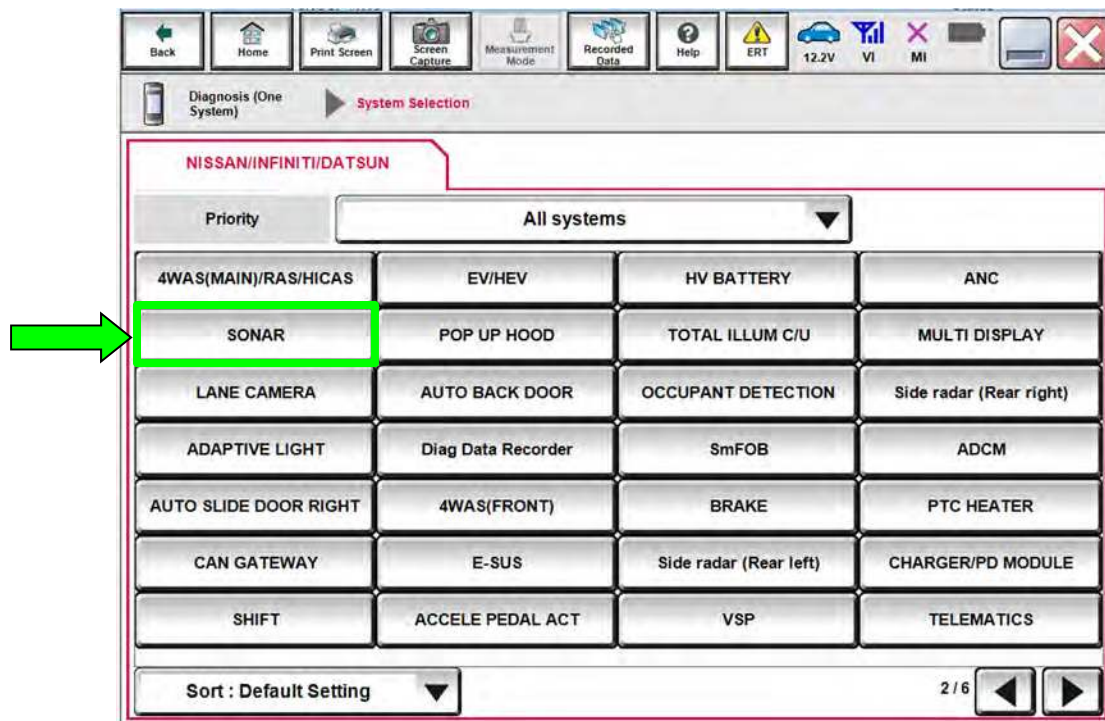
Figure 3

11. Select **SONAR**.

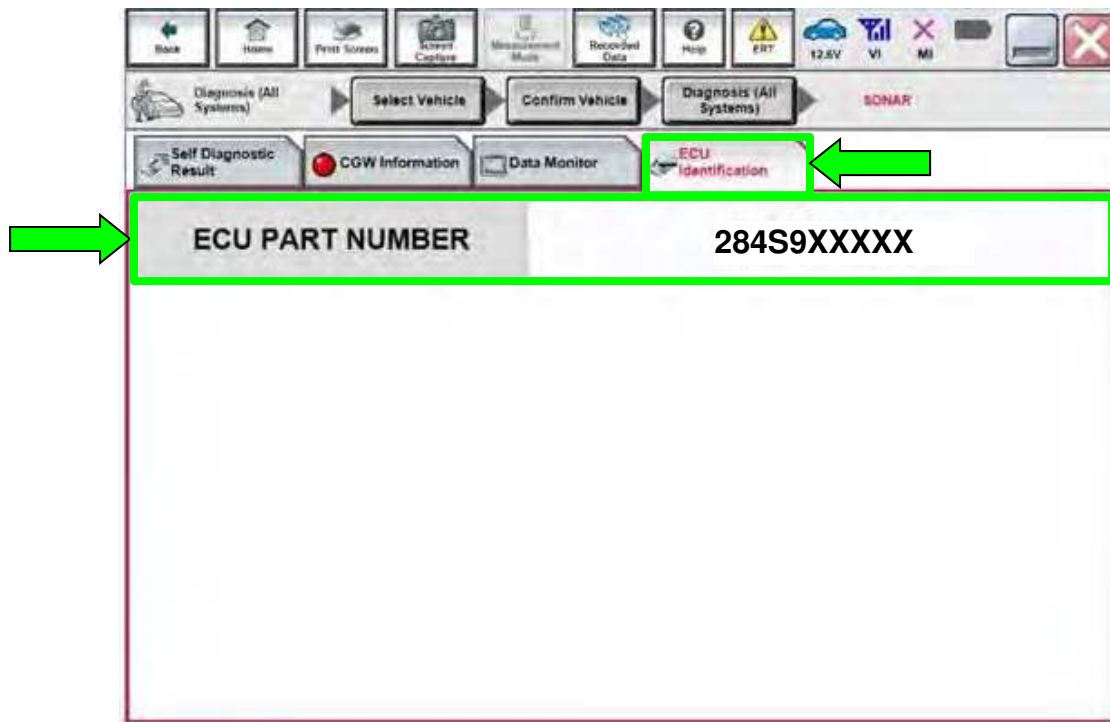
Figure 4

12. Select **ECU Identification**.

- If the **ECU PART NUMBER** is 284S9-1517R, this bulletin does not apply. See the Electronic Service Manual (ESM) for further diagnostic information.
- If the the **ECU PART NUMBER** is not 284S9-1517R, proceed to step 13.

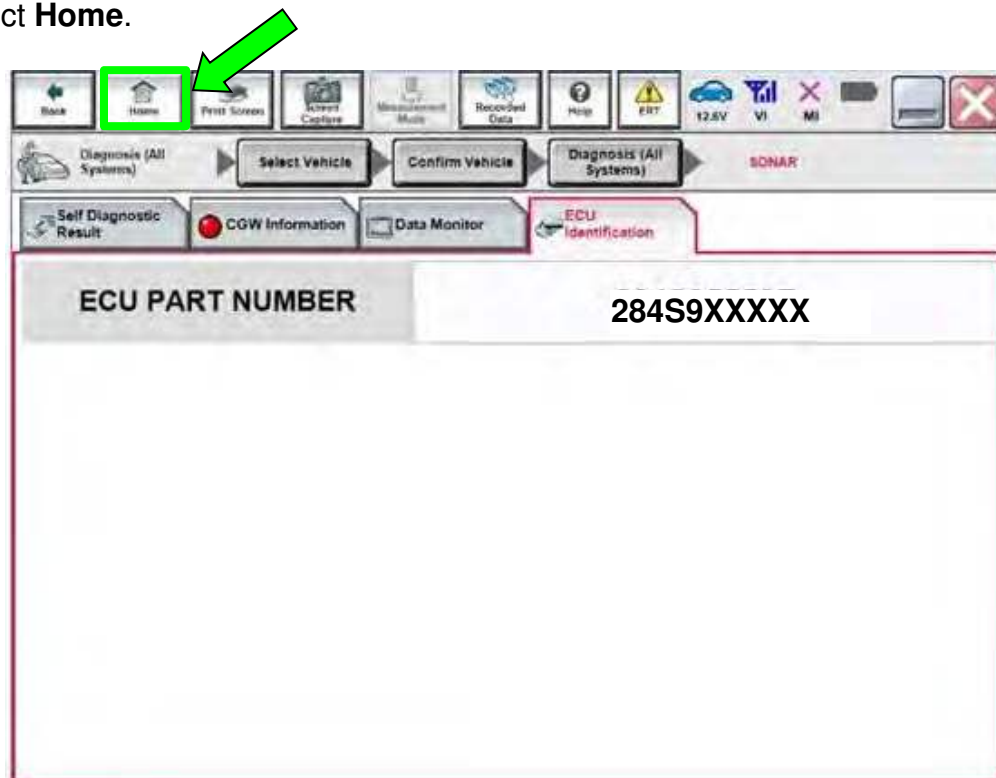
Figure 5

13. Select **Home**.

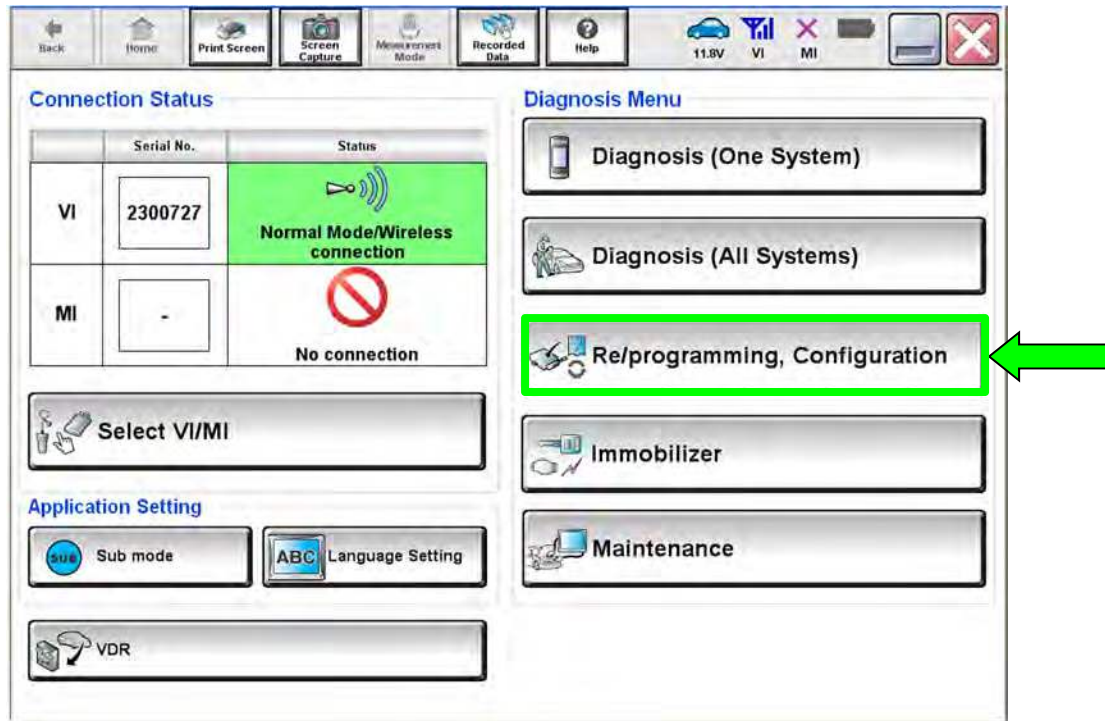
Figure 6

14. Select **Re/programming, Configuration**.

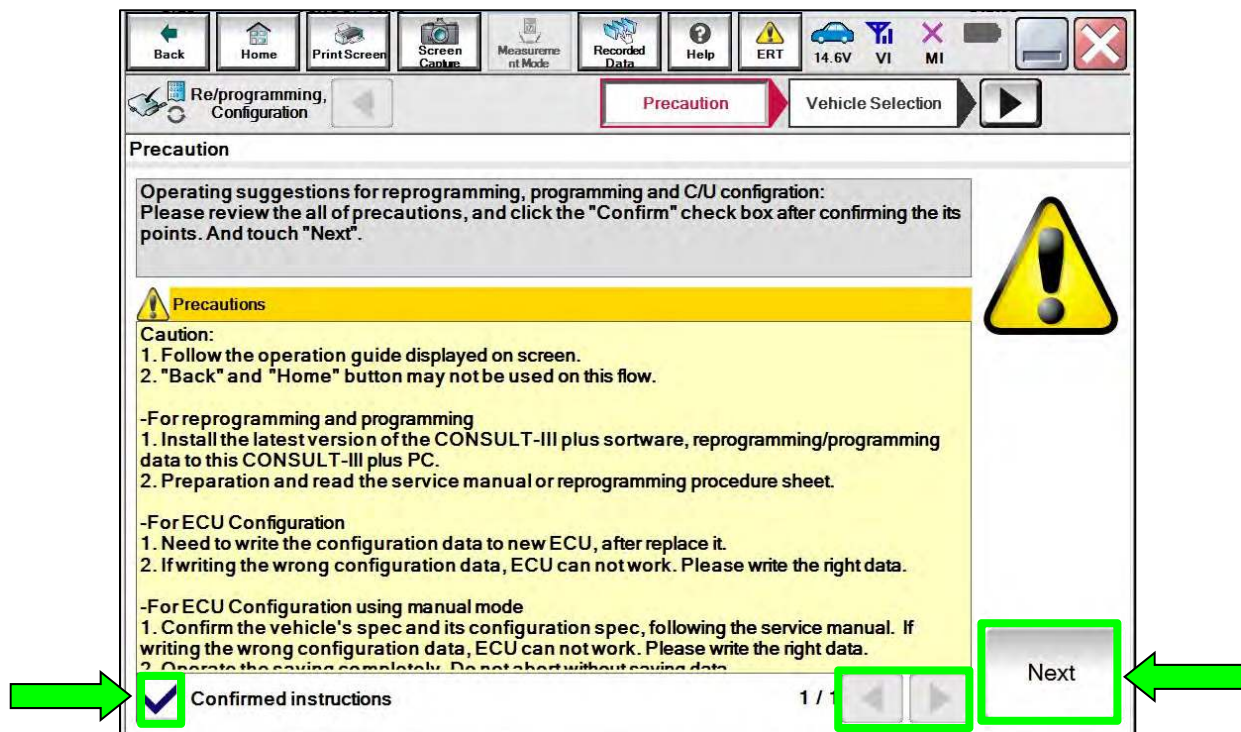
Figure 7

15. Check the box to confirm the precaution instructions have been read, and then select **Next**.

**NOTE:** Use the arrows (if needed) to view and read all the precautions.

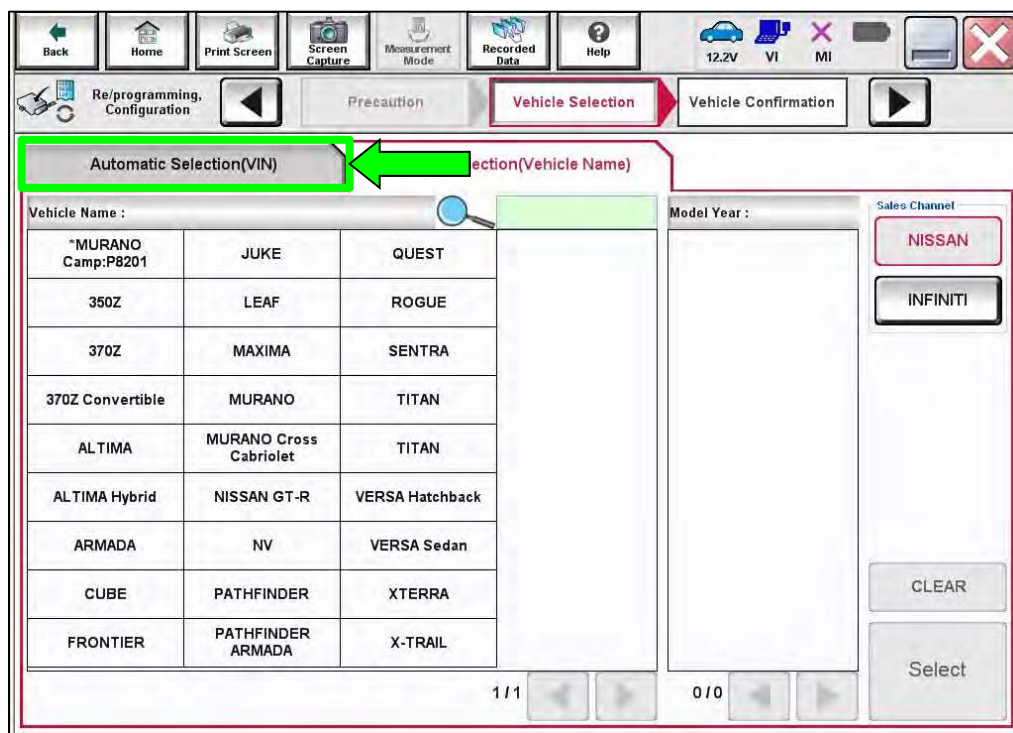
Figure 8

16. Select **Automatic Selection(VIN)**.

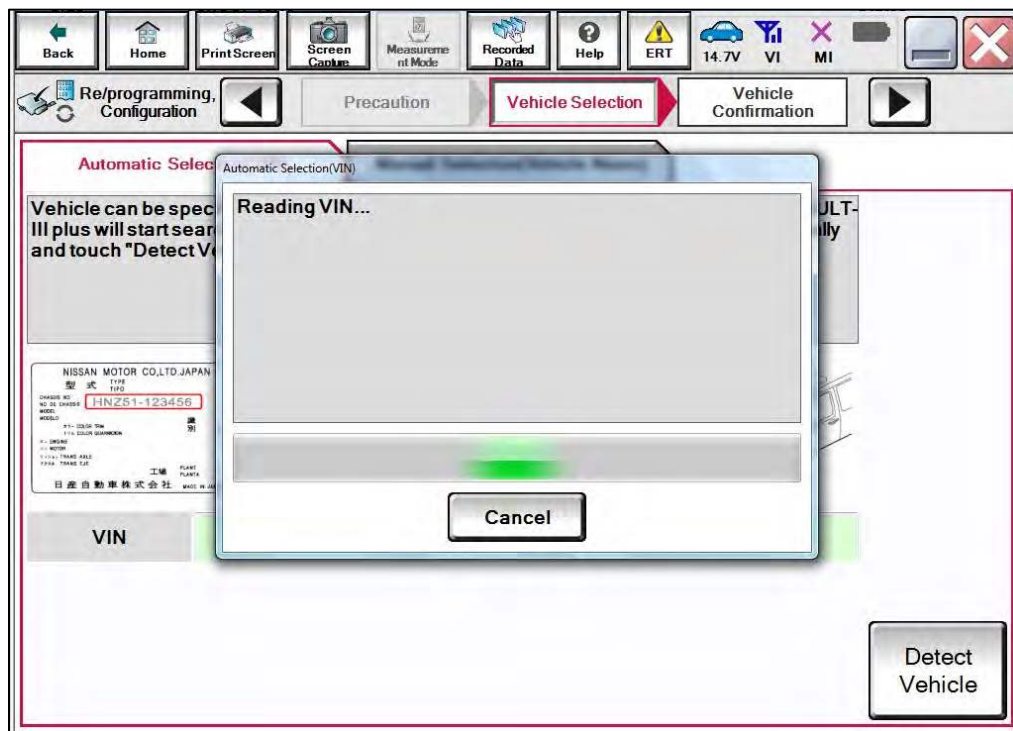
Figure 9

17. Allow C-III plus to perform automatic VIN selection.

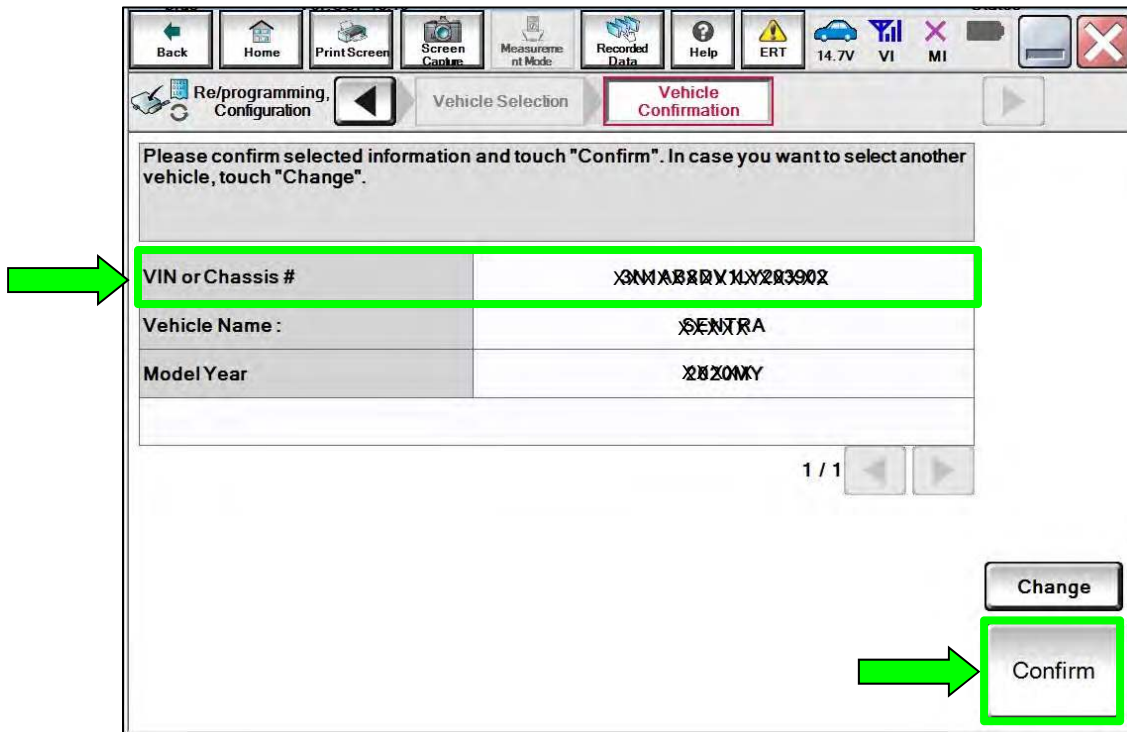
Figure 10

18. Confirm the **VIN or Chassis #** is correct, and then select **Confirm**.

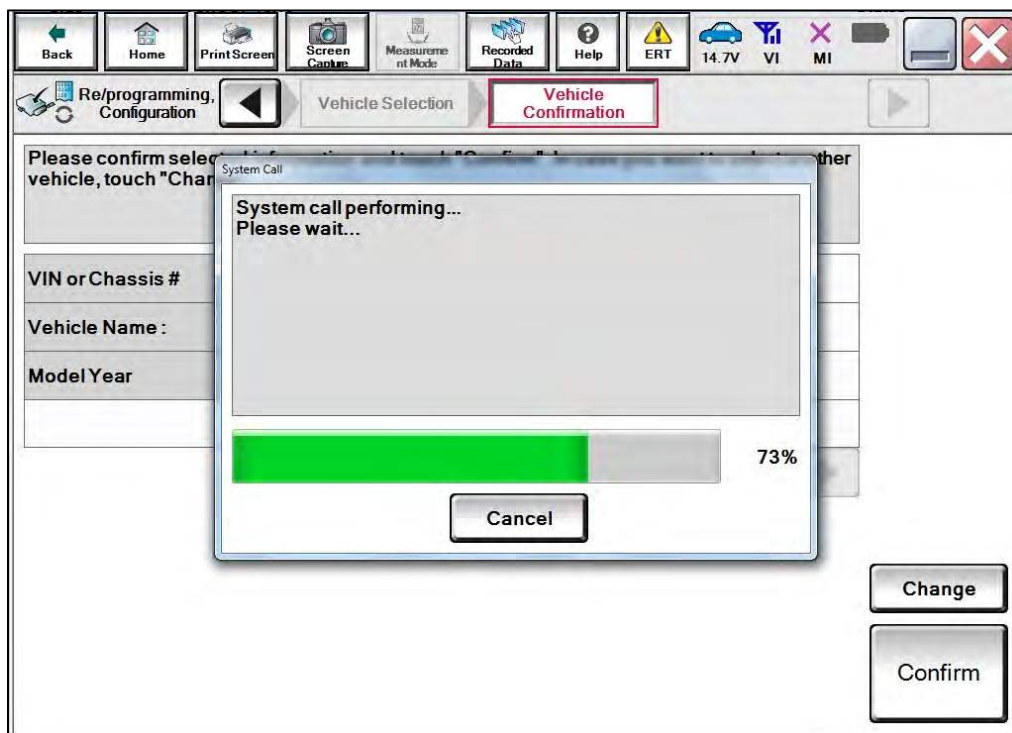
Figure 11

19. Allow the System call to be performed.

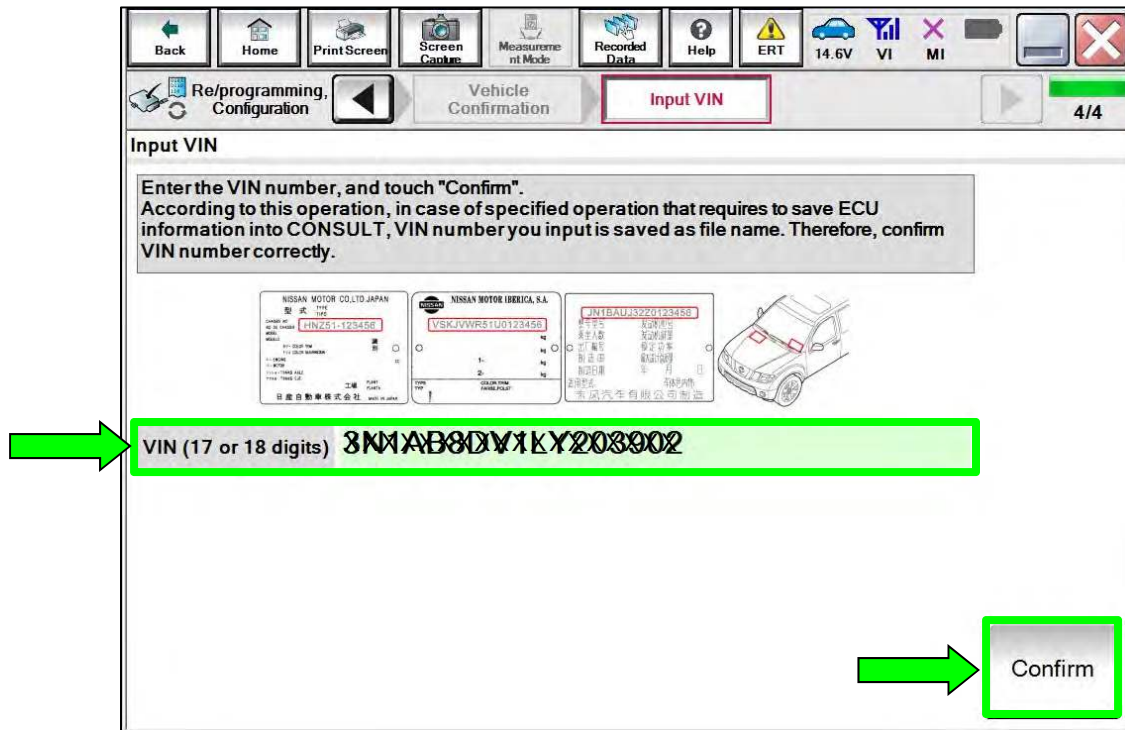
Figure 12

20. Confirm the VIN is correct for the vehicle, and then select **Confirm**.

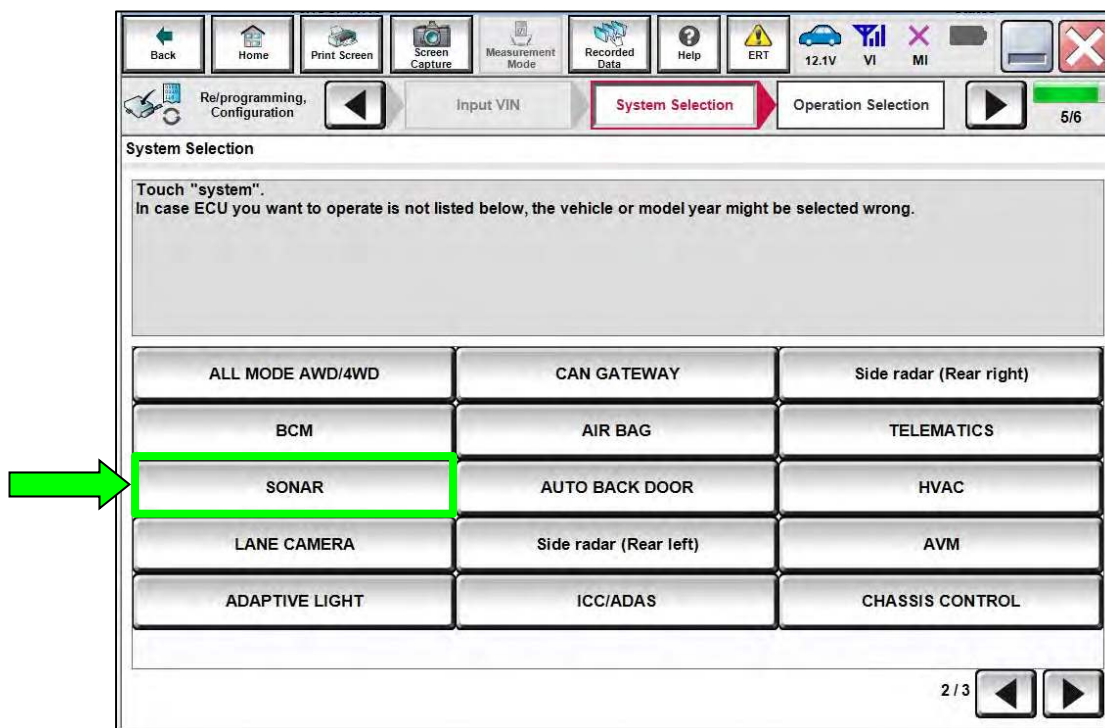
Figure 13

21. Select **SONAR**.

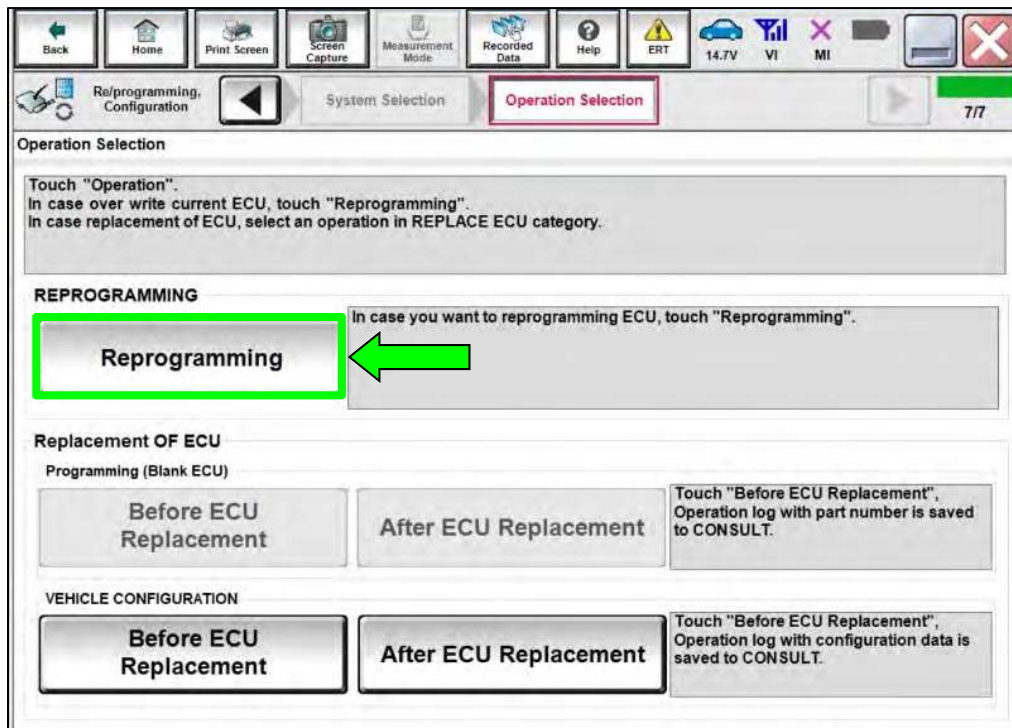
Figure 14

22. Select **Reprogramming**.

**IMPORTANT:** During the reprogramming process, you will receive some errors. These errors are expected. Please follow all of the steps in this procedure to successfully complete the reprogramming process.

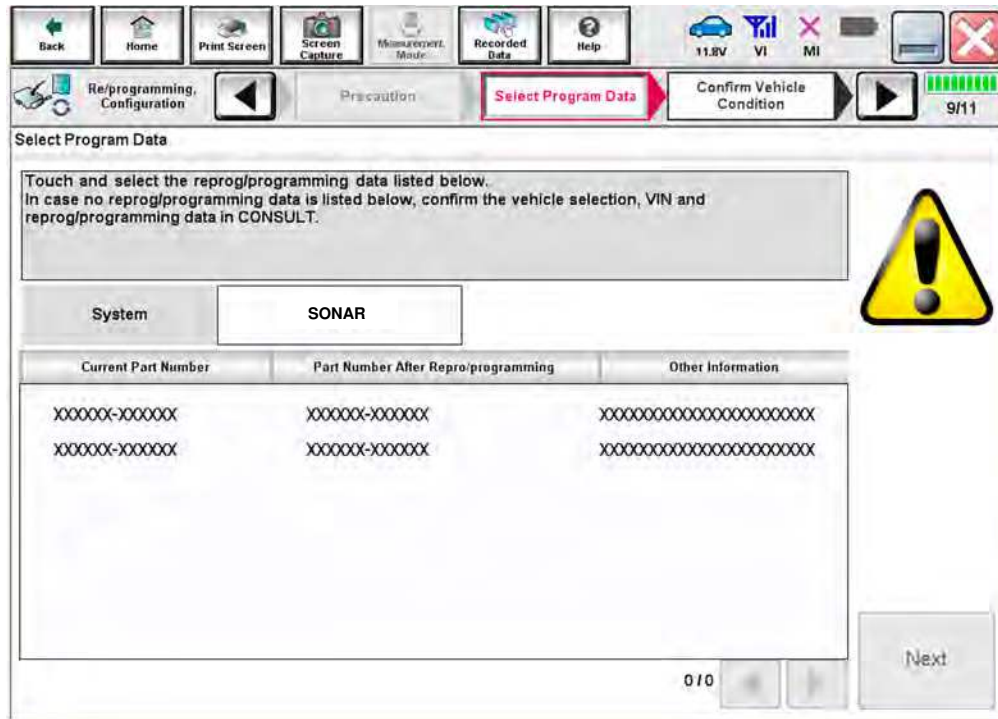
28. In some case, more than one part number for reprogramming is available.

- If the screen in Figure 19 displays, and more than one new part number is available, select and use the reprogramming option that does **not** have the message “Caution! Use ONLY with NTBXX-XXX”.
- If the screen in Figure 19 displays and it is blank (no reprogramming listed), it means there is no reprogramming available for this vehicle. Close C-III plus and refer back to the ESM for further diagnosis.

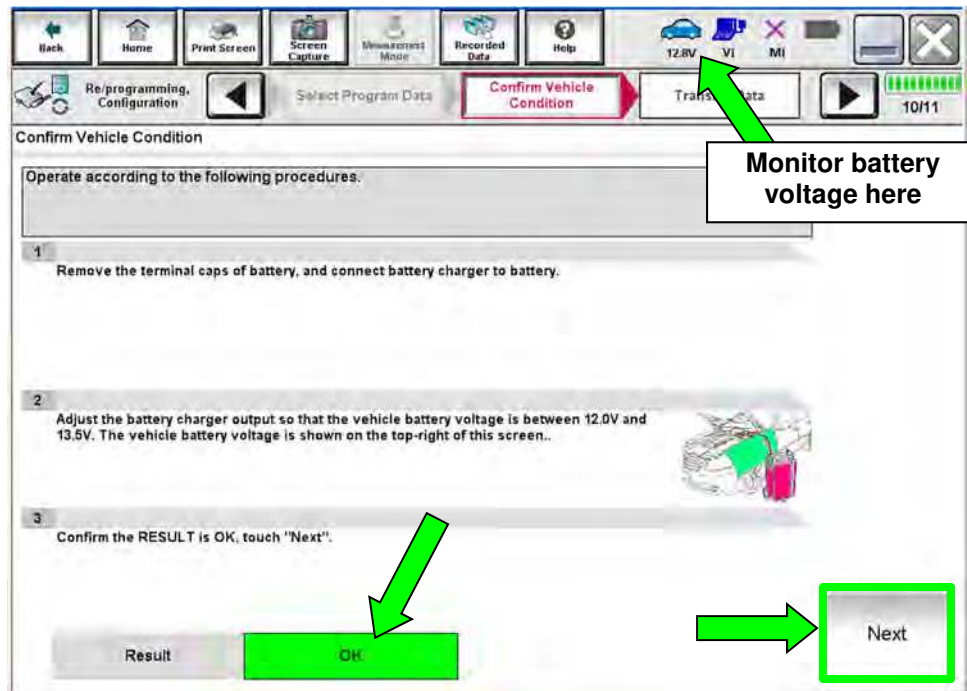
Figure 20

29. Make sure **OK** is highlighted **green** (battery voltage must be between **12.0** and **15.5 Volts**).

30. Select **Next**.

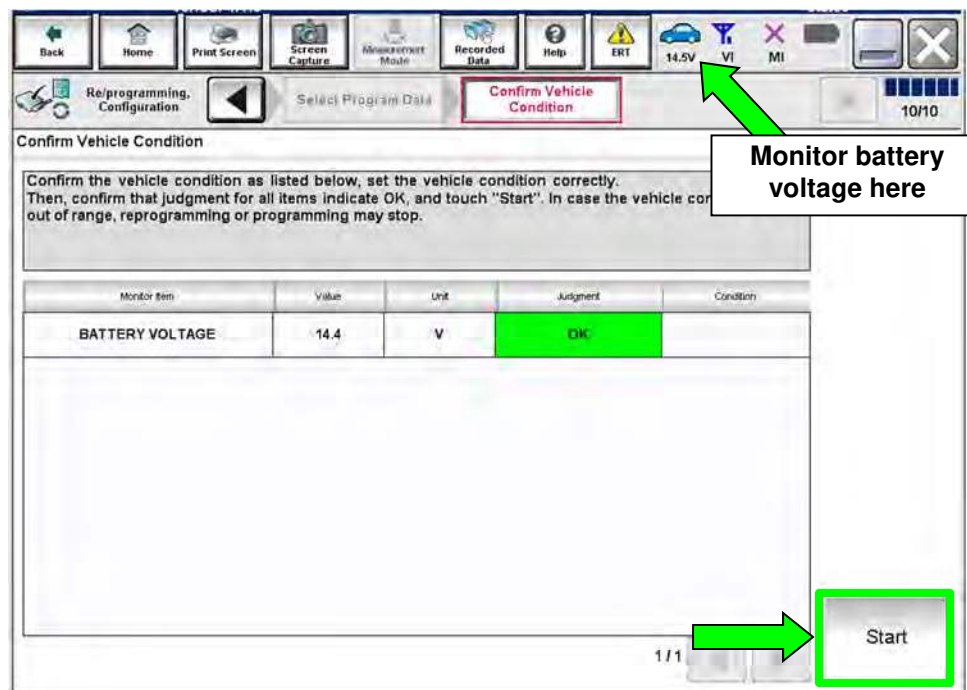
Figure 21

31. Confirm all **Judgment** items are **OK**, then select **Start**.

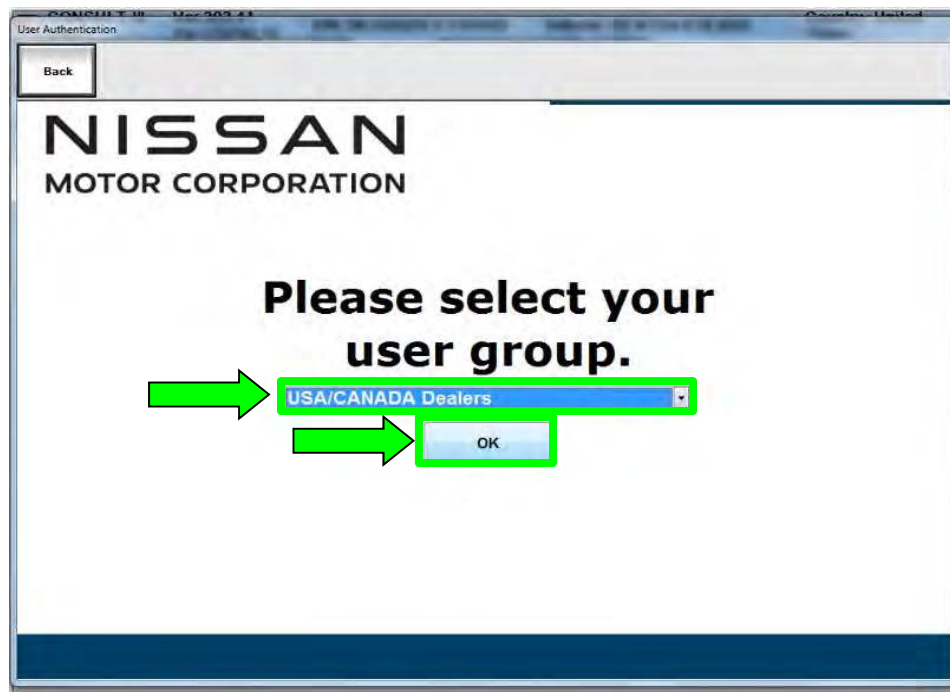
32. Select **USA/CANADA Dealers**.
33. Select **OK**.

- The screen in Figure 22 may not display if the CONSULT PC has remained ON since the last reprogramming.
- If the CONSULT PC is not connected to the internet, the screen in Figure 23 will display.

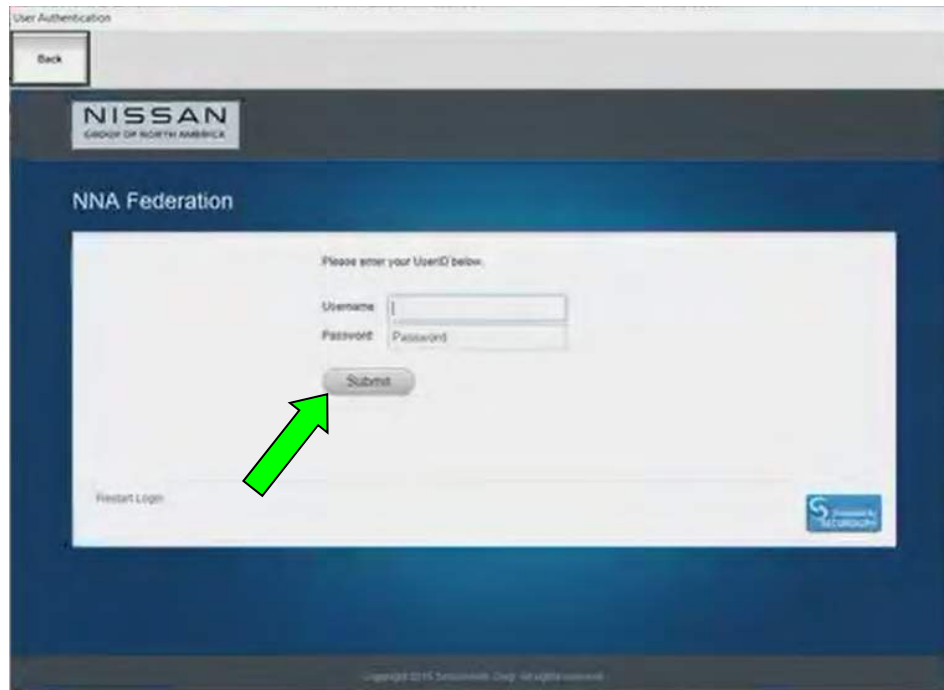
Figure 24

**HINT:** In the next steps, the reprogramming process will begin when **Submit** is selected.

34. Enter your **Username** and **Password**.
  - The CONSULT PC must be connected to the internet via cable or Wi-Fi.
  - If you do not know your username and password, contact your service manager.
35. Select **Submit**.

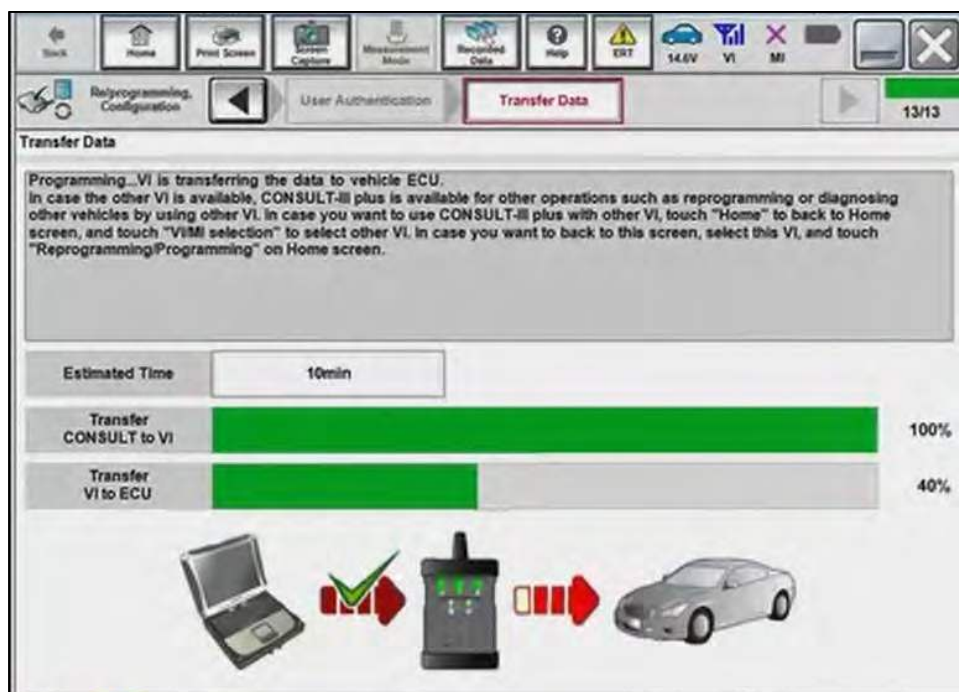
Figure 25

36. Wait for both progress bars to complete.

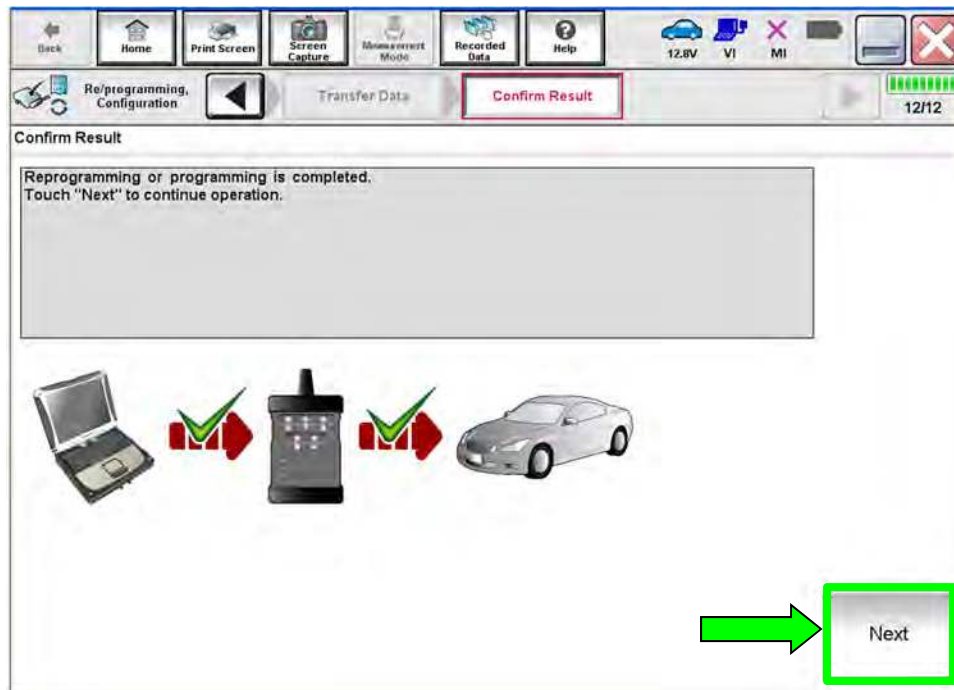
37. When the screen in Figure 26 displays, the reprogramming is complete.
- If the screen in Figure 26 does not display (indicating that reprogramming did not complete), refer to **Sonar Control Unit Recovery** on the next page.
38. Disconnect the battery maintainer or smart charger from the vehicle.
39. Select **Next**.

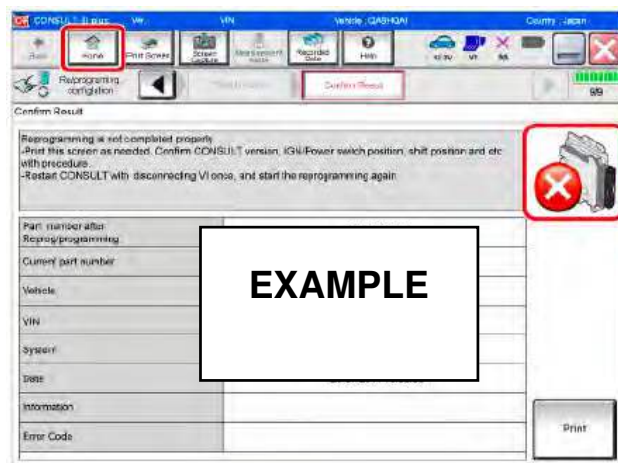
Figure 28

**If reprogramming does not complete and the “X” icon displays as shown in Figure 28:**

- Check battery voltage (12.0 - 15.5 V).
- CONSULT A/C adapter is plugged in.
- Ignition is ON, engine OFF.
- Transmission is in Park.
- All C-III plus / VI cables are securely connected.
- All C-III plus updates are installed.
- **Select Home, and restart the reprogram procedure from the beginning.**

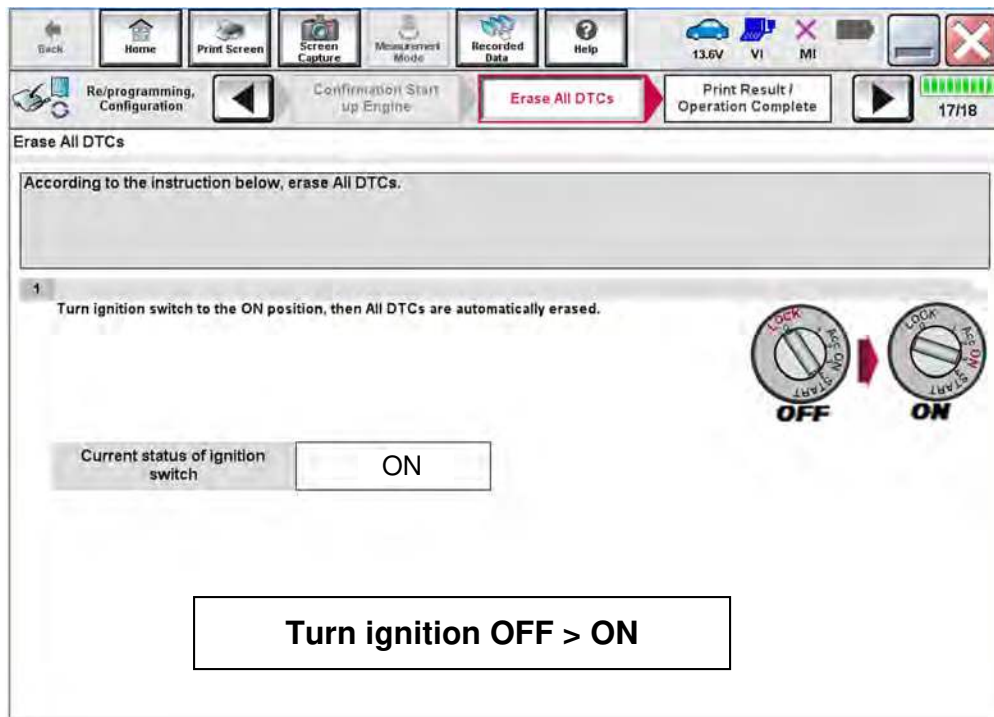
Figure 29

40. Erase all DTCs as follows:

A. Turn the ignition OFF.

B. Turn the ignition ON.

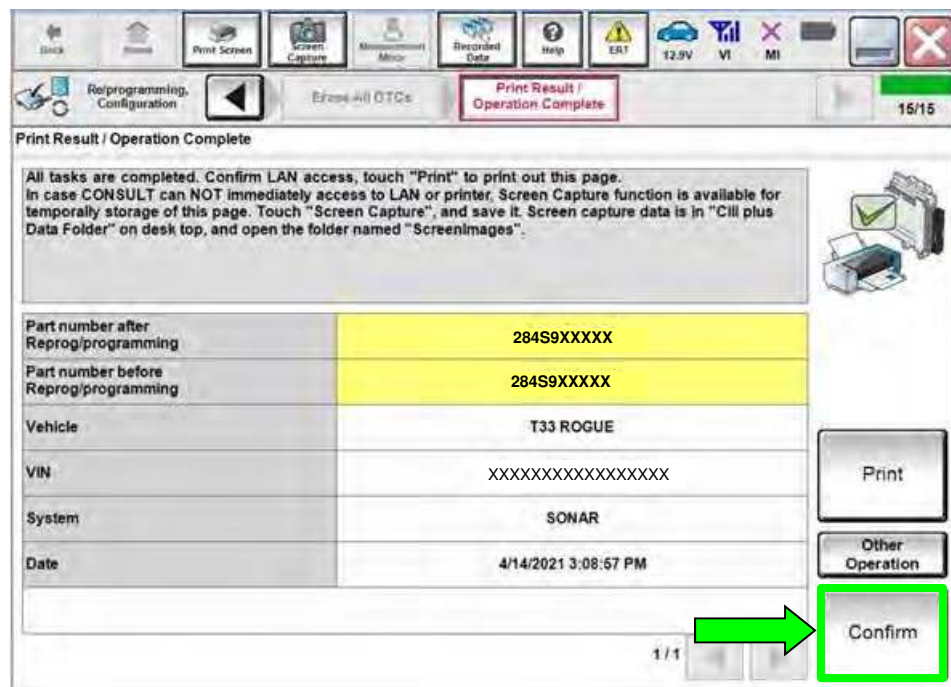
**HINT:** When the entire reprogramming process is complete, the screen in Figure 30 will display.

41. Verify the before and after part numbers are different.
42. Print a copy of the screen below (Figure 30) and attach it to the repair order for warranty documentation.

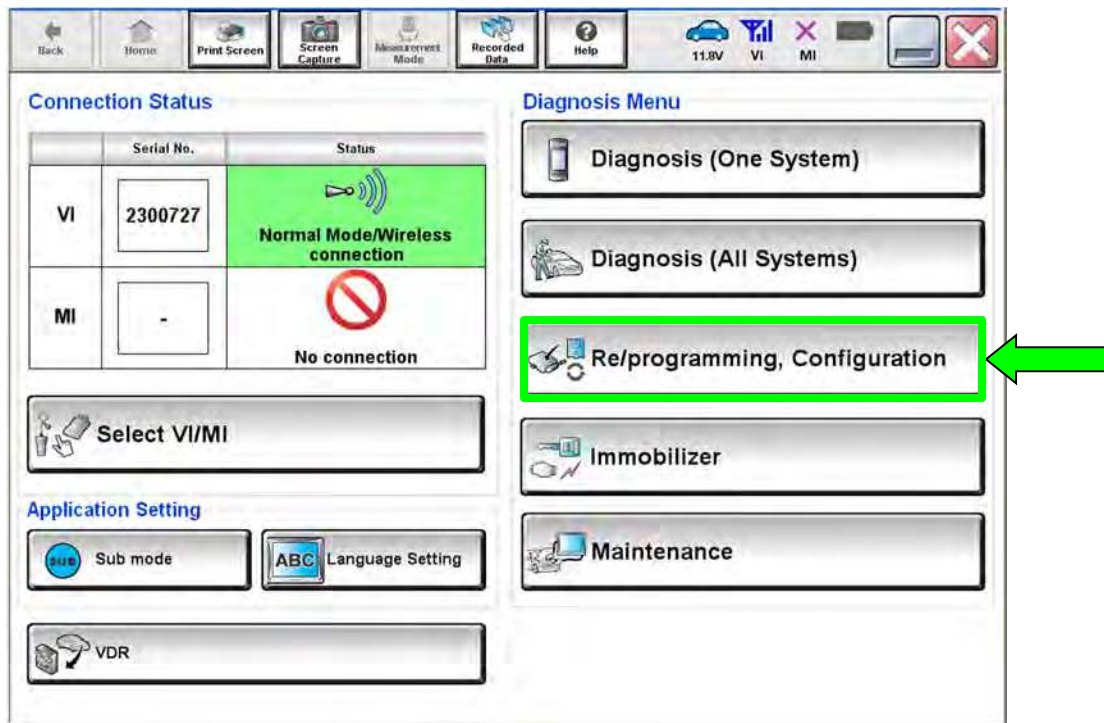
Figure 31

45. Select **Re/programming, Configuration**.

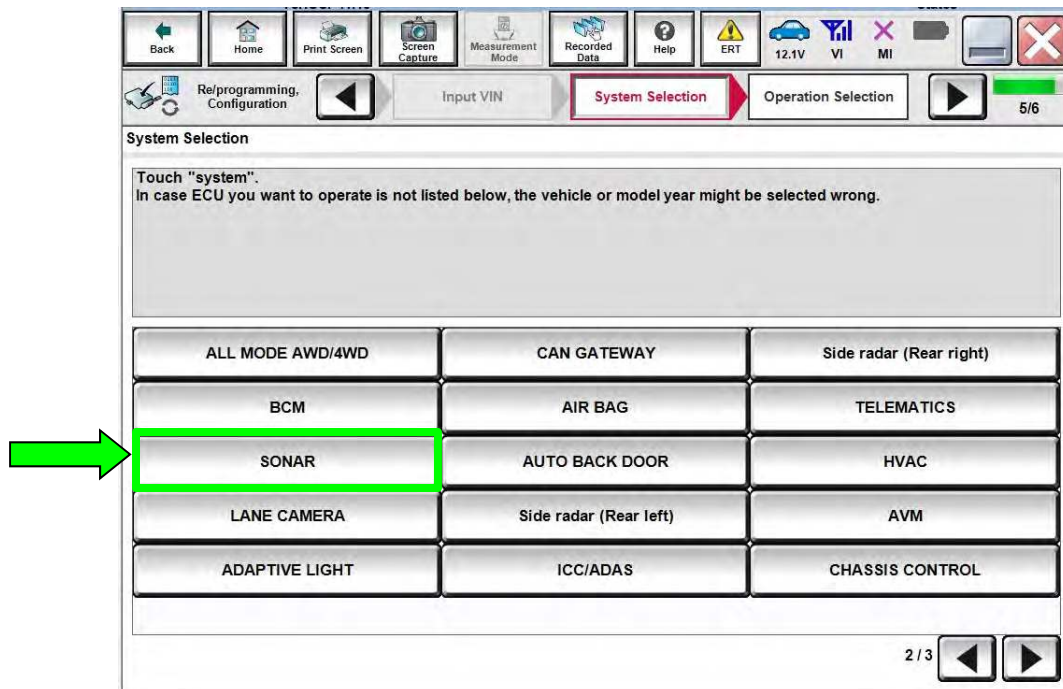
Figure 32

50. Select **SONAR**.

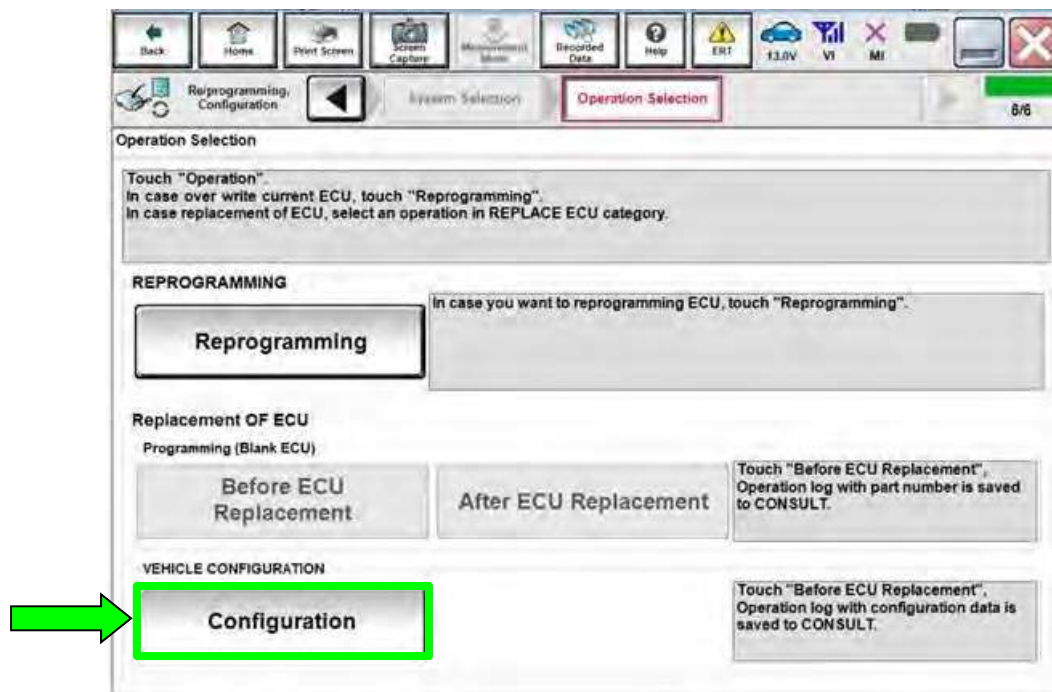
Figure 33

51. Select **Configuration**.

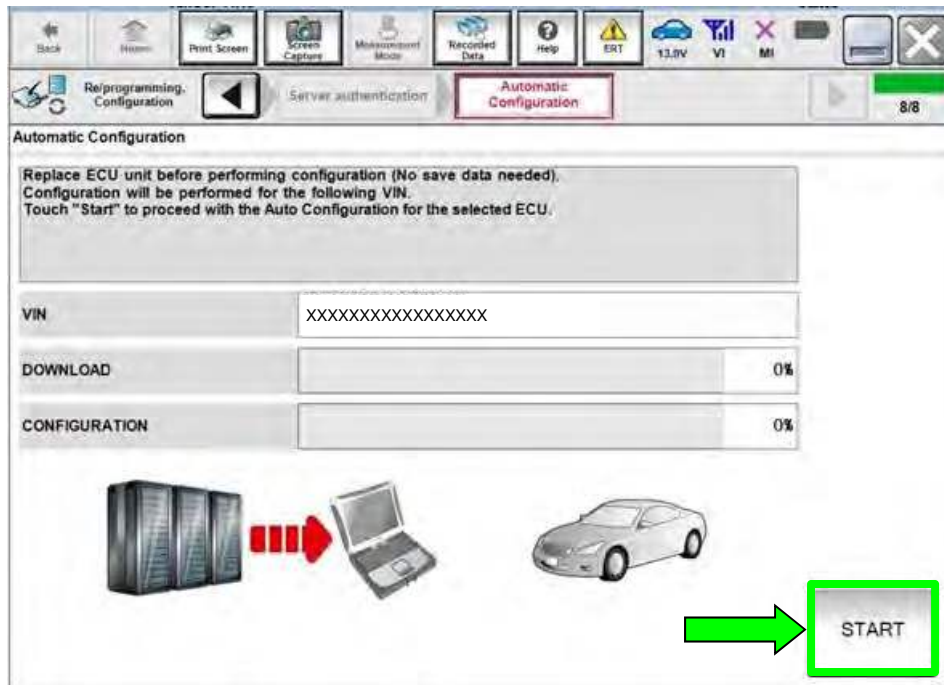
Figure 34

52. Select **START**.

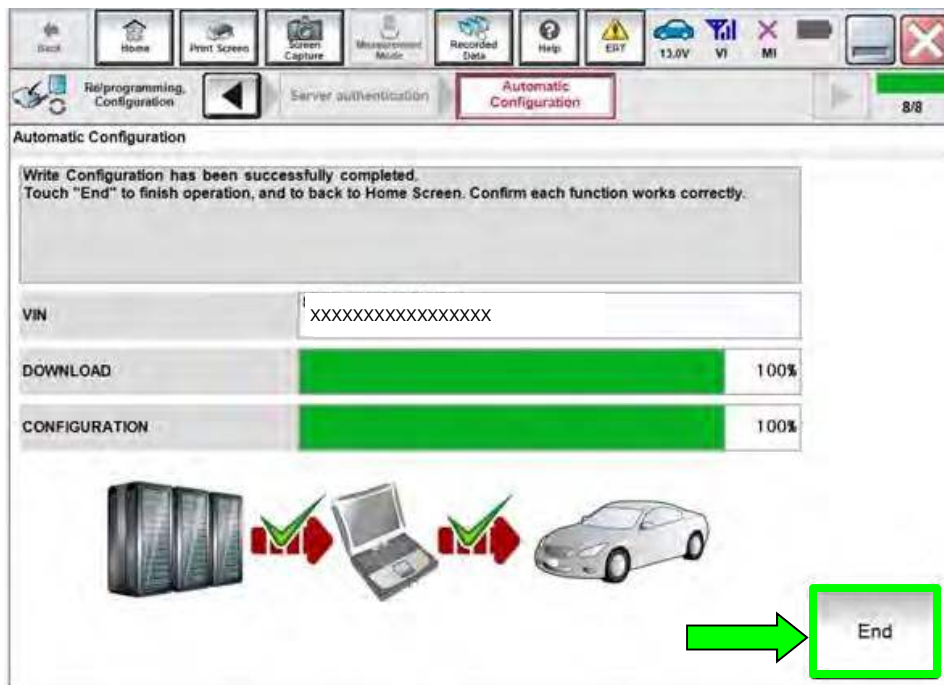
Figure 35

53. Select **End**.

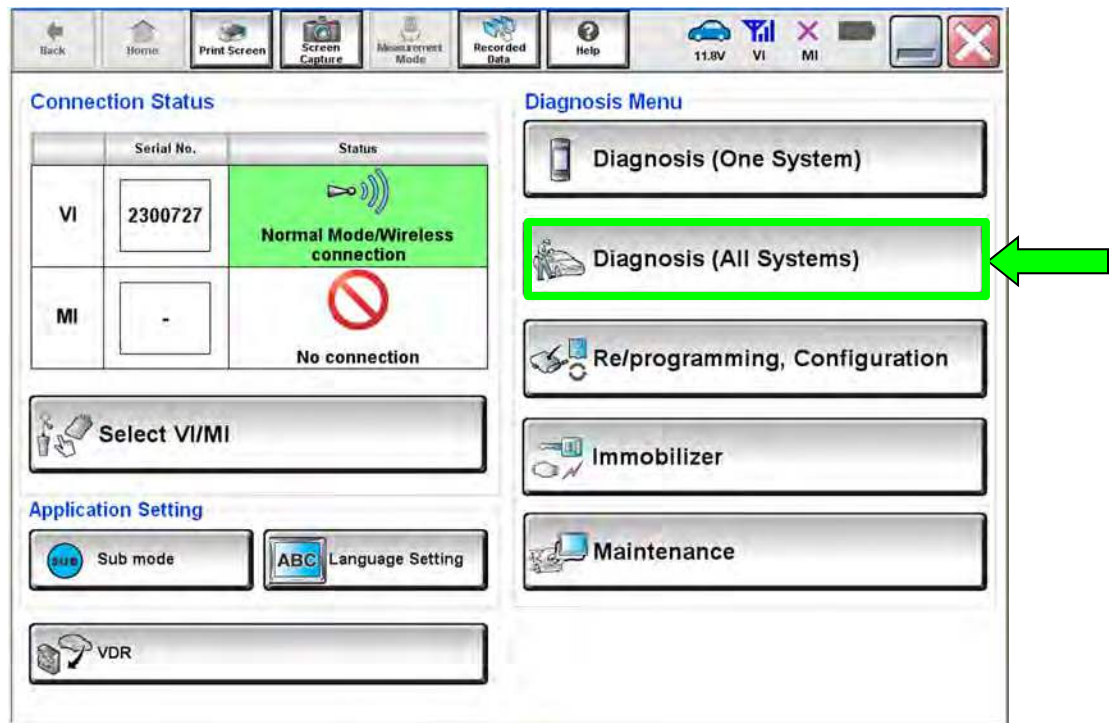
Figure 36

55. Select **Diagnosis (All Systems)**.
