# SERVICE BULLETIN

DA21-003A

## 2021 ROGUE; DTCS B2740-87, B2744-87, AND/OR B274D-87 STORED

**APPLIED VEHICLE:** 2021 Rogue (T33)

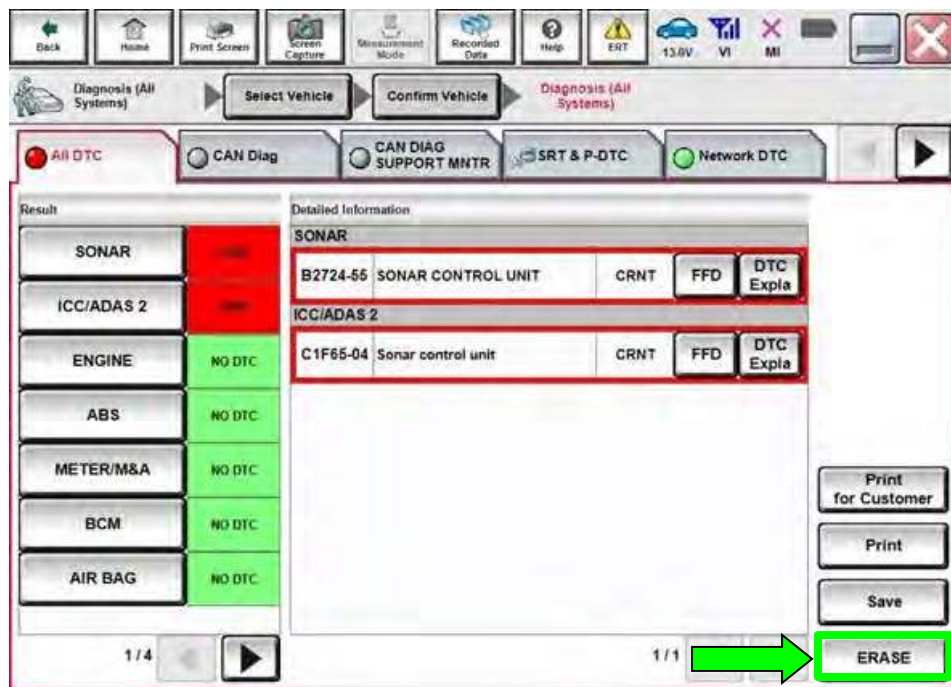
Figure 37

59. Turn the ignition OFF.
60. Turn the ignition ON.
61. DTCs B2724-55 and C1F65-04 may be displayed.
62. Select **ERASE**.
