# Service Bulletin

Bulletin No.: 21-NA-128

Subject: MIL Illuminated- ECM Update for P026C, P20EE, or P11D5

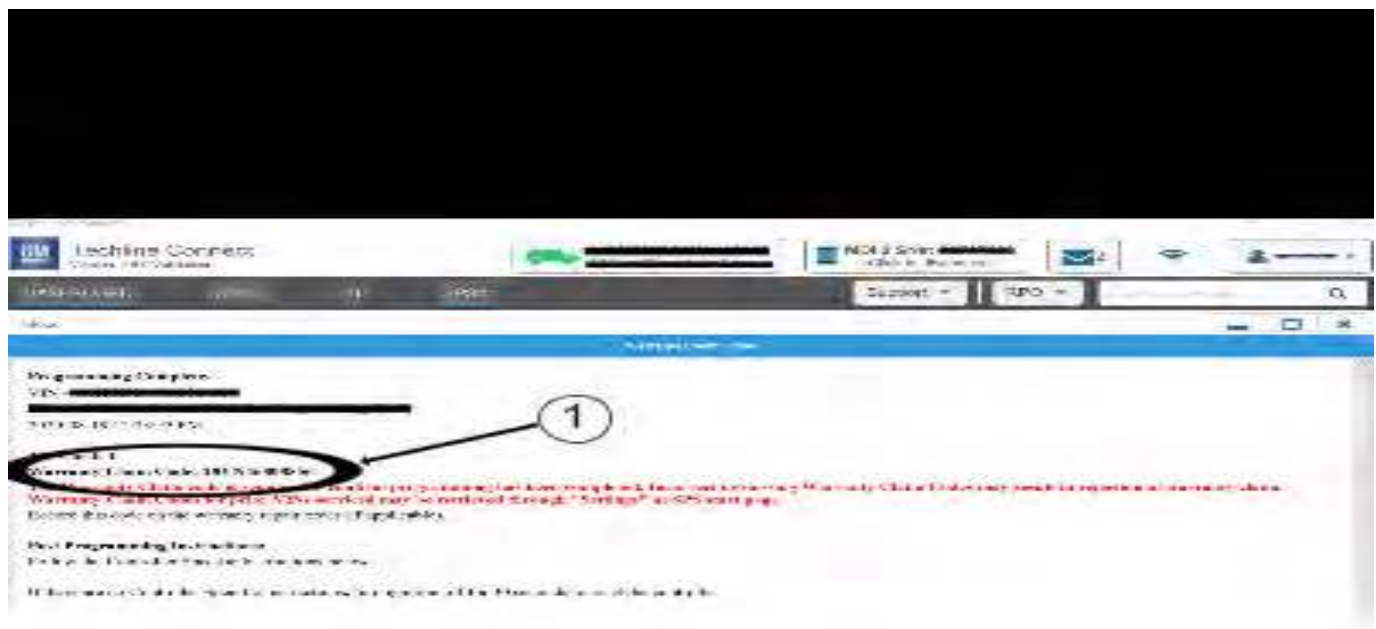
Note: The screenshots above are an example of module programming and may not be indicative of the specific module that is being programmed. Module selection and VIN information have been blacked out.

Important: If the same calibration/software warning is noted on the TLC or SPS Summary screen, select OK and follow screen instructions. After a successful programming event, the WCC is located in the Service

Programming System dialogue box of the SPS Summary screen. No further action is required. Refer to the Warranty section of the bulletin.
