NUMBER  
PI1803Y/Z (Rev 5, 11/04/2021)

## PRODUCT IMPROVEMENT CAMPAIGN

### ENGINE REPLACEMENT INSTRUCTIONS FOR DTC P1326 (PI1803Y/Z)

This bulletin provides information related to the Technical Service Bulletin previously published [PI1803](#) titled "Knock Sensor Detection System - ECU Logic Improvement" equipped w/THETA II engine. Specifically, this bulletin provides instructions on which procedures to follow if, after installation of the KSDS, any one of the subject vehicles below returns to the dealer with Diagnostic Trouble Code (DTC) P1326 (Knock Signal Range/Performance).

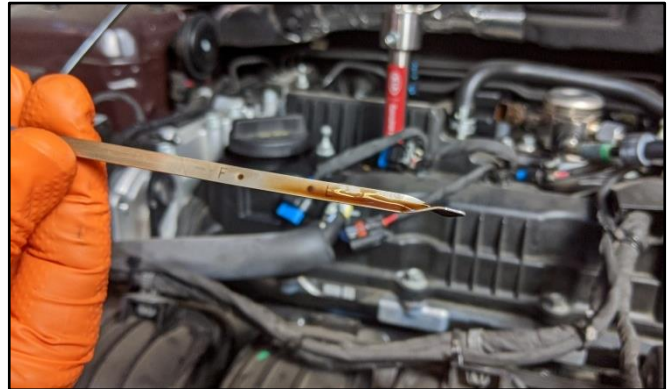
### Oil Level Check: (Applies to all Flowcharts)

1. Measure and record oil dip stick level.
2. Note oil dip stick reading on the RO.
3. If no oil is showing on dipstick, proceed to Oil Level Measurement.

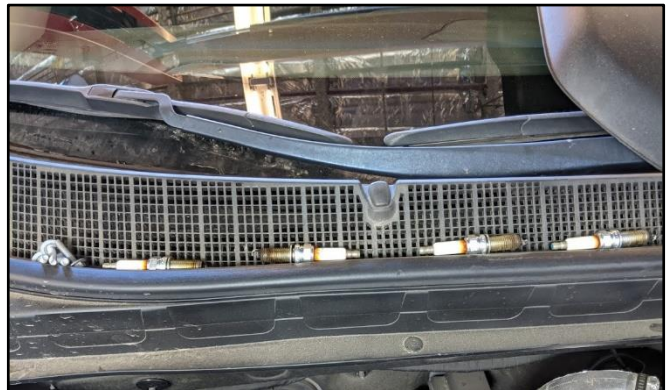
2. Show the removed spark plugs.

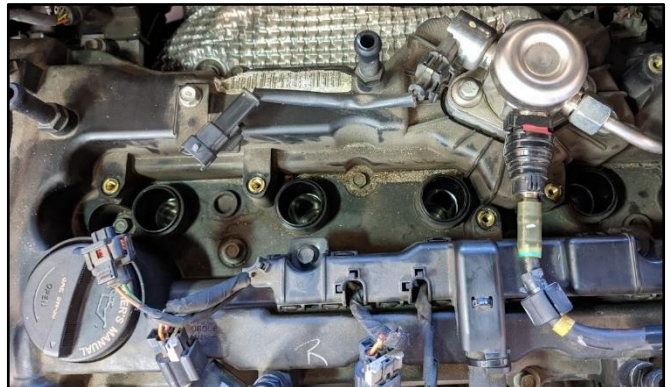
3. Show the empty spark plug holes from the engine.

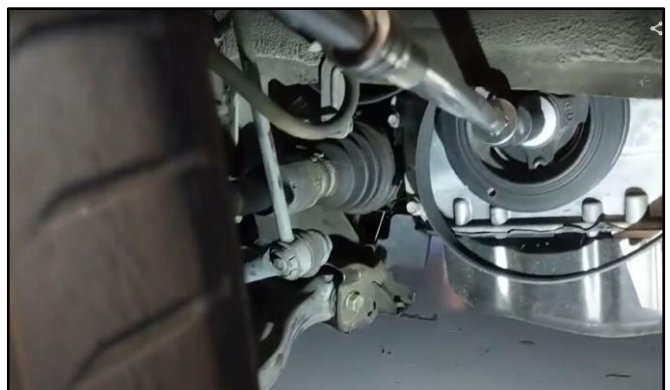
4. Show the removed drive belt and attached torque wrench to crank bolt.
