# Audio Head Unit Software Update (Denso-Ten)

**Service Category** Audio/Visual/Telematics

**Section** Navigation/Multi Info Display

## Audio Head Unit Software Update (Denso-Ten)

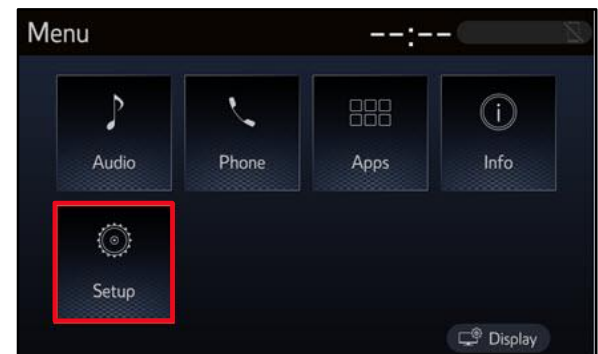
**Figure 1.**

1. Turn the ignition to IG-ON/Ready-OFF.
2. Is the vehicle currently being updated a 2020 – 2022 model year Highlander, Highlander HV, RAV4 and RAV4 HV, or 2021– 2022 model year RAV4 Prime equipped with Premium Audio?
  - **YES** — Continue to step 3.
  - **NO** — Go to step 8.
3. Is the radio experiencing a continuously rebooting condition?
  - **YES** — Continue to step 4.
  - **NO** — Go to step 8.
4. Apply the parking brake.
5. Shift the gear selector to Reverse.
6. Leave the vehicle in Reverse for a minimum of five minutes.
7. After the five minutes have elapsed, shift the gear selector back to Park. The radio will now boot up normally.
8. Press the Menu button on the radio faceplate, then select Setup.

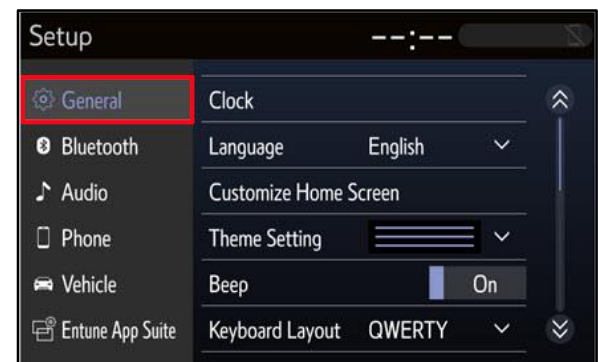
**Figure 2.**

9. Select General on the Setup screen.

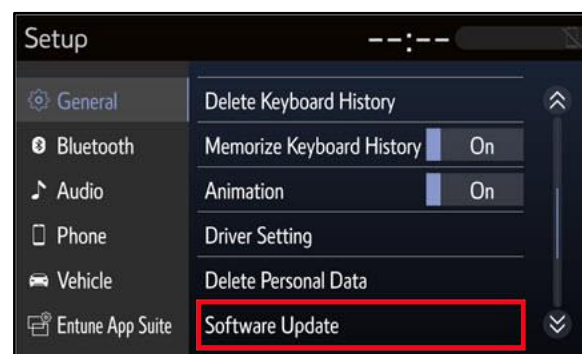
**Figure 3.**

10. Scroll down and select Software Update.

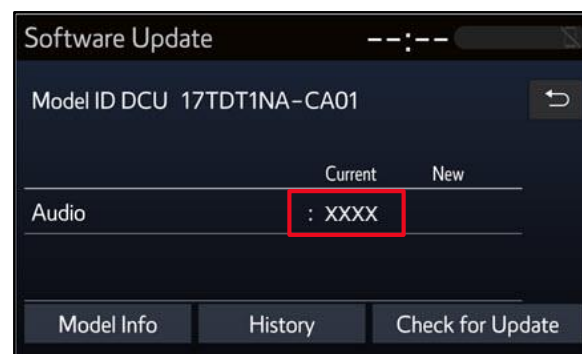
**Figure 4.**

11. Verify that the software version is the same or earlier than indicated in the Introduction.

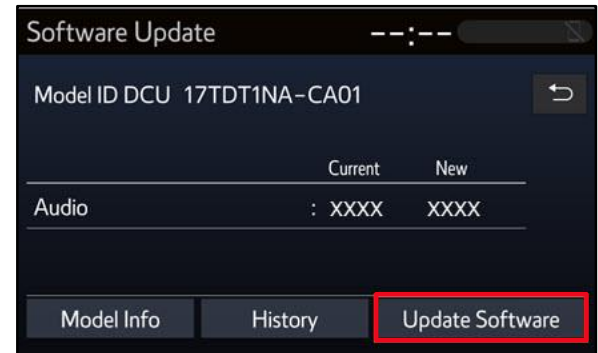
**Figure 5.**

15. Select the Update Software button in the lower right-hand corner.

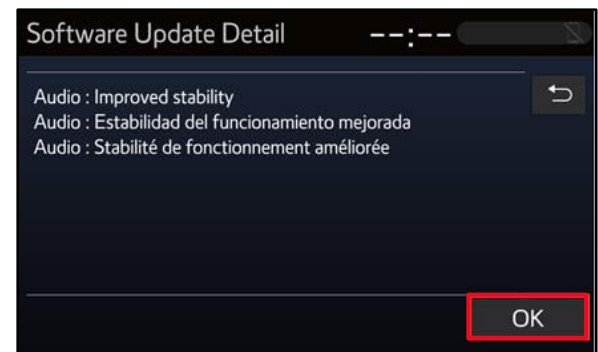
**Figure 6.**

16. Select OK on the Software Update Detail screen.

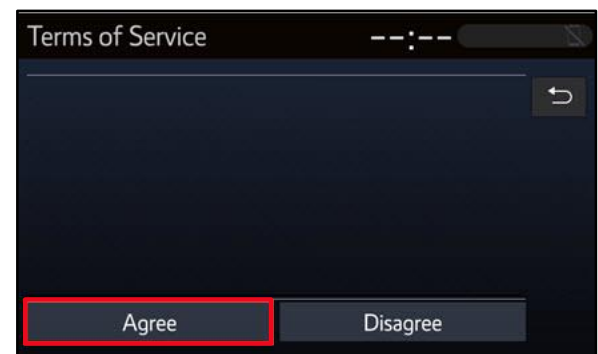
**Figure 7.**

17. Select Agree on the Terms of Service screen.

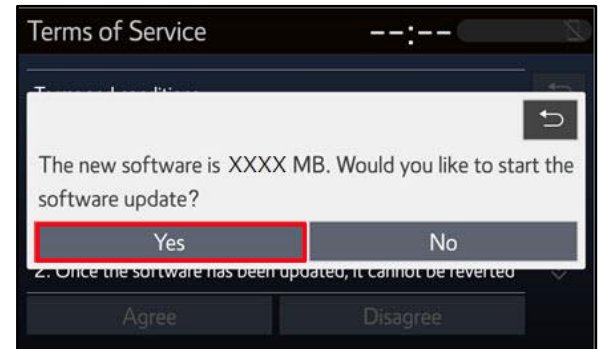
**Figure 8.**

18. Select Yes on the “Would you like to start the software update?” pop-up.

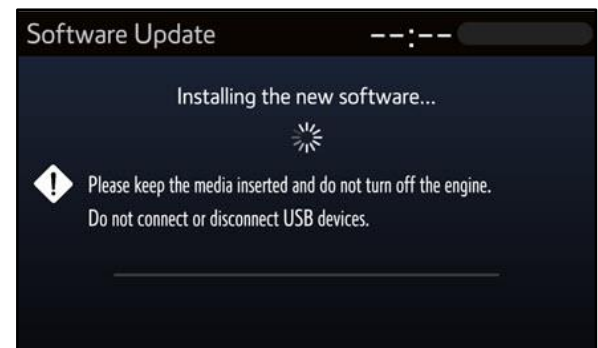
**Figure 9.**

19. Once the head unit begins installation, the update will take approximately 10 minutes.

- Do NOT turn OFF the ignition or ACC BEFORE the software is ready for updating.
- Do NOT remove the USB flash drive until instructed in step 23.

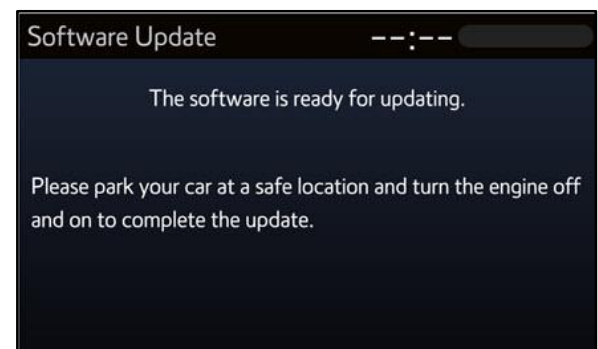
**Figure 10.**

20. When the “The software is ready for updating” screen appears, turn OFF the ignition.

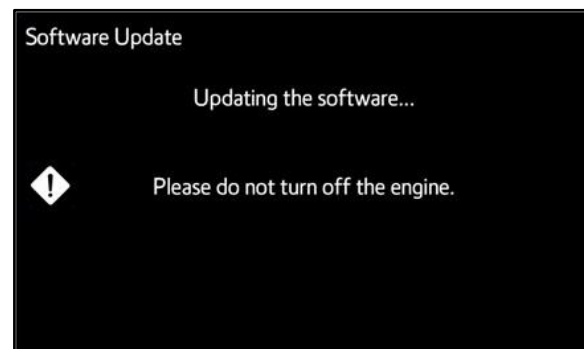
**Figure 11.**

22. AFTER turning the ignition ON, the Software Update screen will appear. Do NOT turn OFF the ignition or remove the USB flash drive. The head unit will reboot during this time.

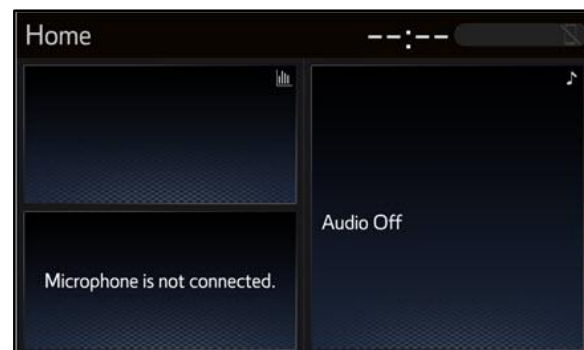
**Figure 12.**

23. Once the software update is complete and the Home screen appears, remove the USB flash drive.

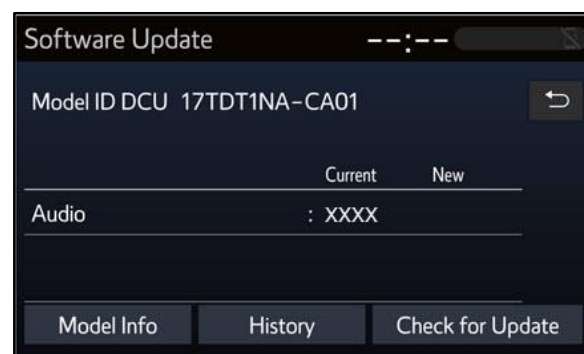
**Figure 13.**

24. Perform steps 9 – 12 to verify the software version matches the current software version information table below.
