## Subject: Short Range Radar (SRR) with DTC U3000 49 Set

| <b>Condition</b> | Some customers may comment on a DIC message stating Service Driver Assist on display. Technicians may find DTC U3000 49 (Control Module Internal Malfunction) set current or in recent history |

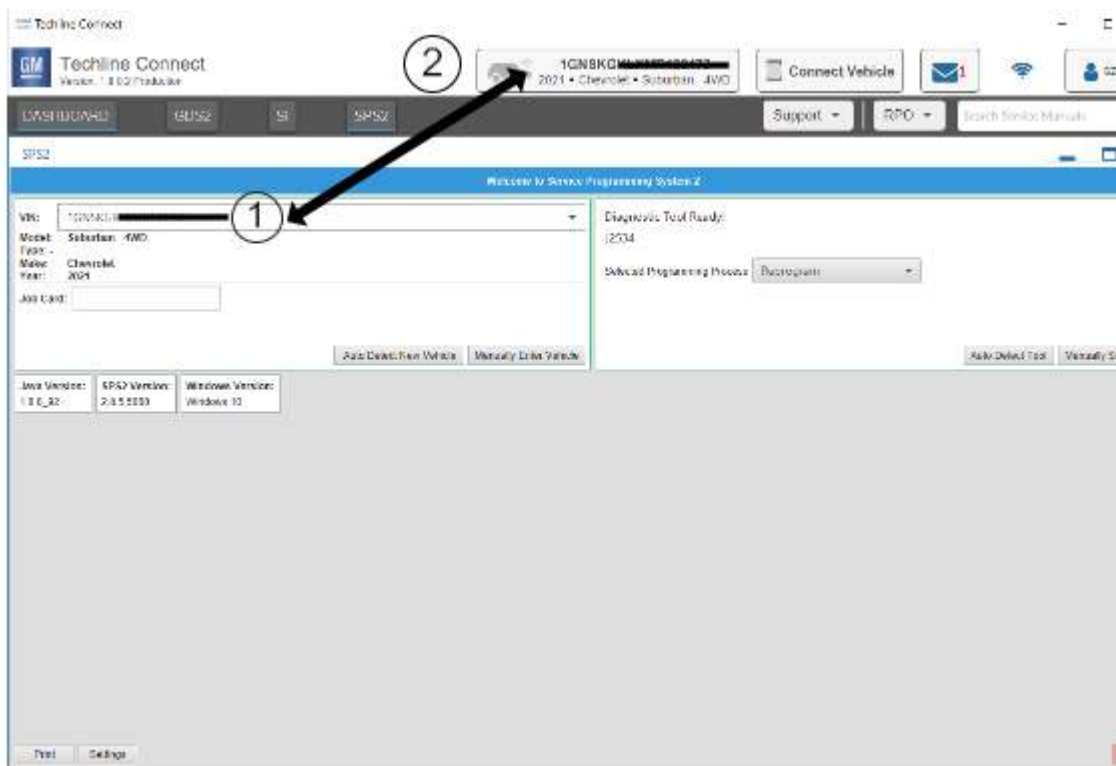
5743643

**Caution:** Be sure the VIN selected in the drop down menu (1) is the same as the vehicle connected (2) before beginning programming.

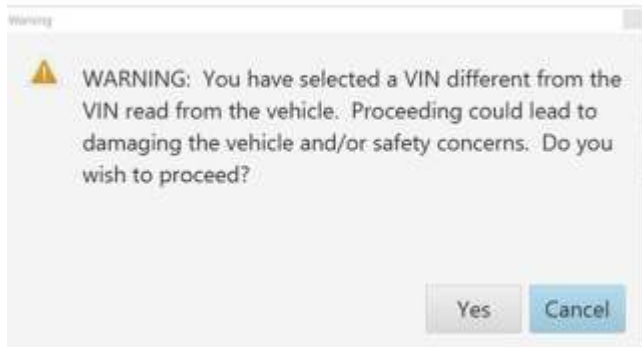
5877000

**Important:** If the vehicle VIN DOES NOT match, the message below will be shown

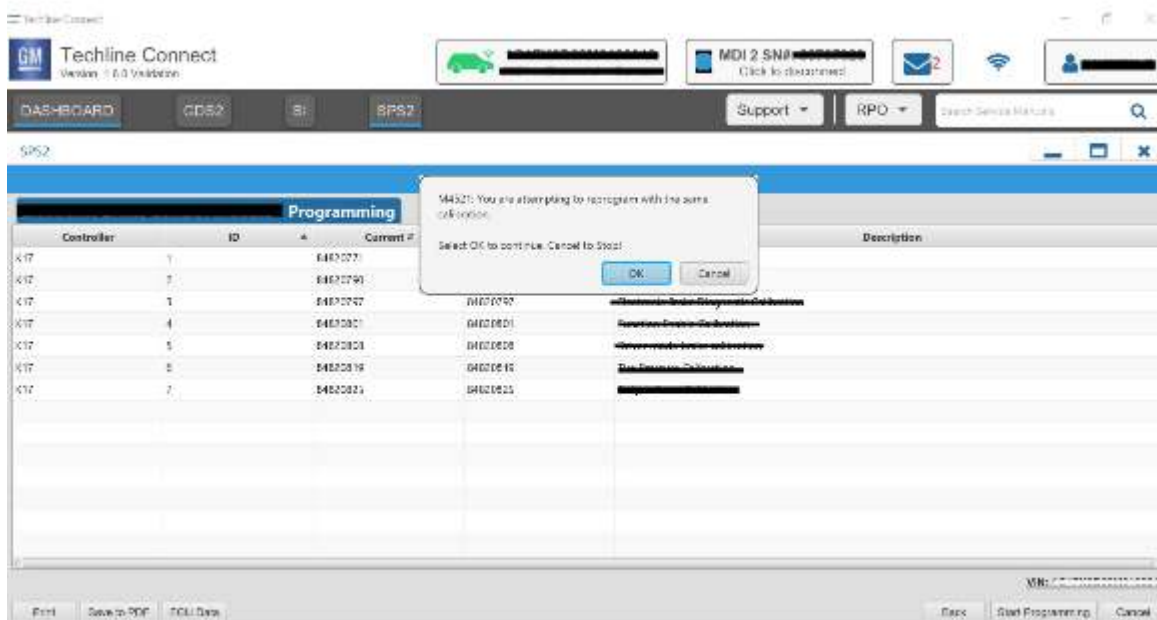
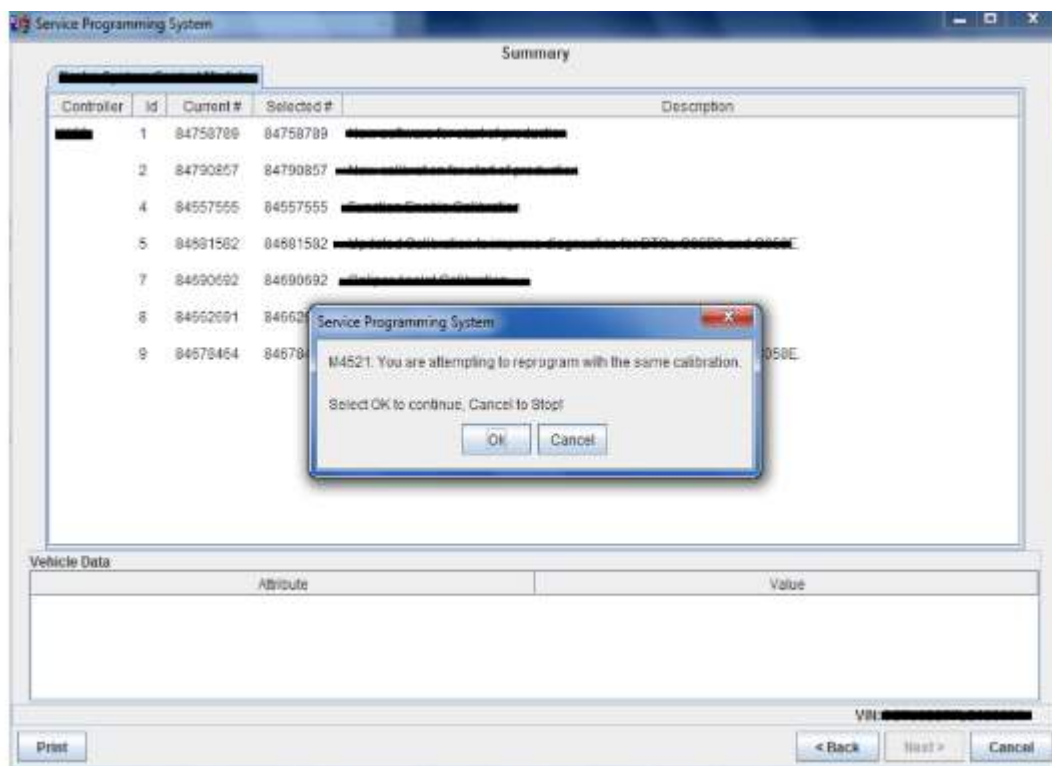
**Important:** Techline Connect and TIS2WEB screens shown above.

**Important:** If the same calibration/software warning is noted on the TLC or SPS Summary screen, select OK and follow screen instructions. After a successful programming event, the WCC is located in the Service Programming System dialogue box of the SPS Summary screen. No further action is required. Refer to the Warranty section of the bulletin.

**Note:** The screenshots above are an example of module programming and may not be indicative of the specific module that is being programmed. Module selection and VIN information have been blacked out.

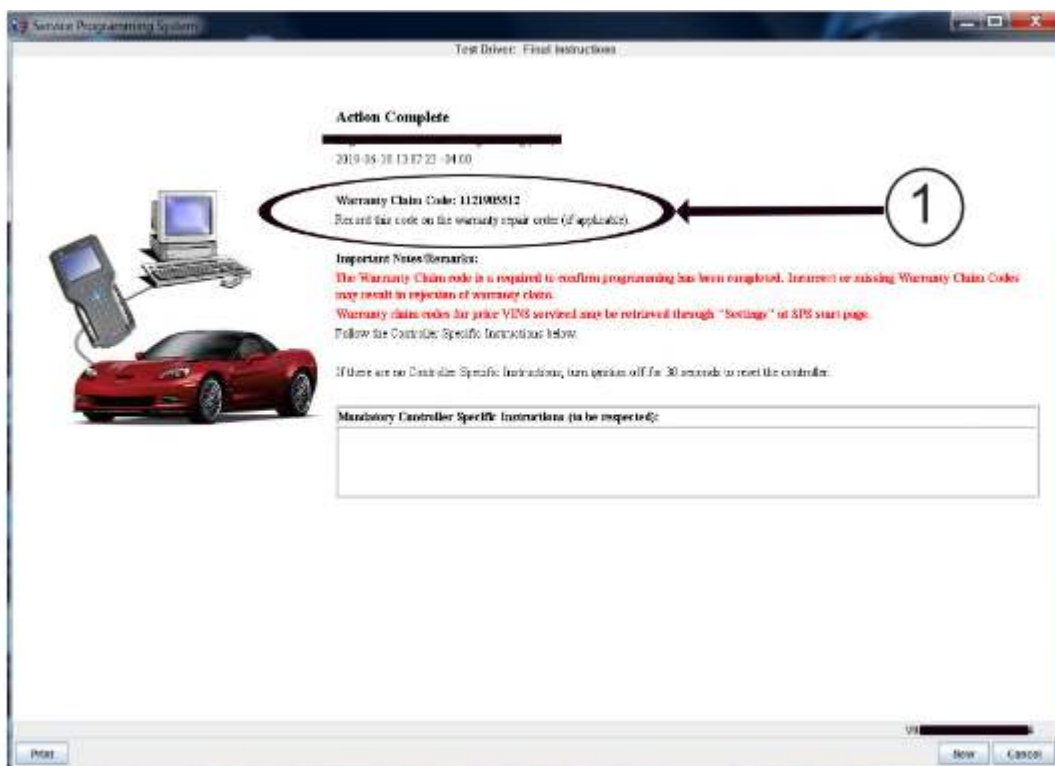
5431209

**Programming Complete:**  
VIN [REDACTED]  
2020-08-19 12:23:43 PM

Card: 1  
**Warranty Claim Code: 28YN46808586**

**Post Programming Instructions:**  
Follow the Controller Specific Instructions below.  
If there are no Controller Specific Instructions, turn ignition off for 30 seconds to reset the controller.
