MODEL  
2020-2021MY  
Soul (SK3)  
2021MY  
Seltos (SP2)

NUMBER  
227 (Rev 1, 01/13/2022)

## TECHNICAL SERVICE BULLETIN

**SERVICE ACTION: MIL ON DTC P0605 AND/OR P2181  
ECM LOGIC IMPROVEMENT (SA463)**

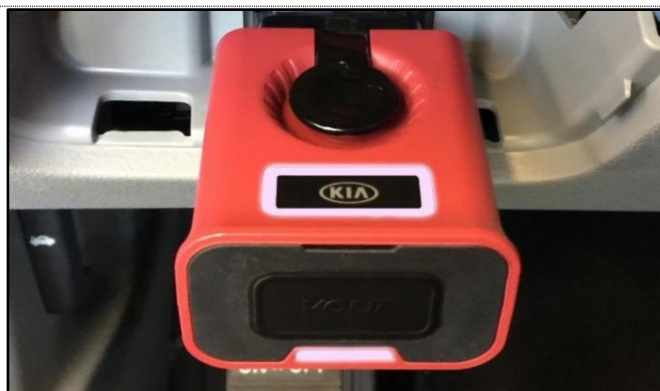
1. Connect the VCI-II to the OBD-II connector, located under the driver's side of the instrument panel.

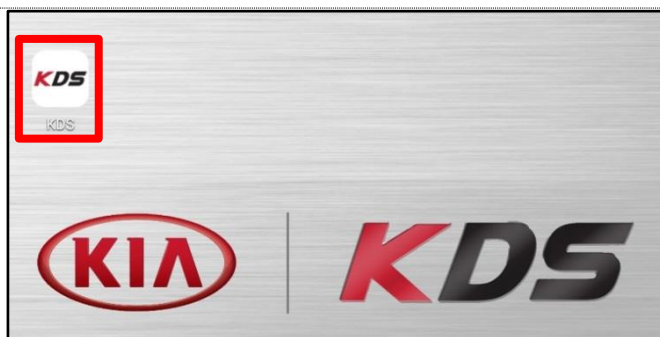
2. With the ignition ON, turn ON the KDS tablet. Select **KDS** from the home screen.

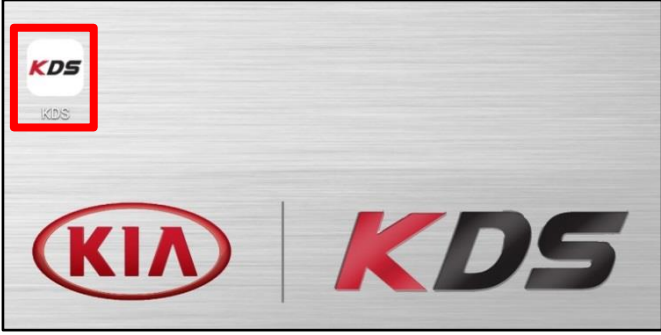
| 2. With the ignition ON, turn ON the KDS tablet. Select <b>KDS</b> from the home screen. | |
