# Audio Head Unit Software Update (Pioneer)

## Audio Head Unit Software Update (Pioneer)

Some 2020 – 2022 model year Lexus vehicles equipped with Pioneer Audio (version 1804) or earlier may exhibit one or more of the following conditions:

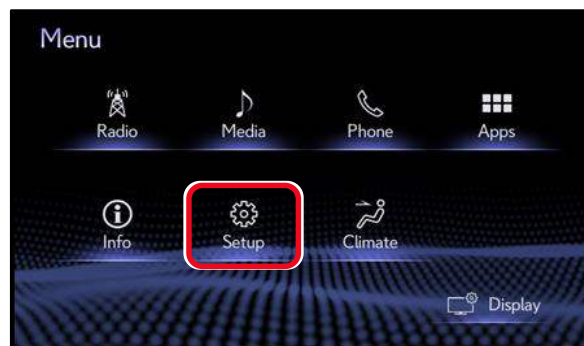
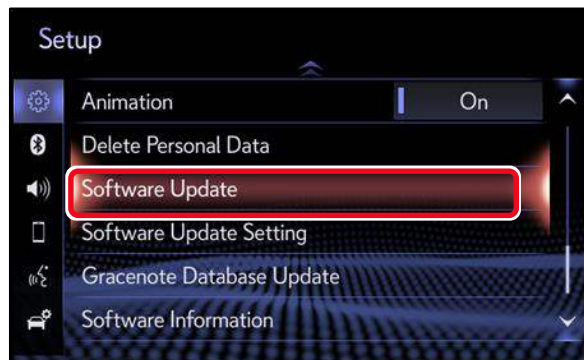
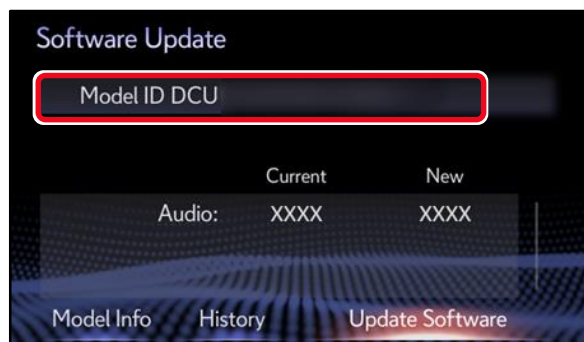
1. Start the engine.
2. Select Setup from the menu.
3. Scroll down and select Software Update.
4. Record the Model ID.
5. Verify that the Current software version is the same or earlier than indicated in the Introduction.
6. Download the appropriate multimedia software update file from the Multimedia Software Update section.

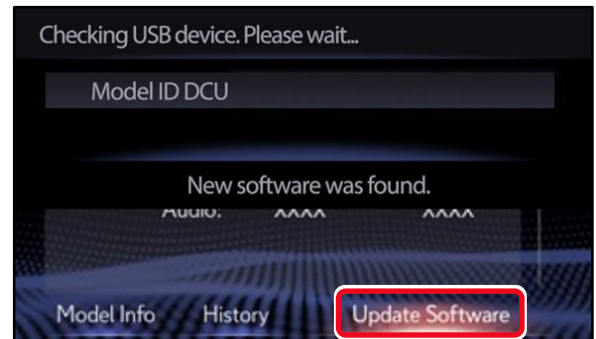
**Figure 4.**

7. Insert the prepared USB flash drive into the vehicle's USB port.

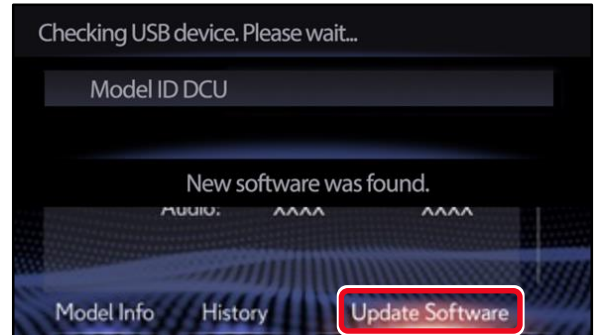
**Figure 5.**

9. Select the Update Software button in the lower right corner.

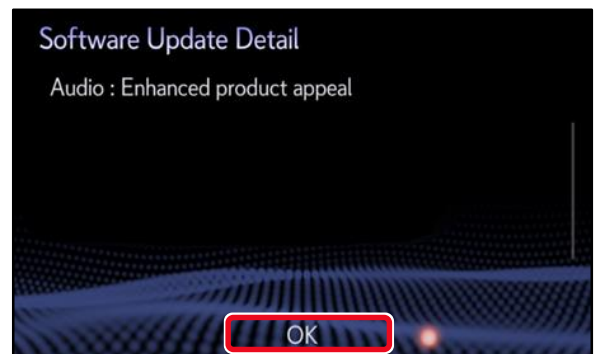
**Figure 6.**

10. Select OK on the Software Update Detail screen.

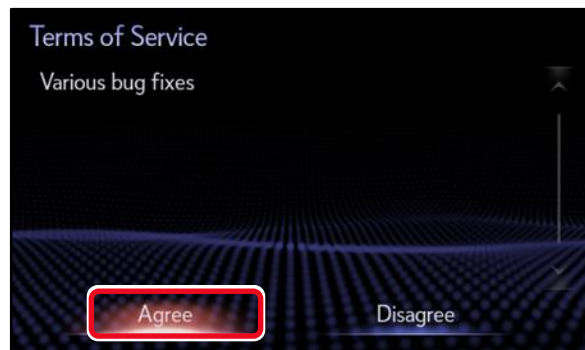
**Figure 7.**

11. Select Agree on the Terms of Service screen.

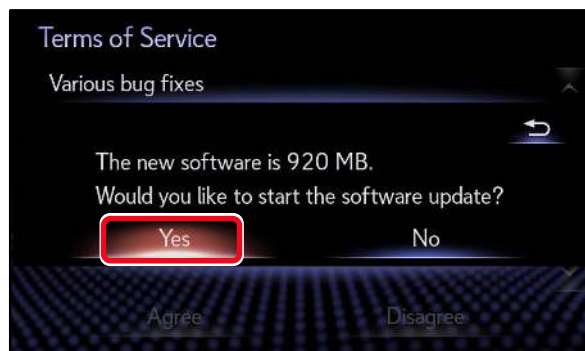
**Figure 8.**

12. Select Yes on the "Would you like to start the software update?" pop-up.

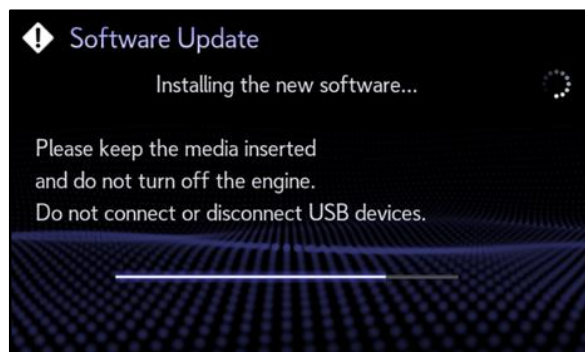
**Figure 9.**

13. Once the head unit begins installation, the update will take approximately 10 minutes.

- Do NOT turn OFF the vehicle or ACC BEFORE the software is ready for updating.
- Do NOT remove the USB flash drive until instructed in step 16.

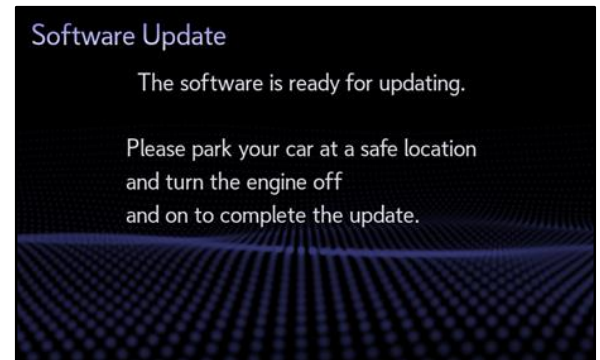
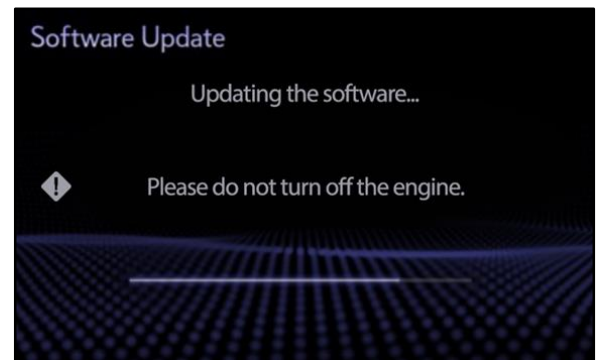
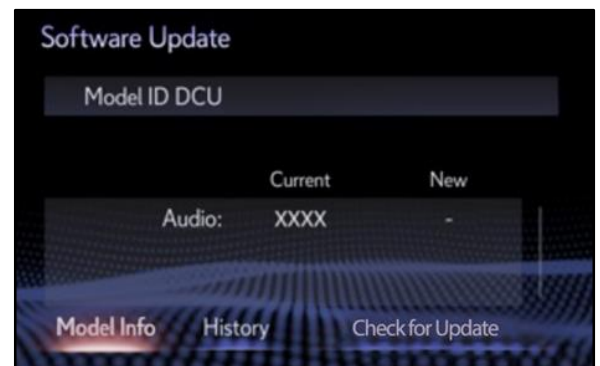
14. When the “The software is ready for updating.” screen appears, turn OFF the vehicle.
15. Turn the vehicle ON to complete the software update.
16. Once the software update is complete, remove the USB flash drive.
17. Perform steps 1 – 5 to verify the current software version has been updated.
