| | FUE | 2022MY<br>Carnival (KA4) |
| | 057 | April 2022 |
| TECHNICAL SERVICE BULLETIN | | |
| SUBJECT: MIL ON DTC P0456 ECM LOGIC IMPROVEMENT | | |

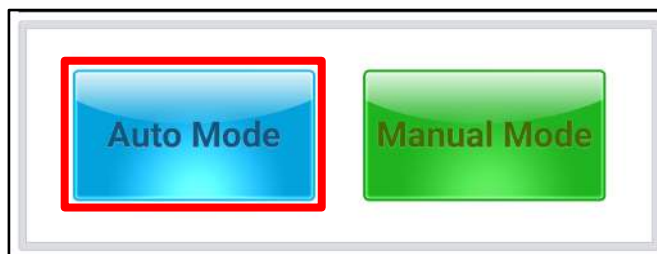
6. Select Auto Mode.

Do NOT attempt to perform a Manual Mode upgrade UNLESS Auto Mode fails. Always follow the instructions given on the KDS in either Auto or Manual mode.
