# Service Bulletin

Bulletin No.: 21-NA-243

Subject: Short Range Radar (SRR) with DTC U3000 49 Set

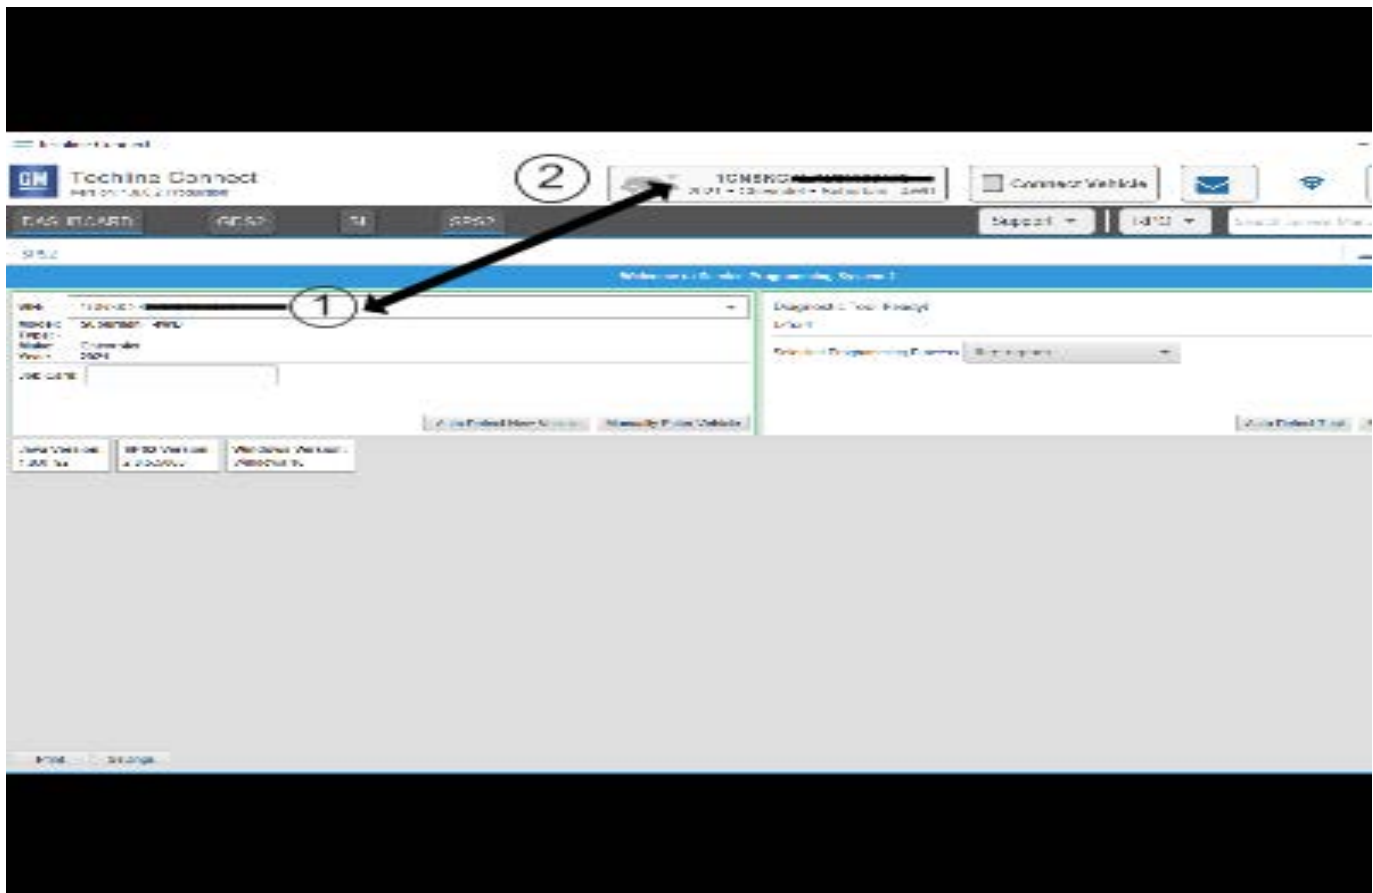
Caution: Be sure the VIN selected in the drop down menu (1) is the same as the vehicle connected (2) before beginning programming.
