# Technical Service Bulletin

## 37 Transmission warning message in cluster (DTC P060A00)

37 13 17 2029027/8 September 11, 2013. Supersedes Technical Service Bulletin Group 37 number 13-02 dated April 26, 2013 for reasons listed below.

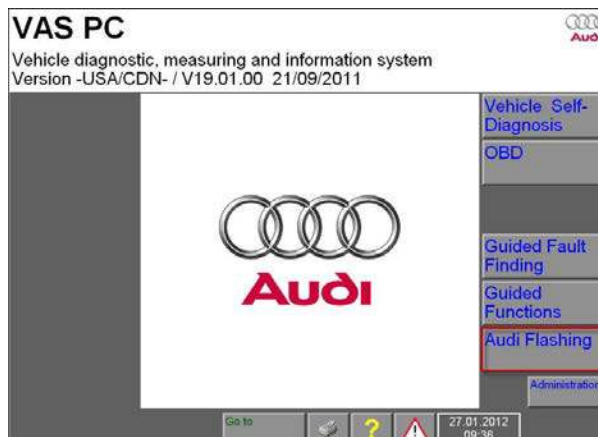
- Turn off any appliances with high electromagnetic radiation (such as mobile phones).
  - If communication with a module cannot be properly established, appropriate repairs must be made before attempting SVM. If the tester cannot communicate with a module, the tester cannot flash software onto the module.
5. Enter the SVM code into the User Test Plan by selecting the **Audi Flashing** option at the main tester screen, unless otherwise directed by the TSB or TAC Helpline.

**Figure 2.** Audi Flashing.
