# Technical Service Bulletin

## 37 Transmission warning message in cluster, P074100 stored in TCM

37 13 80 2028985/6 January 16, 2013. Supersedes Technical Service Bulletin Group 37 number 12-72 dated November 8, 2012 for reasons listed below.

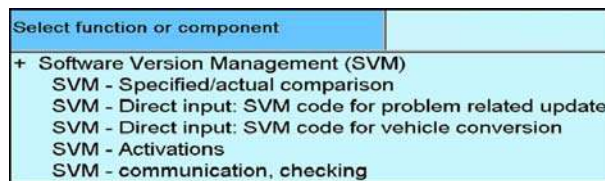
Figure 1. SVM options.

SVM is a function within GFF with the options illustrated in Figure 1 and explained below.
