# DCM Reset and Firmware Update (LG)

**Service Category** Audio/Visual/Telematics

**Section** Cellular Communication

## DCM Reset and Firmware Update (LG)

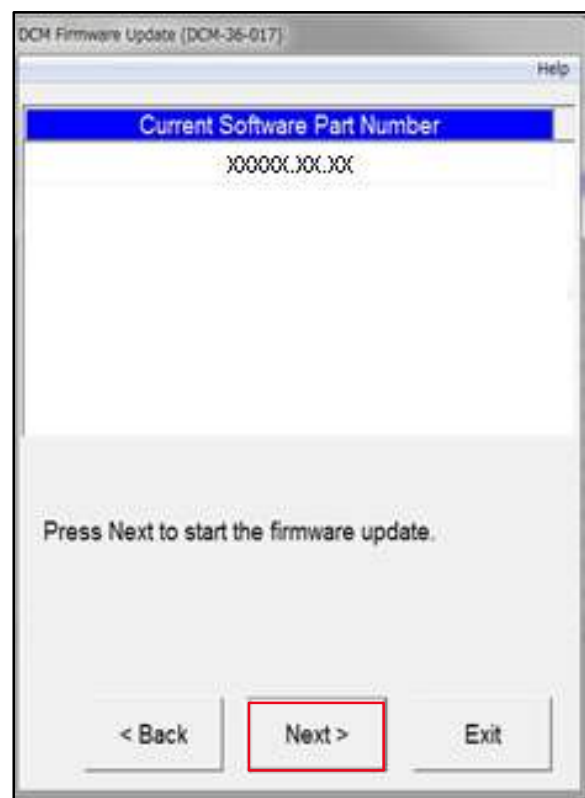
**Figure 5.**

11. Click on Next when the current software part number screen appears.

If the screen in Figure 5 does NOT appear and an error message displays, begin the Firmware Update Procedure again from step 4. The battery reset MUST be performed again.

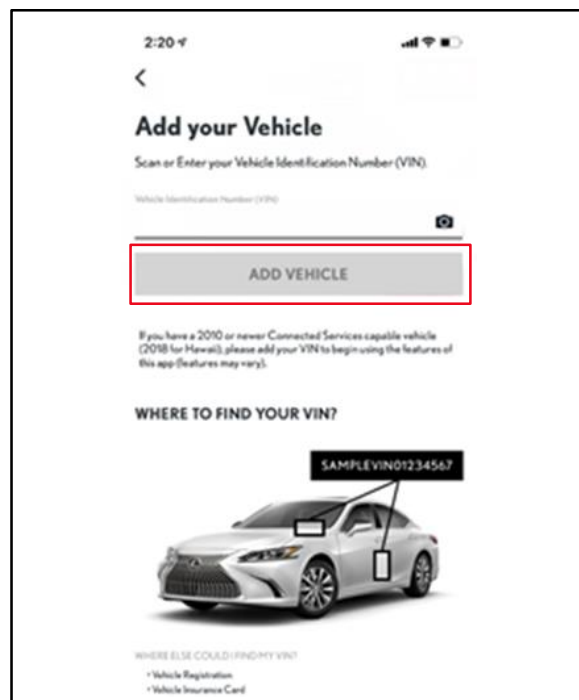
**Figure 11.**

19. Click on Add Vehicle to perform the enrollment again.
