# Service Bulletin

Bulletin No.: 20-NA-218

Subject: Possible Crank No Start or Extended Crank with DTC P12A6

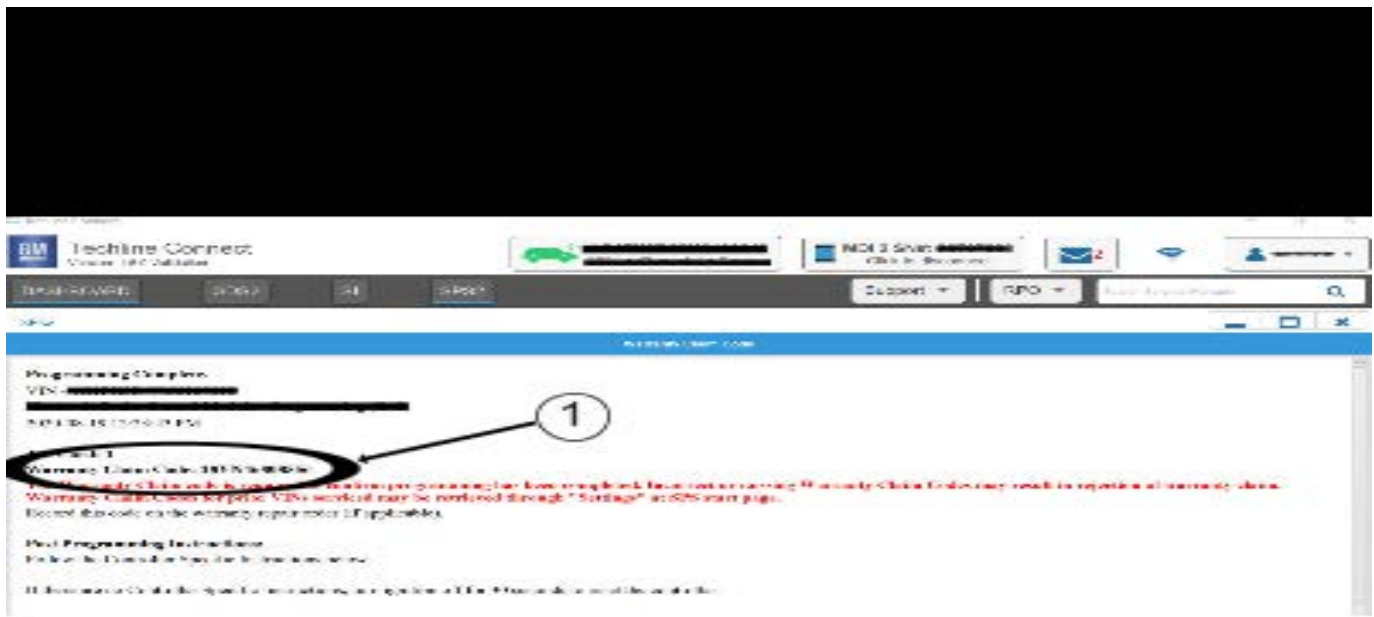
Note: The screenshot above is an example of module programming and may not be indicative of the specific module that is being programmed. Module selection and VIN information have been blacked out.

Important: To avoid warranty transaction rejections, you MUST record the warranty claim code provided on the Warranty Claim Code (WCC) screen shown above on the job card. Refer to callout 1 above for the location of the WCC on the screen.
