# Service Bulletin

Bulletin No.: 21-NA-214

**Subject:** Service Engine Soon Lamp Illuminated, Harsh or Delayed Transmission Shifts Including Slip, Surge, Shudder, Noise, Whine, Growl, Shake and/or Vibration, DTCs P2002, P2463, P2459, P144E, P0421, P0422, P0106 P20EE, P129F, P16F3, P20FF, P226D, P249D, P249E, P11CC and / or P11D5 Set Current or in Recent History

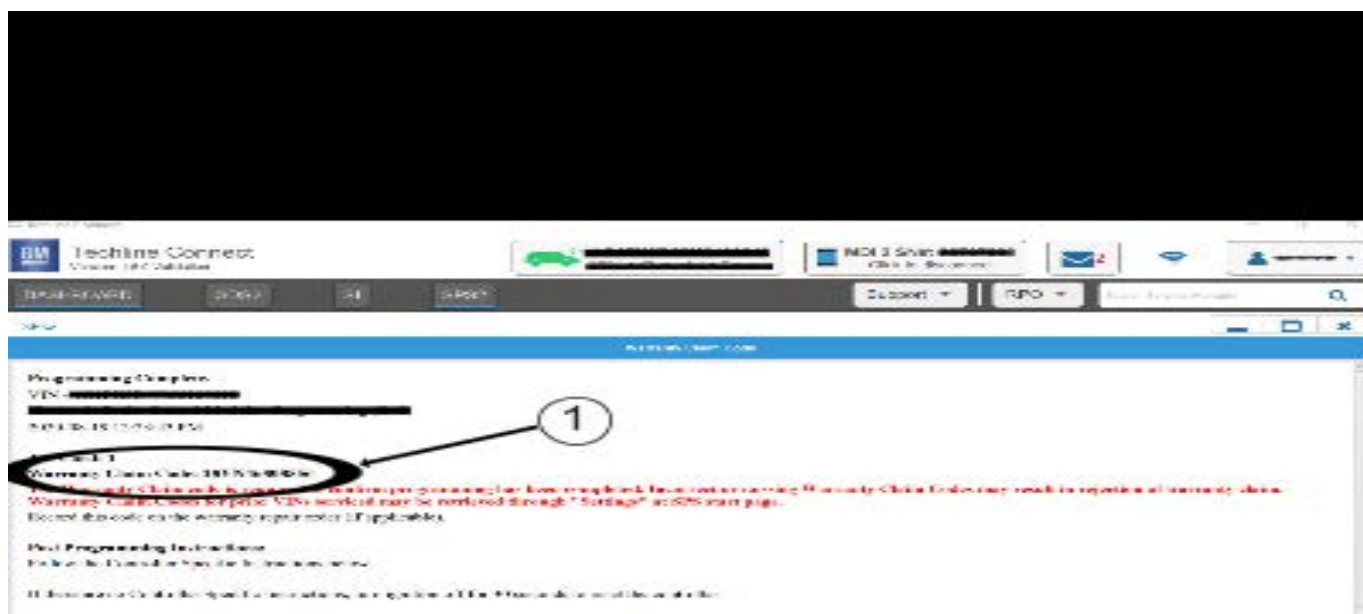
5644478

Note: The screenshots above are an example of module programming and may not be indicative of the specific module that is being programmed. Module selection and VIN information have been blacked out.
