# Service Bulletin

Bulletin No.: 22-NA-019

Subject: Malfunction Indicator Lamp (MIL) Illuminated with DTC P2251 and/or DTC P2254 Set

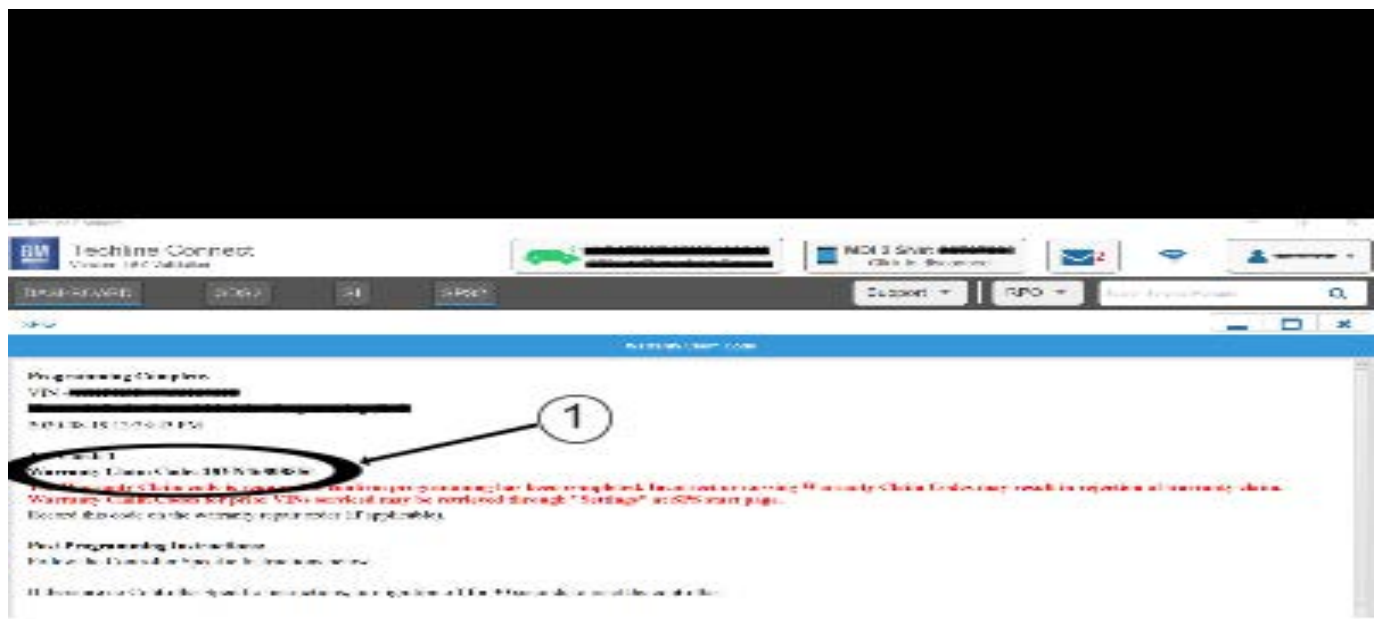
Note: The screenshots above are an example of module programming and may not be indicative of the specific module that is being programmed. Module selection and VIN information have been blacked out.

Important: To avoid warranty transaction rejections, you **MUST** record the warranty claim code provided on the Warranty Claim Code (WCC) screen shown above on the job card. Refer to callout 1 above for the location of the WCC on the screen.

Important: If the same calibration/software warning is noted on the TLC or SPS Summary screen, select OK and follow screen instructions. After a successful programming event, the WCC is located in the Service

Programming System dialogue box of the SPS Summary screen. No further action is required. Refer to the Warranty Information section of this bulletin.
