MODEL  
2020-2021MY  
Soul (SK3)  
2021MY  
Seltos (SP2)

NUMBER  
227 (Rev 2, 07/14/2022)

## TECHNICAL SERVICE BULLETIN

**SERVICE ACTION: MIL ON DTC P0605 AND/OR P2181  
ECM LOGIC IMPROVEMENT (SA463)**

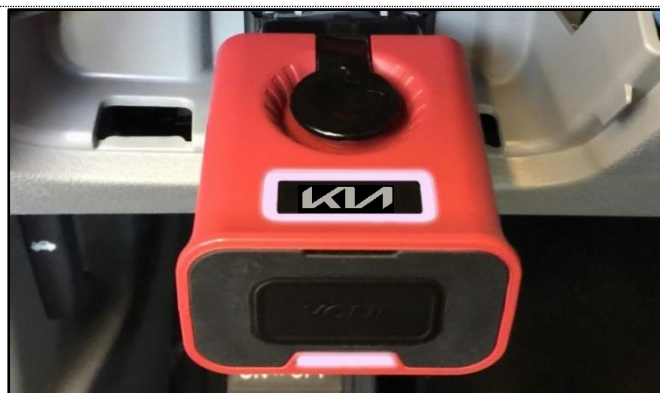
1. Connect the VCI-II to the OBD-II connector, located under the driver's side of the instrument panel.

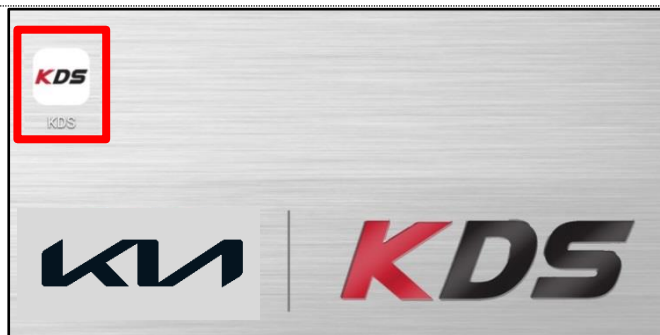
2. With the ignition ON, turn ON the KDS tablet. Select **KDS** from the home screen.

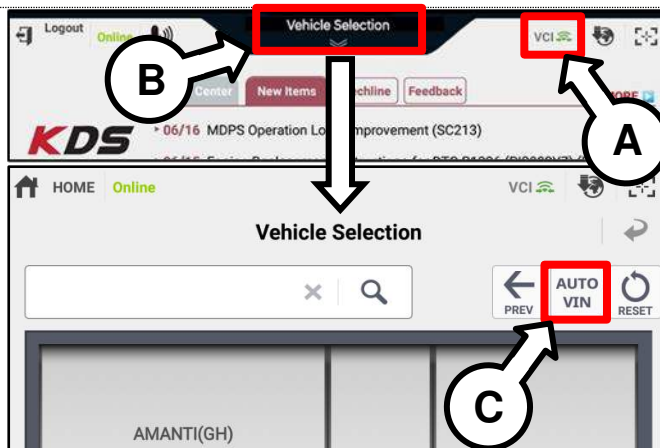
3. Confirm communication with VCI (A) and then configure the vehicle (B) using the **AUTO VIN** (C) feature.

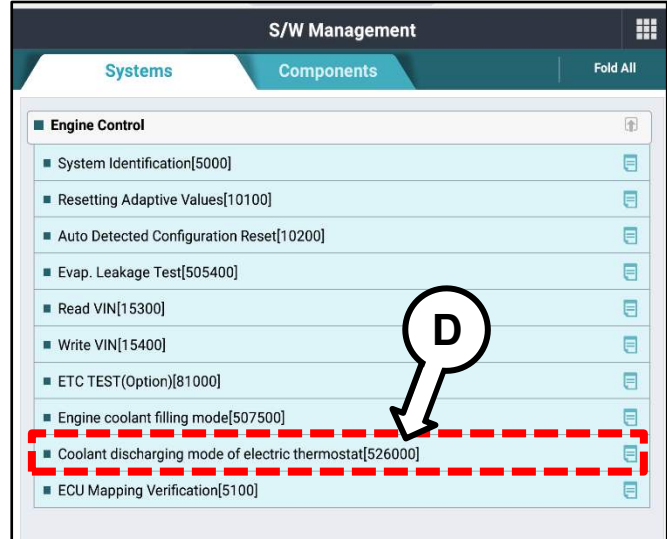
2. From the Systems / Engine Control menu, select '**Coolant Discharging Mode of Electric Thermostat**' (D).

The KDS screenshot(s) shown are from a 2021MY Seltos (SP2). Your screens may be displayed slightly different.

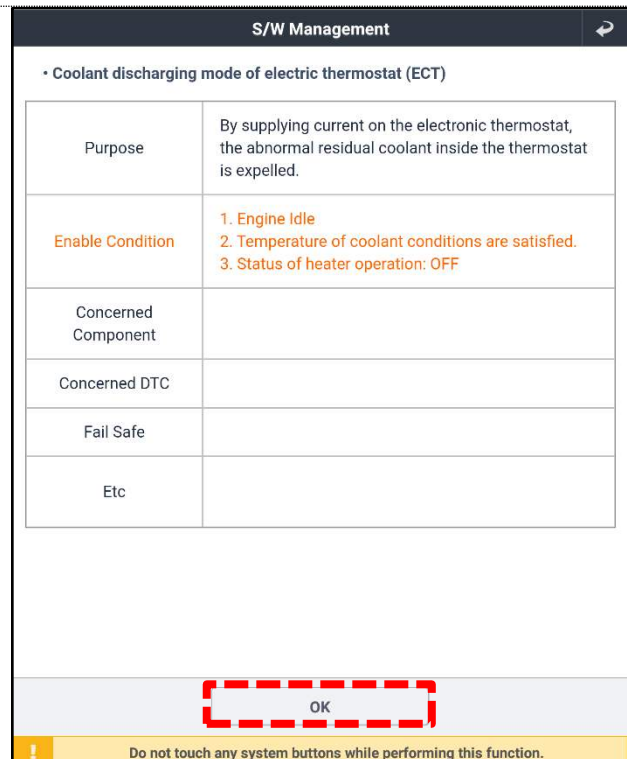
3. Select '**OK**'.

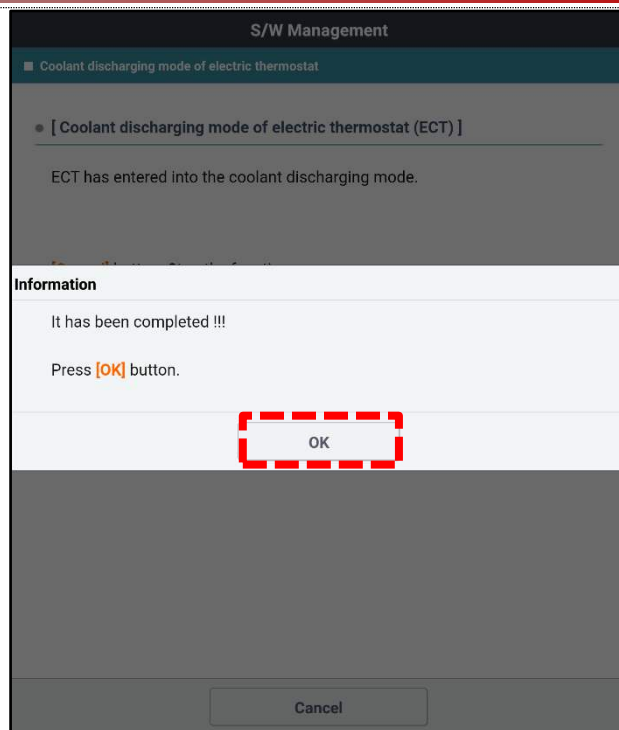
6. When the procedure is completed select **'OK'**.

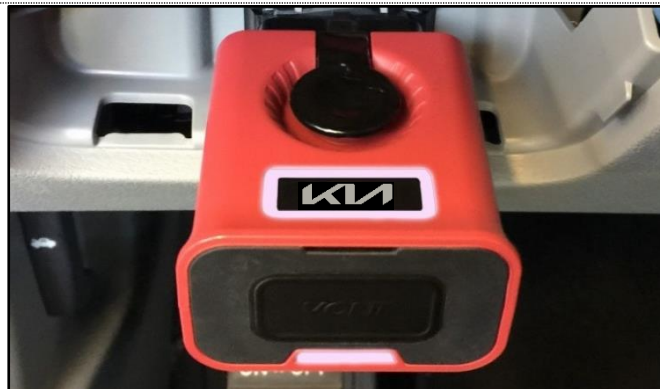
The ECU upgrade function on KDS operates wirelessly. It is not necessary to perform the upgrade via USB cable.

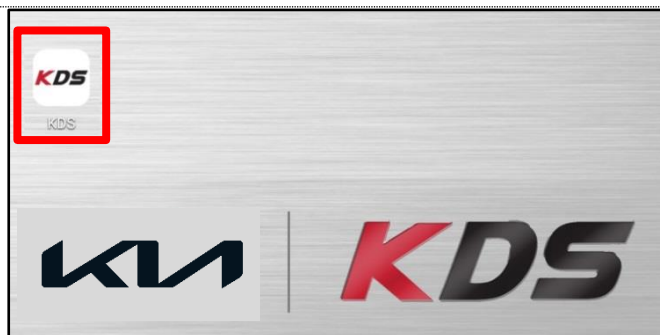
2. With the ignition ON, turn ON the KDS tablet. Select **KDS** from the home screen.

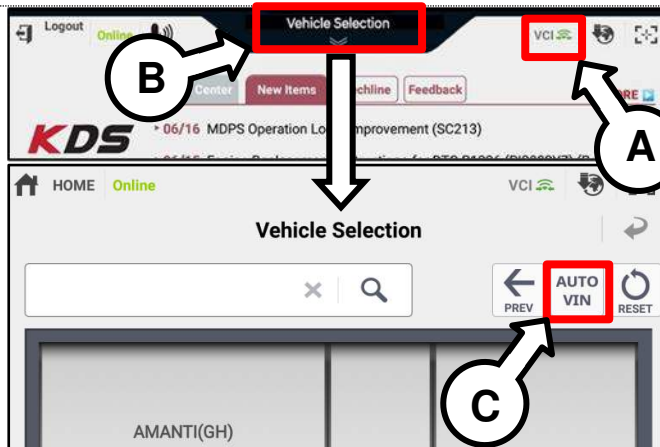
3. Confirm communication with VCI (A) and then configure the vehicle (B) using the **AUTO VIN** (C) feature.

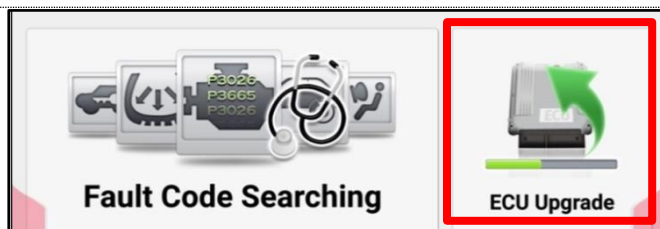
4. Select **ECU Upgrade**.

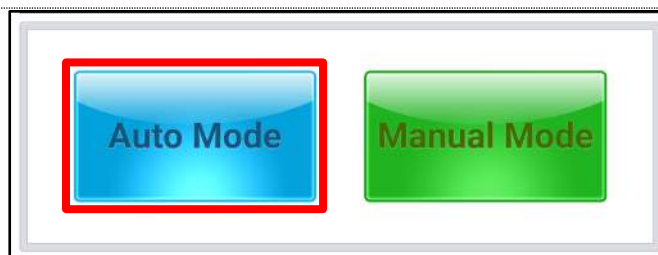
Do NOT attempt to perform a Manual Mode upgrade UNLESS Auto Mode fails. Always follow the instructions given on the KDS in either Auto or Manual mode.

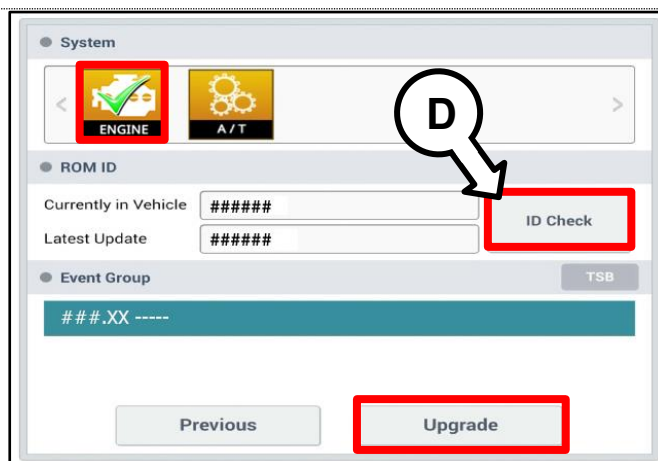
7. Select the **Engine** system under the System selection menu.

Touch **ID Check** (D) and confirm that the latest update is available.

Select appropriate **Upgrade Event** listed below, and select **Upgrade** to continue.

- **#519** (SK3) (11/24/2018-10/24/2020)  
**OR –**
- **#618** (SK3) (10/25/2020-1/4/2021)  
**OR –**
- **#520** (SP2) (11/20/2019-10/15/2020)  
**OR –**
- **#619** (SP2) (10/16/2020-1/13/2021)

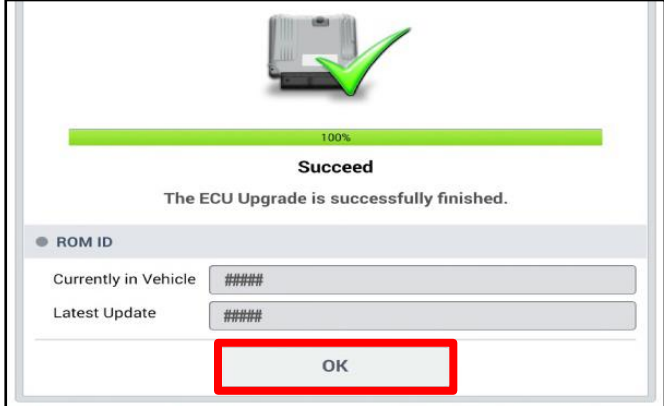
| 11. | Once the upgrade is complete, touch <b>OK</b> to finalize the procedure. | |

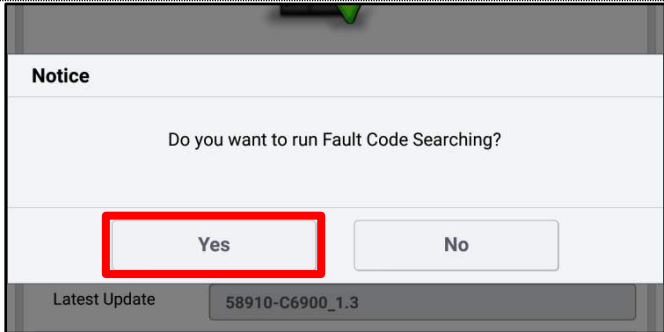
| 12. | When prompted, select <b>YES</b> to check for Diagnostic Trouble Codes (DTC) and erase any DTCs stored such as EPS, ESC, and TPMS that may have been set during the upgrade. | |
