# Service Bulletin

Bulletin No.: 22-NA-147

Subject: Service 4–Wheel Drive Message Illuminated in DIC with DTC C15AC Set

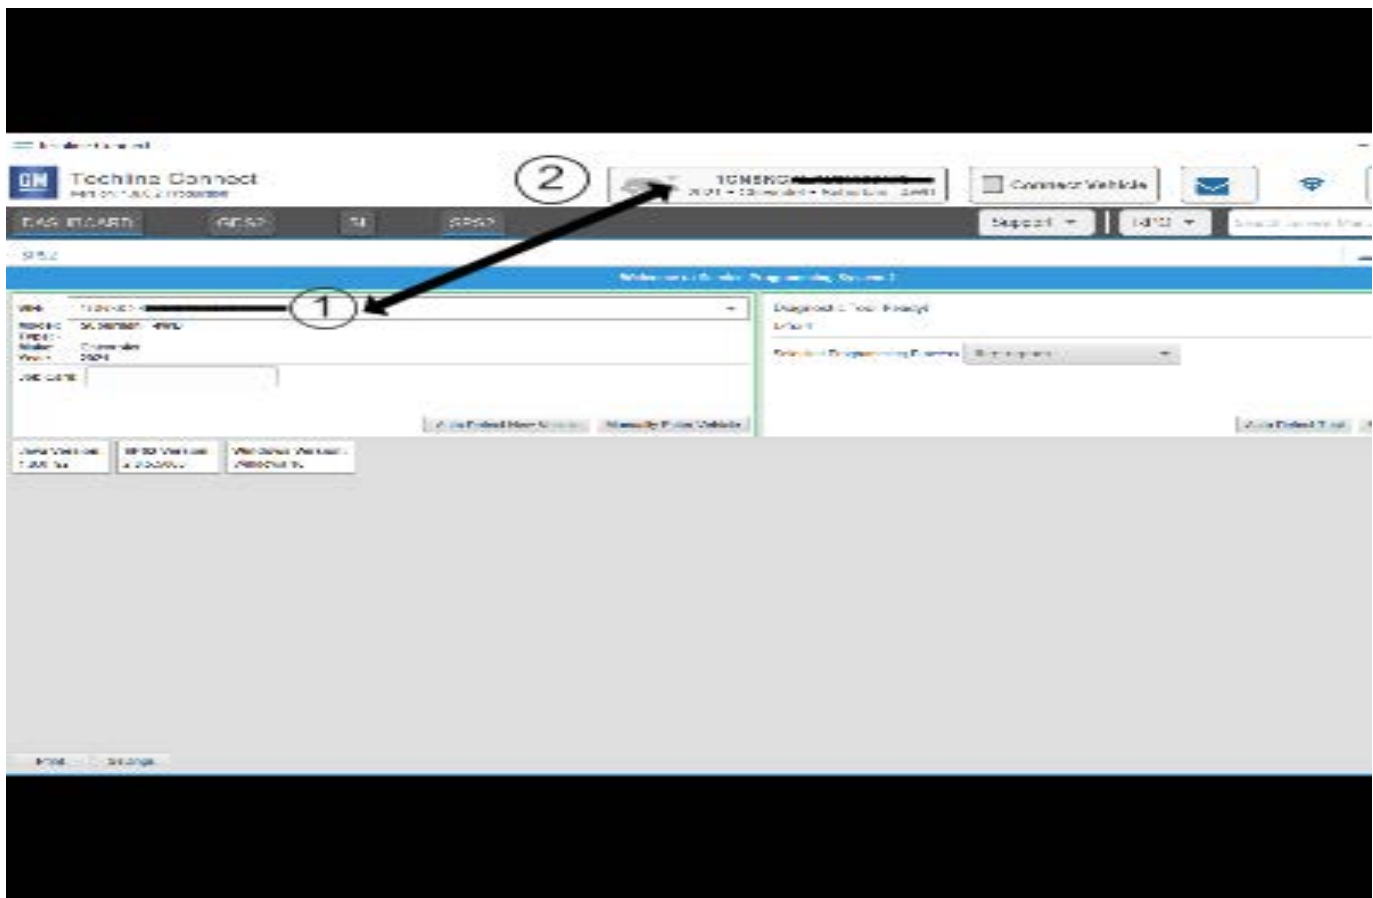
Caution: Be sure the VIN selected in the drop down menu (1) is the same as the vehicle connected (2) before beginning programming.
