# Service Bulletin

Bulletin No.: 22-NA-019

Subject: Malfunction Indicator Lamp (MIL) Illuminated with DTC P2251 and/or DTC P2254 Set

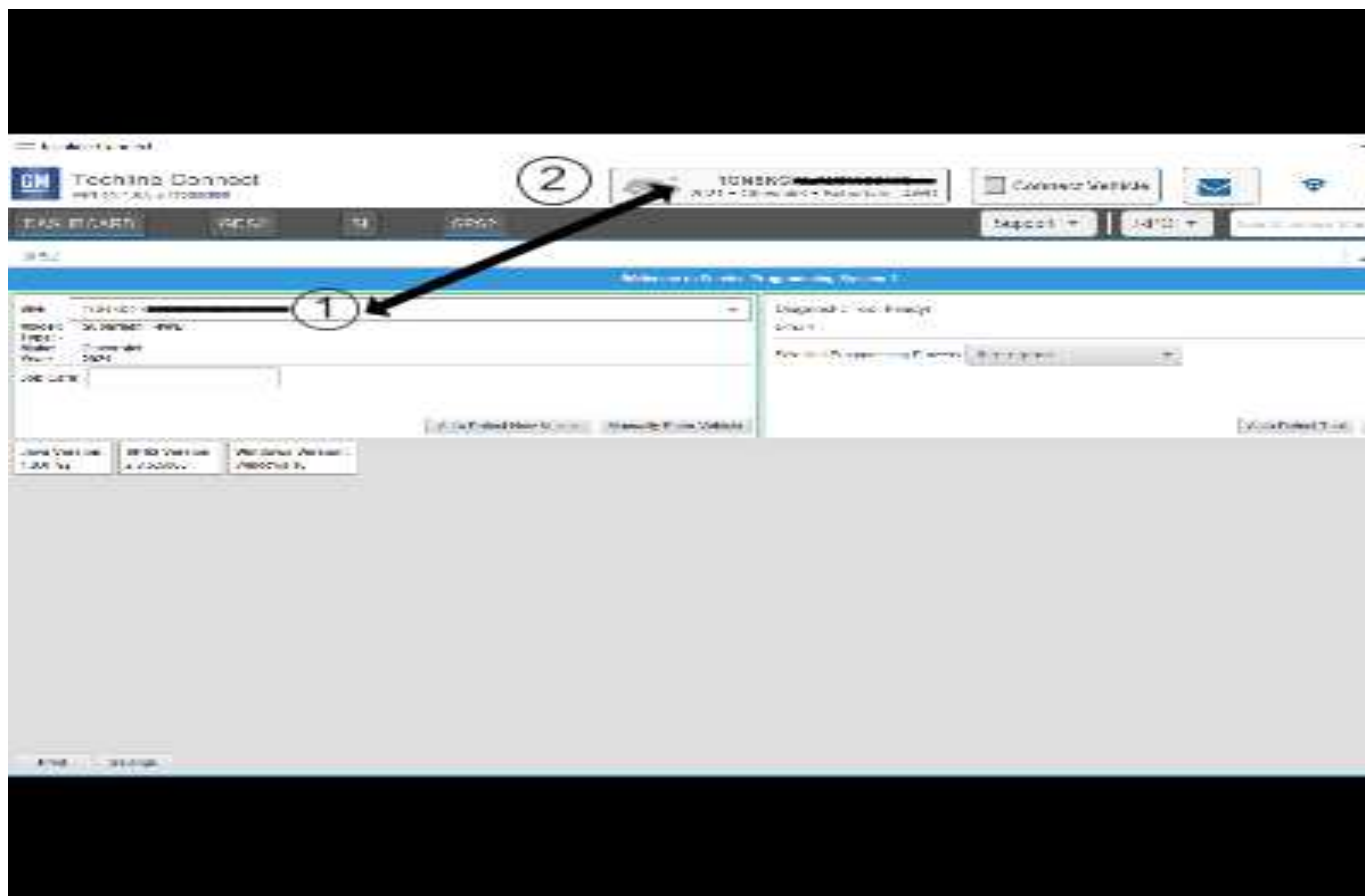
Caution: Be sure the VIN selected in the drop down menu (1) is the same as the vehicle connected (2) before beginning programming.

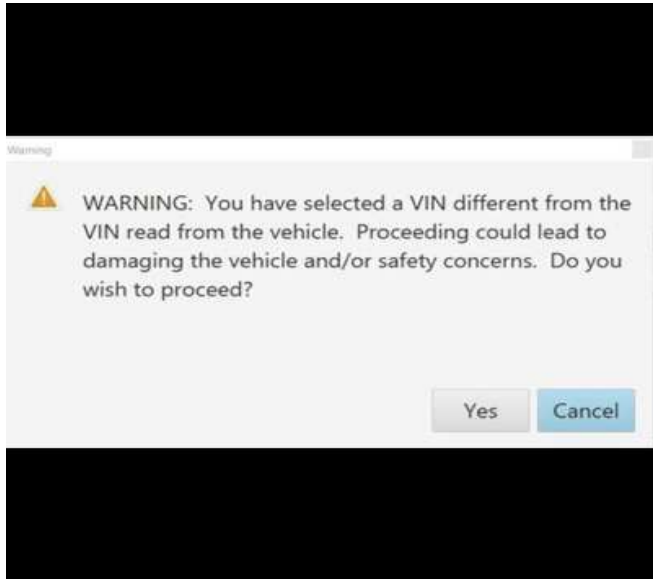
Important: If the vehicle VIN DOES NOT match, the message below will be shown.

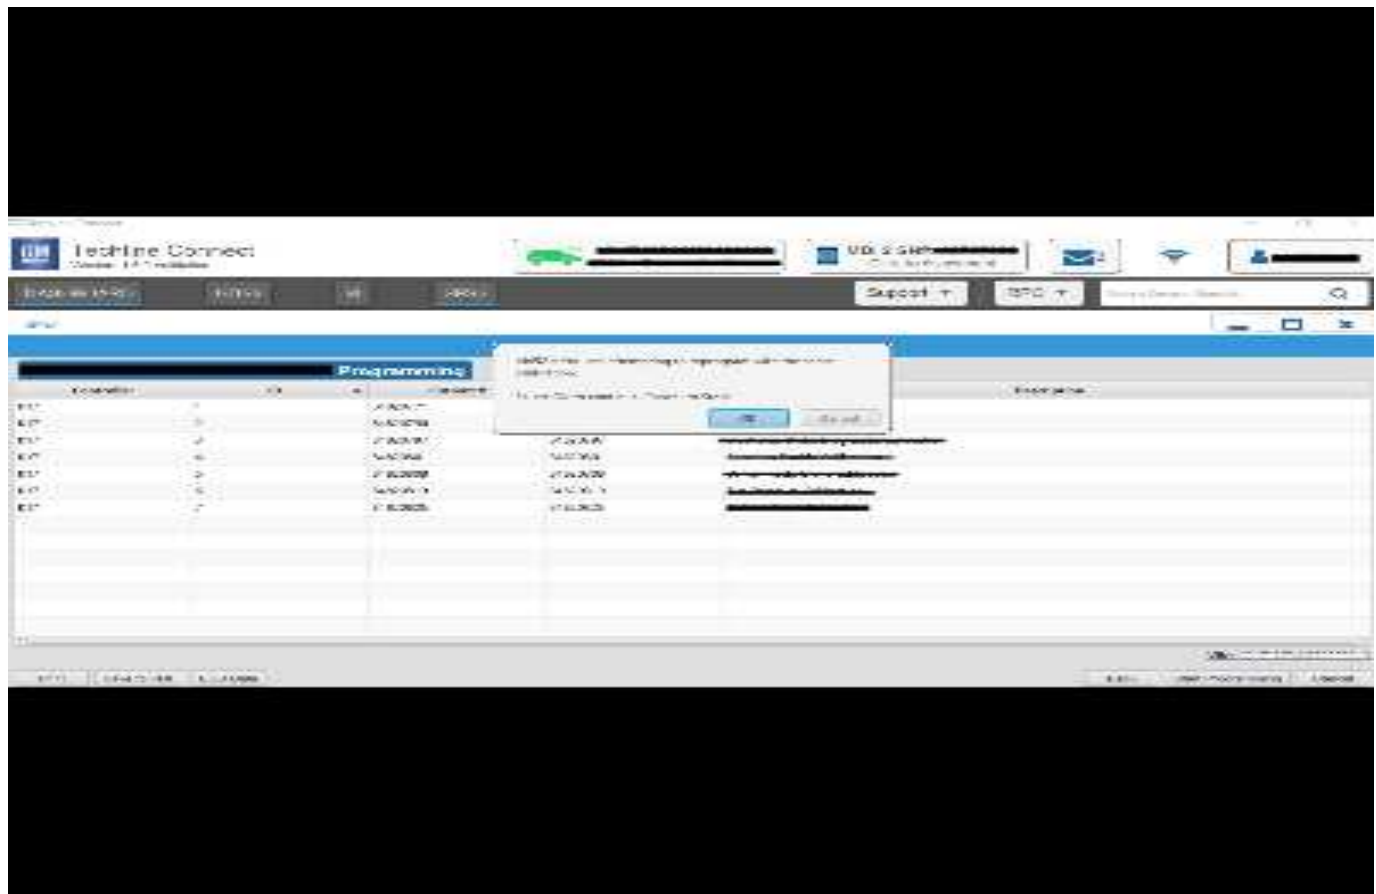
564477

Important: Techline Connect screen shown above.

Important: If the same calibration/software warning is noted on the TLC or SPS Summary screen, select OK and follow screen instructions. After a successful programming event, the WCC is located in the Service Programming System dialogue box of the SPS

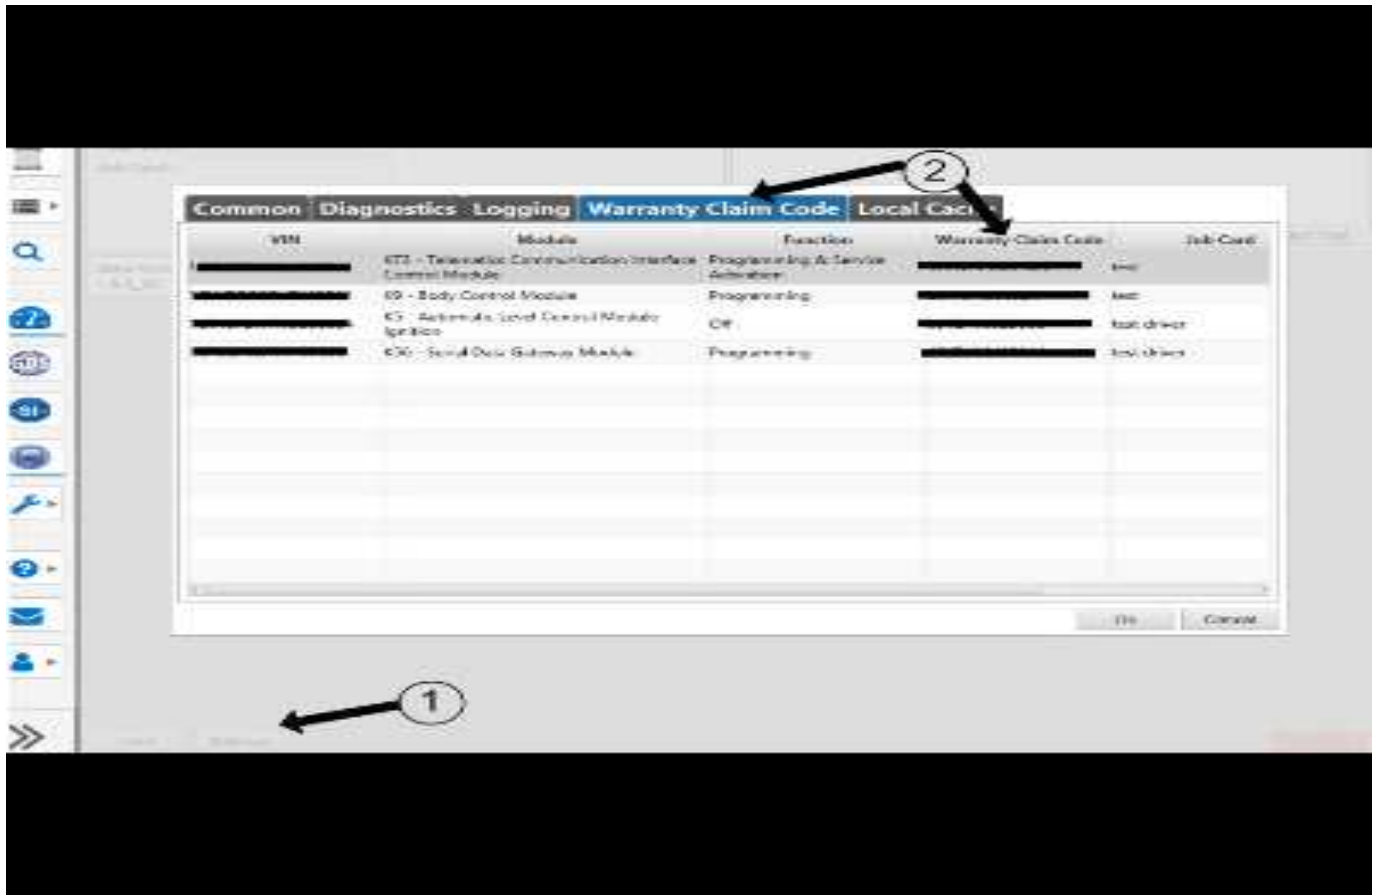
6125774

If the Warranty Claim Code was not recorded on the Job Card, the code can be retrieved in the SPS2 system as follows:

The VIN, Warranty Claim Code and Date/Time will be listed on a roster of recent programming events. If the code is retrievable, dealers should resubmit the transaction making sure to include the code in the SPS Warranty Claim Code field.
