# Service Bulletin

Bulletin No.: 22-NA-189

Subject: Non-Operating Remote Start with DTCs P31DB/P31E8 Set

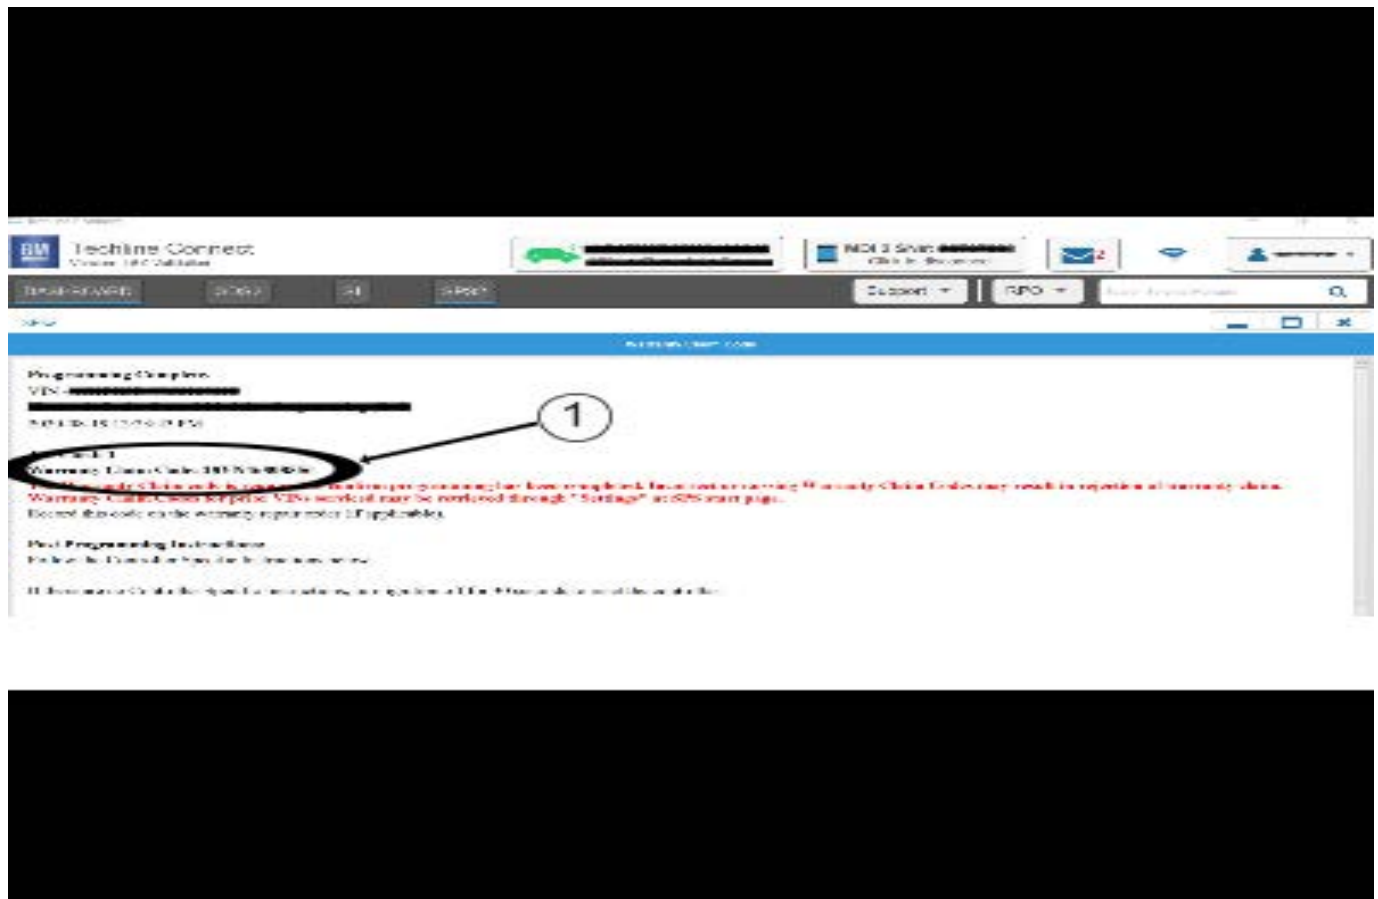
5644478

Note: The screenshot above is an example of module programming and may not be indicative of the specific module that is being programmed. Module selection and VIN information have been blacked out.

Important: To avoid warranty transaction rejections, you **MUST** record the warranty claim code provided on the Warranty Claim Code (WCC) screen shown above on the job card. Refer to callout 1 above for the location of the WCC on the screen.
