# Service Bulletin

Bulletin No.: 22-NA-206

**Subject:** Service Engine Soon (SES) Light/Message with DTCs P16F3 and/or P060C in Engine Control Module (ECM)

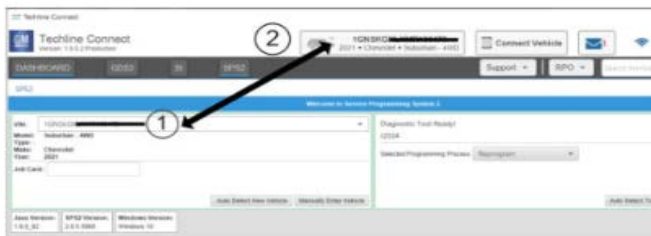
6175813

Caution: Be sure the VIN selected in the drop down menu (1) is the same as the vehicle connected (2) before beginning programming.

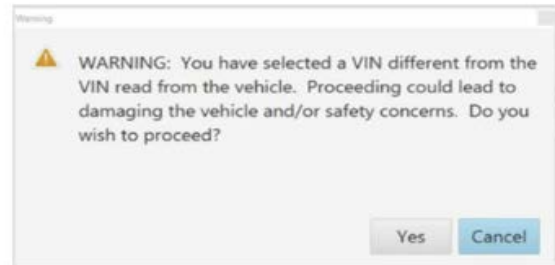
6175816

Important: If the vehicle VIN DOES NOT match, the message below will be shown.

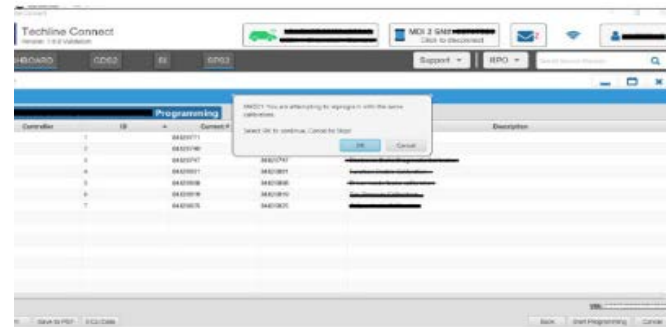
6175818

Important: Techline Connect screen shown above.

Important: If the same calibration/software warning is noted on the TLC or SPS Summary screen, select OK and follow screen instructions. After a successful programming event, the WCC is located in the Service Programming System dialogue box of the SPS

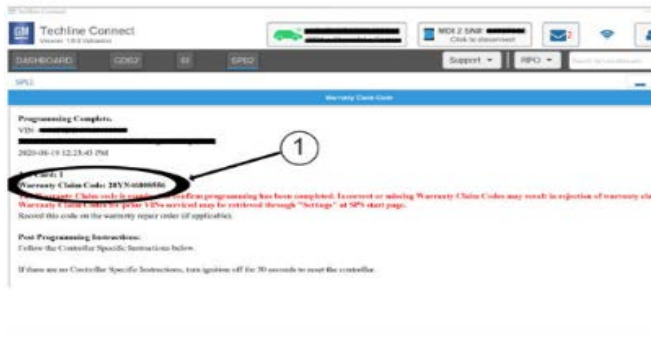
6175820

Note: The screenshot above is an example of module programming and may not be indicative of the specific module that is being programmed. Module selection and VIN information have been blacked out.

Important: To avoid warranty transaction rejections, you **MUST** record the warranty claim code provided on the Warranty Claim Code (WCC) screen shown above on the job card. Refer to callout 1 above for the location of the WCC on the screen.

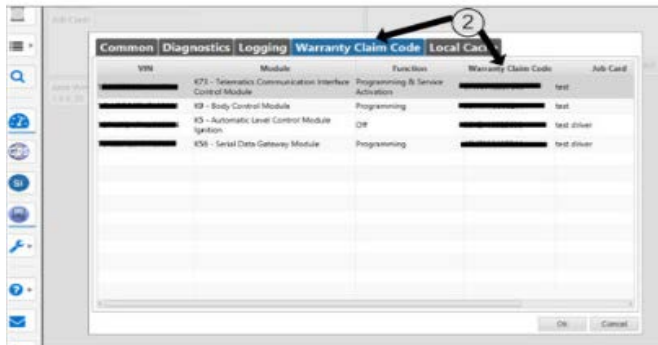
6175823

Warranty Claim Code Information Retrieval

If the SPS Warranty Claim Code was not recorded on the Job Card, the code can be retrieved in the SPS system as follows:
