# Service Bulletin

Bulletin No.: 22-NA-188

Subject: MAF Sensor Calibration Update – DTCs P227C and P10BC Set After ECM Replacement

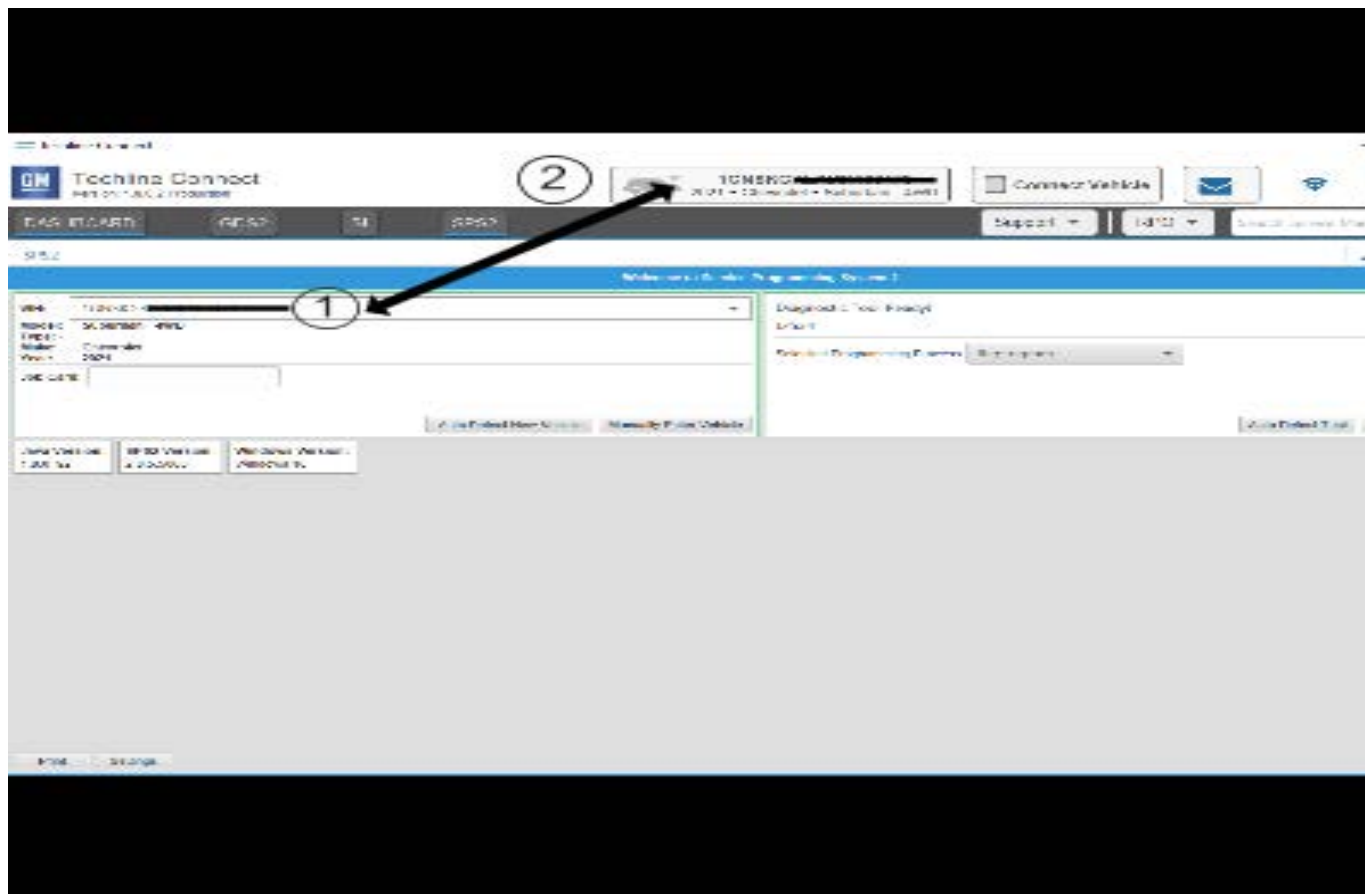
Caution: Be sure the VIN selected in the drop down menu (1) is the same as the vehicle connected (2) before beginning programming.

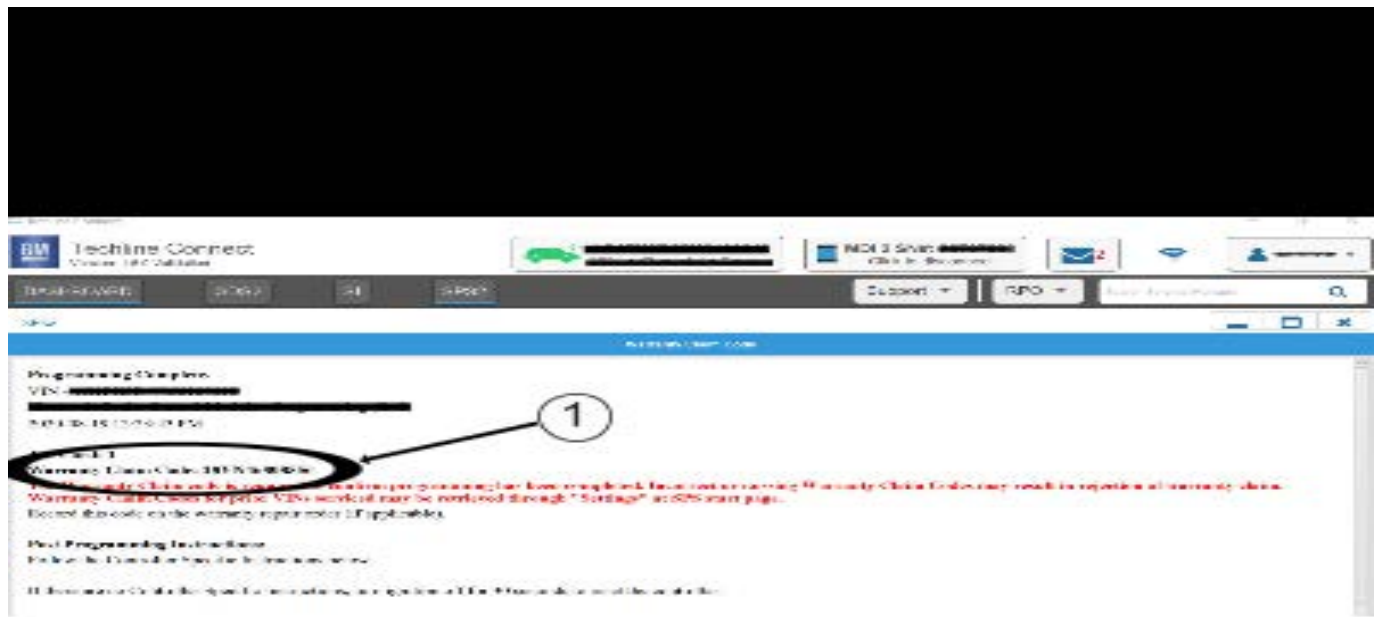
Note: The screenshot above is an example of module programming and may not be indicative of the specific module that is being programmed. Module selection and VIN information have been blacked out.

Important: To avoid warranty transaction rejections, you **MUST** record the warranty claim code provided on the Warranty Claim Code (WCC) screen shown above on the job card. Refer to callout 1 above for the location of the WCC on the screen.
