## Service Update

### A222379710 DTC P0521 Permanent Status Not Properly Cleared

**Release Date:** December 2022

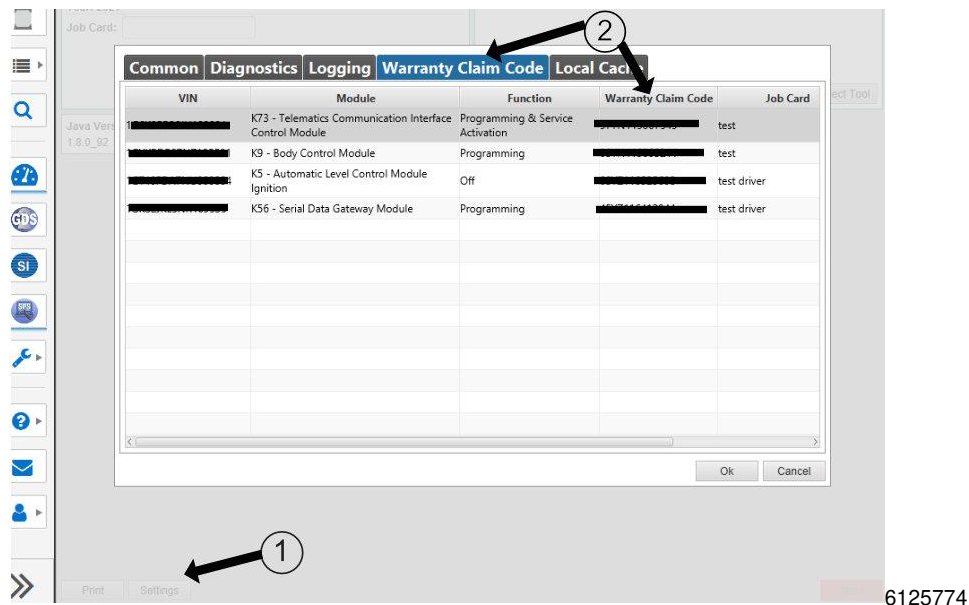
If the Warranty Claim Code was not recorded on the Job Card, the code can be retrieved in the SPS2 system as follows:

1. Open TLC on the computer used to program the vehicle.
2. Select and start SPS2.
3. Select Settings (1).
4. Select the Warranty Claim Code tab (2).

The VIN, Warranty Claim Code and Date/Time will be listed on a roster of recent programming events. If the code is retrievable, dealers should resubmit the transaction making sure to include the code in the SPS Warranty Claim Code field.

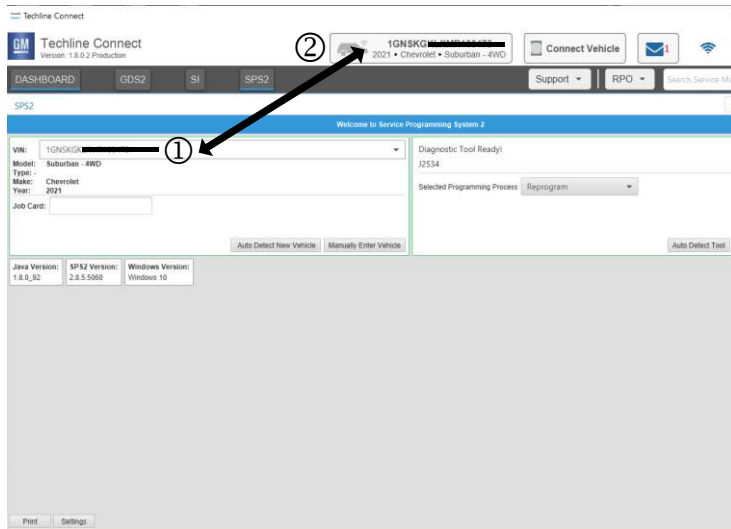
5743643

**Caution:** Be sure the VIN selected in the drop-down menu (1) is the same as the vehicle connected (2) before beginning programming.

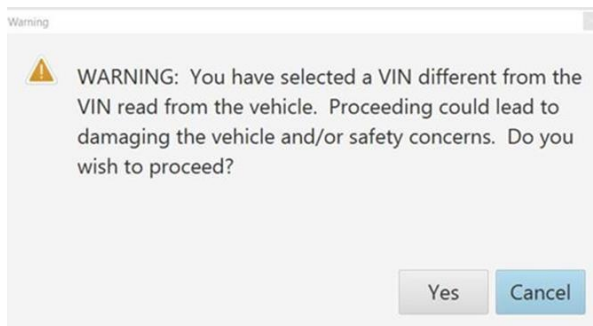
5877000

**Important:** If the vehicle VIN DOES NOT match, the message below will be shown.

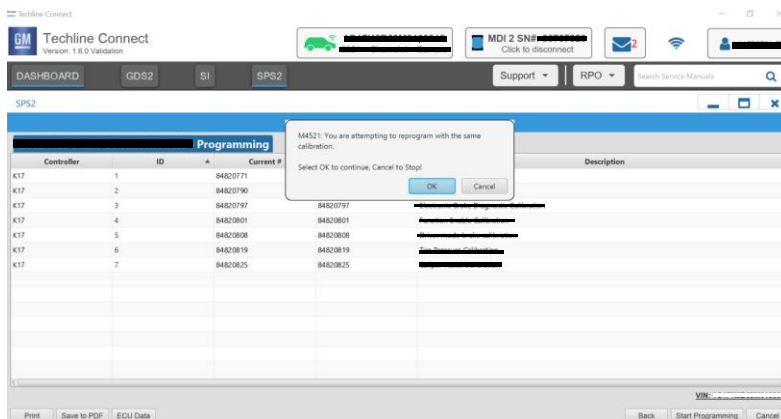
5644477

**Important:** Techline Connect screens shown above.

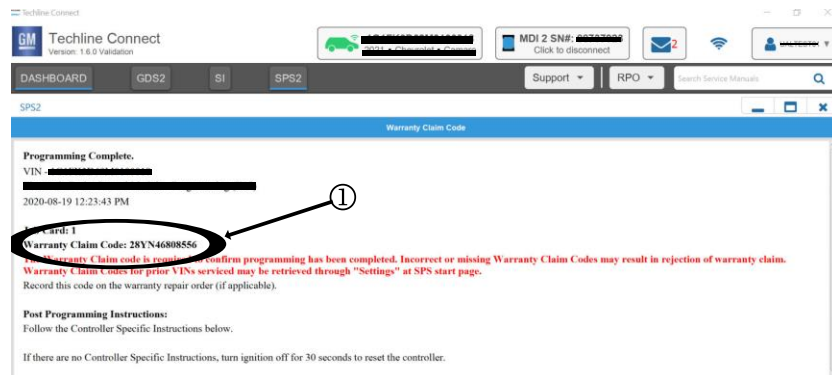
5644478

1. Reprogram the Engine Control Module. Refer to *K20 Engine Control Module: Programming and Setup* in SI.

**Note:** The screenshot above is an example of module programming and may not be indicative of the specific module that is being programmed. Module selection and VIN information have been blacked out.
