# Technical Service Bulletin

## PSS 01 MIL on, fuel rail pressure low (P0087)

01 13 81 2033211/3 March 28, 2013. Supersedes Technical Service Bulletin Group 01 number 13-74 dated March 12, 2013 for reasons listed below.

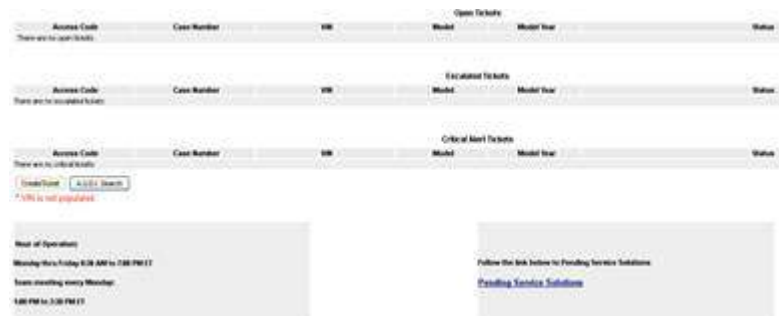
Figure 2. Technical Assistance page

1. Diagnose the vehicle according to the instructions listed below. If customer's vehicle condition matches the condition listed in the *Technical Background* of this PSS TSB, continue with the points below.
2. Create a PSS record in the PSS application via the hyperlink in Accessaudi.com (Figure 1) or Technical Assistance page in Elsa (Figure 2).

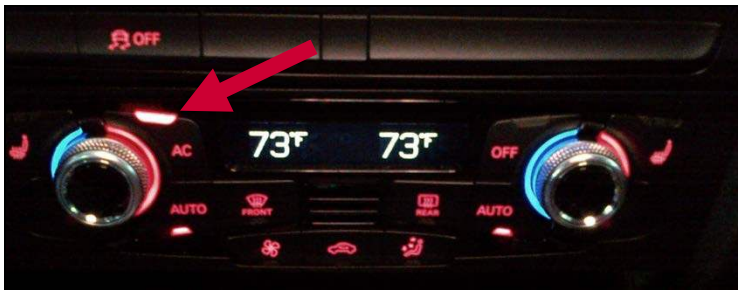
**Figure 1:** Climate control with A/C LED on

A: You can use other settings for climate control as long as the LED for A/C on is illuminated (*Figure 1*).
