MODEL  
2017-2019MY  
Optima (JF P/HEV)

NUMBER  
192 (Rev 1, 01/18/2023)

**SERVICE ACTION: BMS/OPU/MCU  
LOGIC IMPROVEMENT (SA411)**

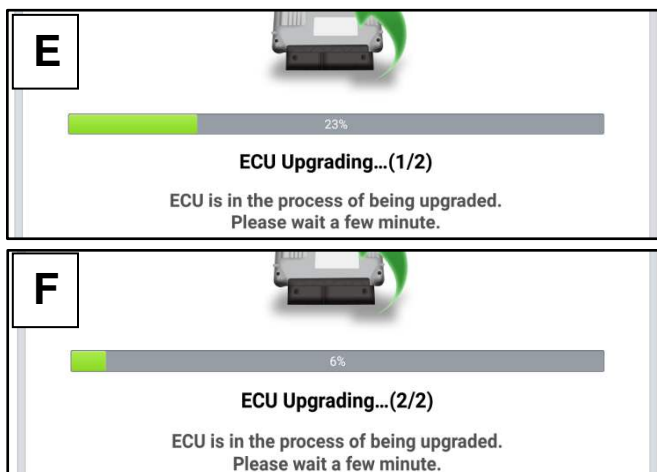
9. If a “Communication Fail” screen appears, verify that the VCI-II and KDS are communicating properly. Touch **OK** and restart the procedure from step 4.

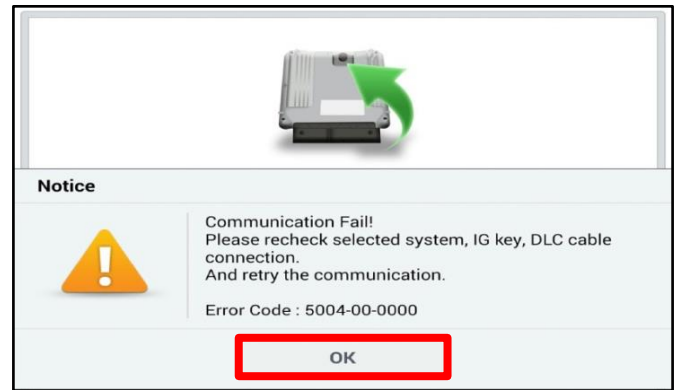
10. When instructed on the KDS, turn the ignition **OFF** for ten (10) seconds then back on. Touch **OK** to continue.

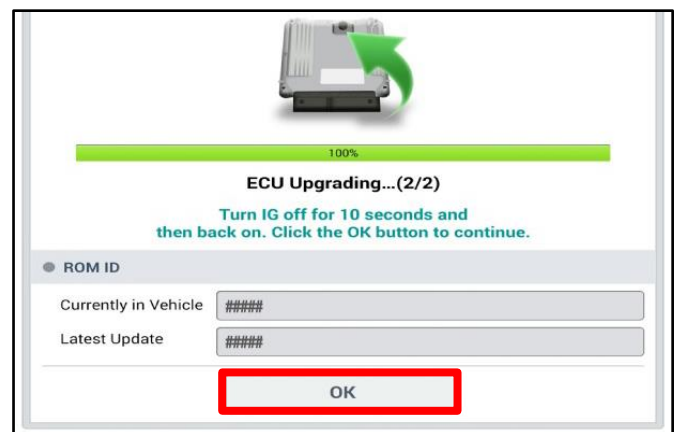
11. Once the upgrade is complete, touch **OK** to finalize the procedure.

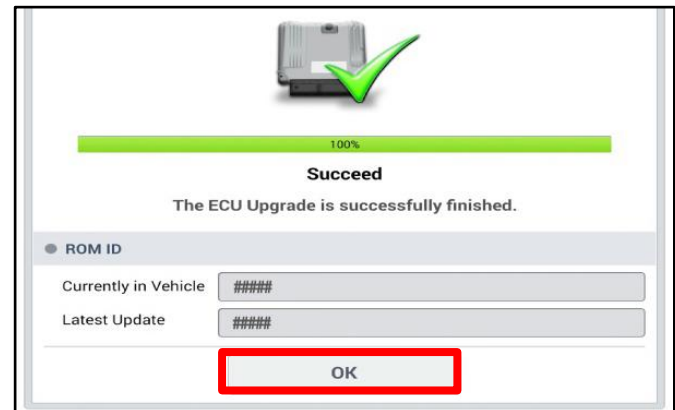
12. When prompted, select **YES** to check for Diagnostic Trouble Codes (DTC) and erase any DTCs stored such as EPS, ESC, and TPMS that may have been set during the upgrade.
