# Service Bulletin

Bulletin No.: 21-NA-127

Subject: Head Up Display (HUD) Blank, Non-Responsive to Brightness, Aim or Page Controls – DTC U1518 Set

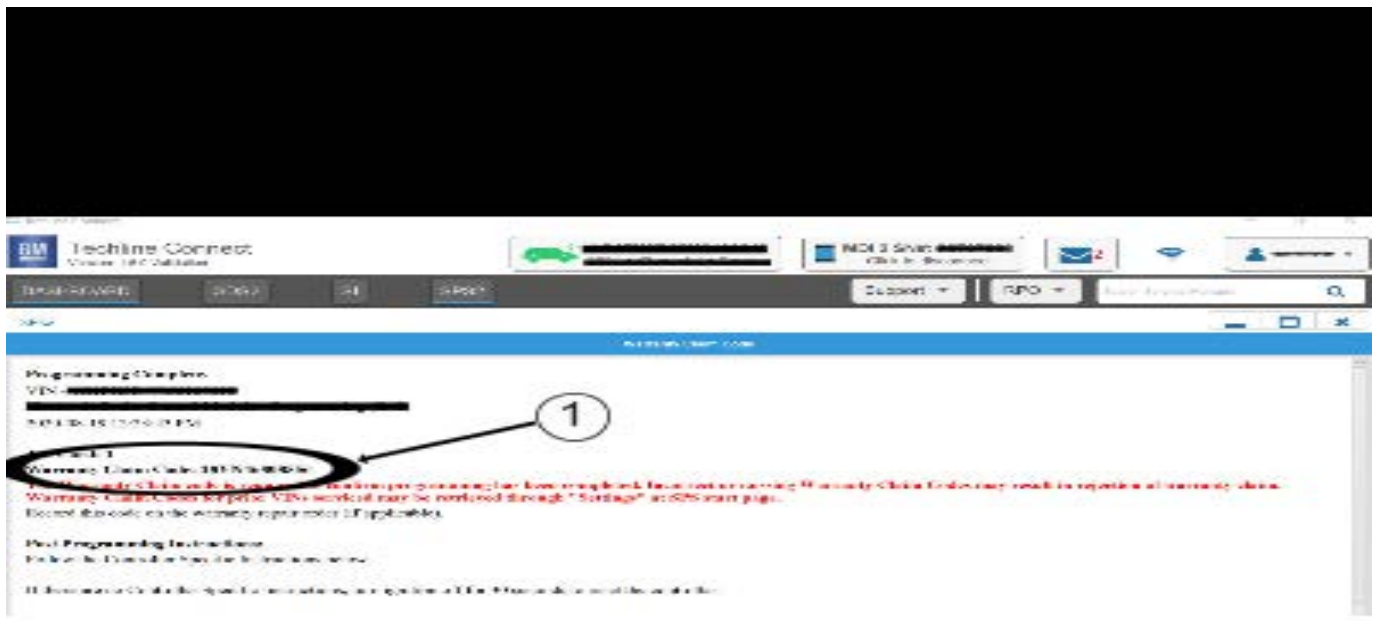
5644477

Note: The screenshot above is an example of module programming and may not be indicative of the specific module that is being programmed. Module selection and VIN information have been blacked out.
