# Service Bulletin

Bulletin No.: 22-NA-229

**Subject:** Possible Audible Knock Due to Reduced Knock Sensor Detection Capability DTC P0325, P0330, P0326, P0331, P06B6 or P06B7 May be Set in History

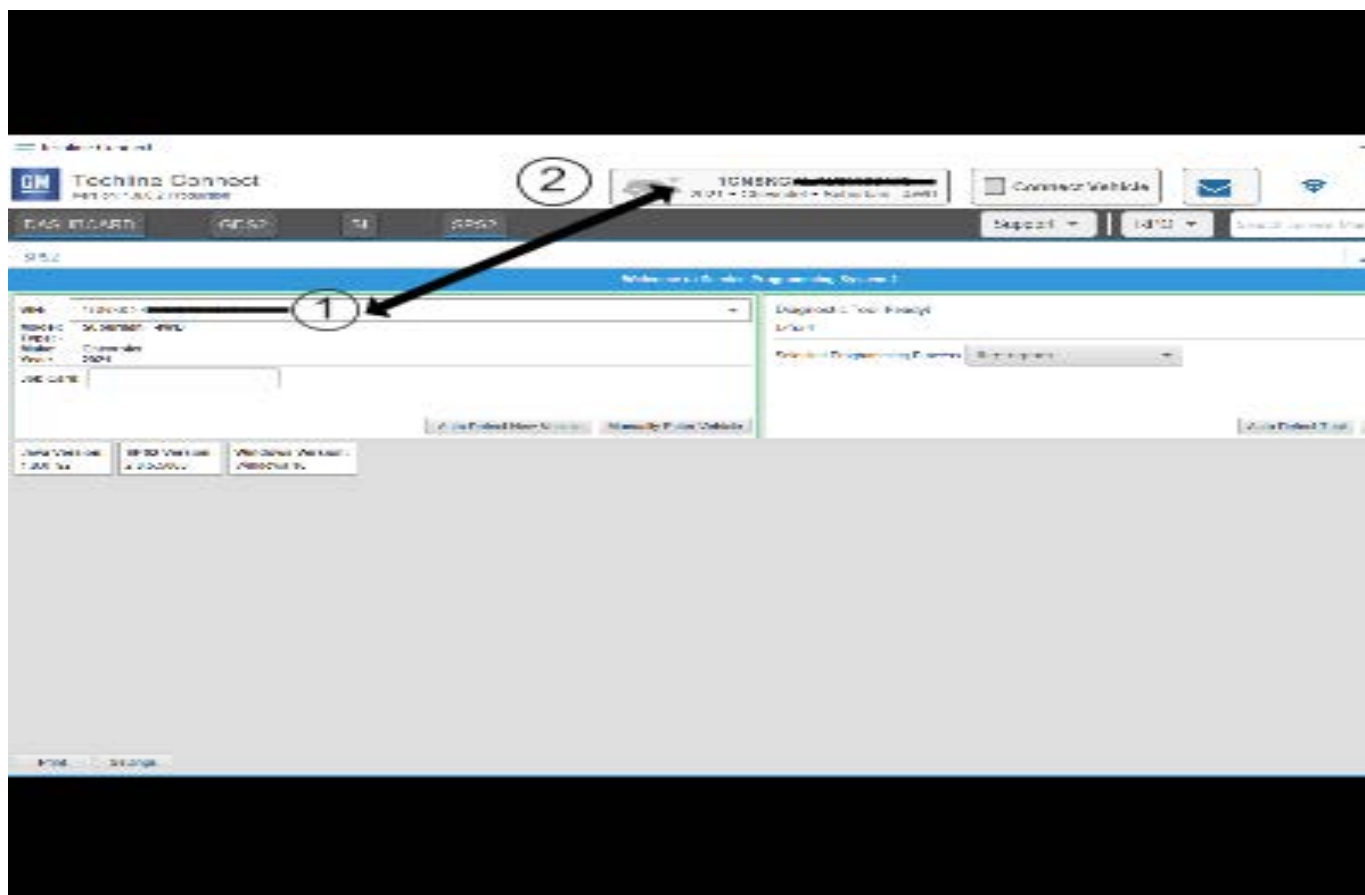
Caution: Be sure the VIN selected in the drop down menu (1) is the same as the vehicle connected (2) before beginning programming.

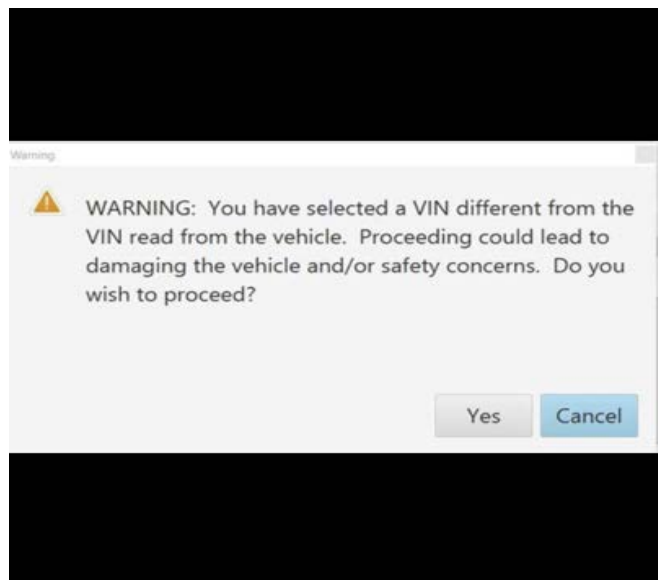
5877000

Important: If the vehicle VIN DOES NOT match, the message below will be shown

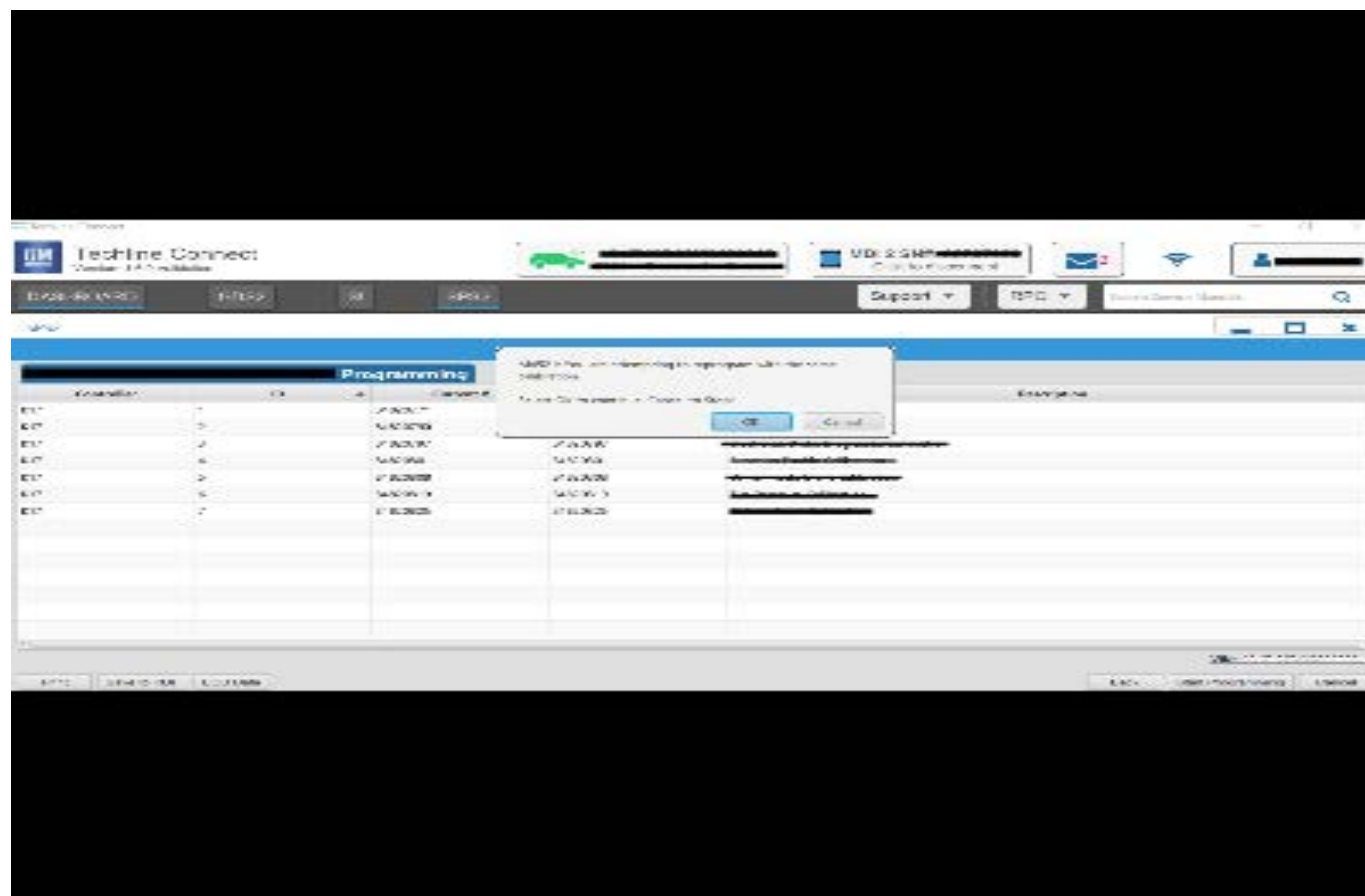
5644477

Important: Techline Connect and TIS2WEB screens shown above.

**Important:** If the same calibration/software warning is noted on the TLC or SPS Summary screen, select OK and follow screen instructions. After a successful programming event, the WCC is located in the Service

Programming System dialogue box of the SPS Summary screen. No further action is required. Refer to the Warranty section of the bulletin.

Important: To avoid warranty transaction rejections, you MUST record the warranty claim code provided on the Warranty Claim Code (WCC) screen shown above on the job card. Refer to callout 1 above for the location of the WCC on the screen.

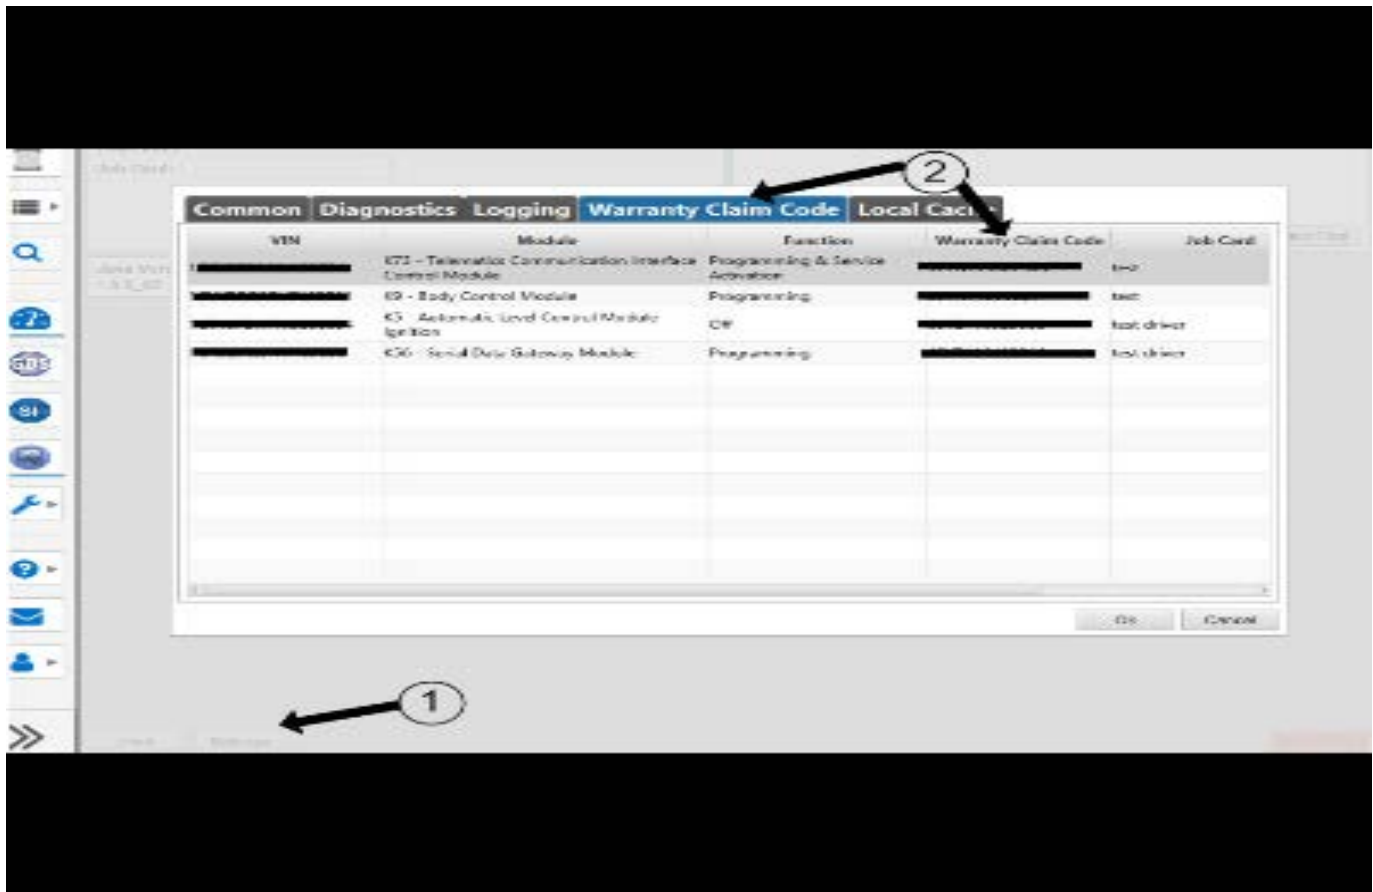
If the Warranty Claim Code was not recorded on the Job Card, the code can be retrieved in the SPS2 system as follows:

The VIN, Warranty Claim Code and Date/Time will be listed on a roster of recent programming events. If the code is retrievable, dealers should resubmit the transaction making sure to include the code in the SPS Warranty Claim Code field.
