# Service Bulletin

Bulletin No.: 23-NA-026

Subject: LM2 Engine Calibration Update for DTC P003A

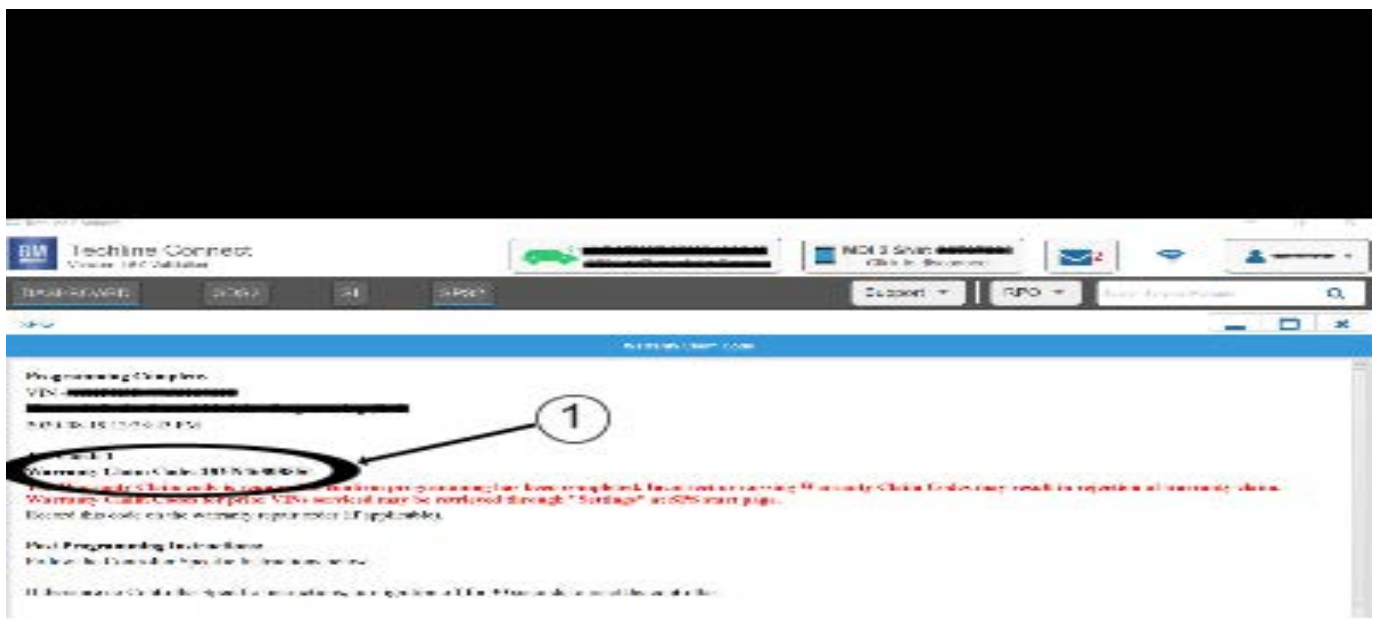
5644478

Note: The screenshot above is an example of module programming and may not be indicative of the specific module that is being programmed. Module selection and VIN information have been blacked out.

Important: To avoid warranty transaction rejections, you **MUST** record the warranty claim code provided on the Warranty Claim Code (WCC) screen shown above on the job card. Refer to callout 1 above for the location of the WCC on the screen.

1. Reprogram the Engine Control Module. Refer to K20 Engine Control Module: Programming and Setup in the Service Manual.
