2019-2022MY  
Niro EV (DE EV)

293

## TECHNICAL SERVICE BULLETIN

## BMS DTC JUDGEMENT LOGIC IMPROVEMENT

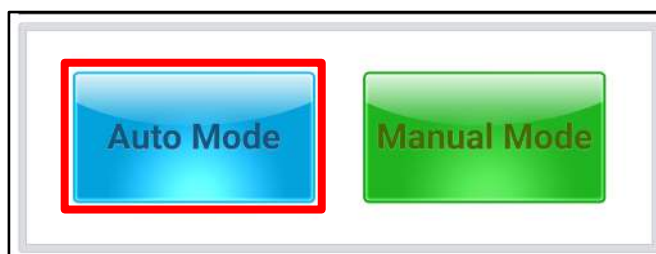
6. Select Auto Mode.

Do NOT attempt to perform a Manual Mode upgrade UNLESS Auto Mode fails. Always follow the instructions given on the KDS in either Auto or Manual mode.
