**HYUNDAI**  
**Technical Service Bulletin**

| GROUP<br><b>CAMPAIGN</b> | NUMBER<br><b>23-01-036H</b> |
| DATE<br><b>MAY 2023</b> | MODEL(S)<br><b>ELANTRA (CN7A)<br/>SONATA (DN8A)<br/>SANTA FE (TMA)</b> |

**SUBJECT:** HECU MODULE DARK CURRENT MEASUREMENT AND REPLACEMENT (SERVICE CAMPAIGN 990)

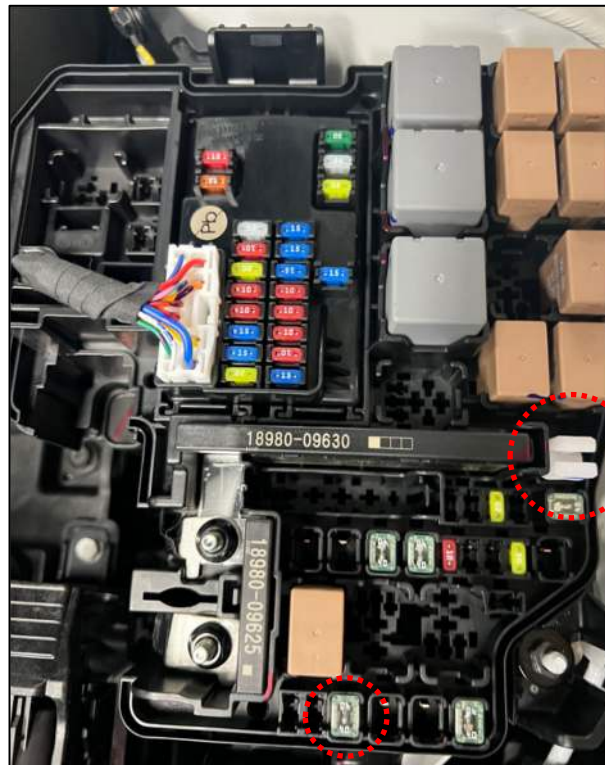
Locate the ABS fuse location in the junction box (see the *Fuse Box Measurement Point Guide*).

Use the fuse puller to remove the 40A ABS fuse.

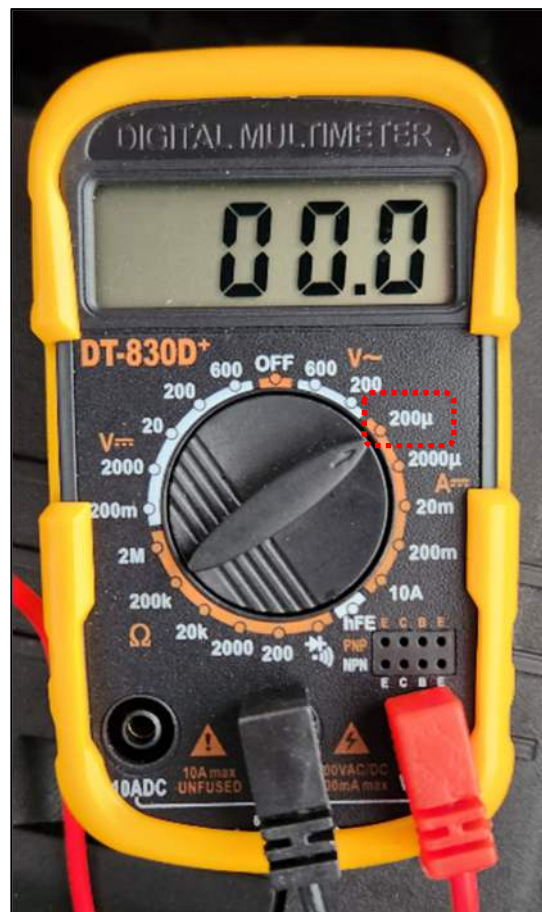
4. Set the multi-meter to the 200  $\mu$ A setting. Connect the probe leads as shown – black in the center **COM** terminal, red on the right side **V $\Omega$ mA** terminal.

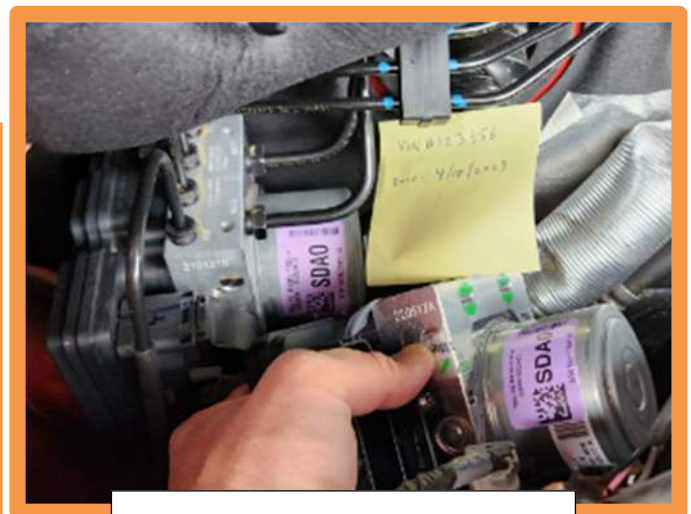
Example of STUI Photo

If HECU is replaced: Using STUI, take a photo showing the newly installed HECU, along with the removed original HECU. Include the last 6 digits of the VIN and the date of repair on a piece of paper.
