# Service Bulletin

Bulletin No.: 22-NA-100

**Subject:** Check Engine, Traction Control, Antilock Brake System Lamps Illuminated on DIC—  
DTC C0582 Set

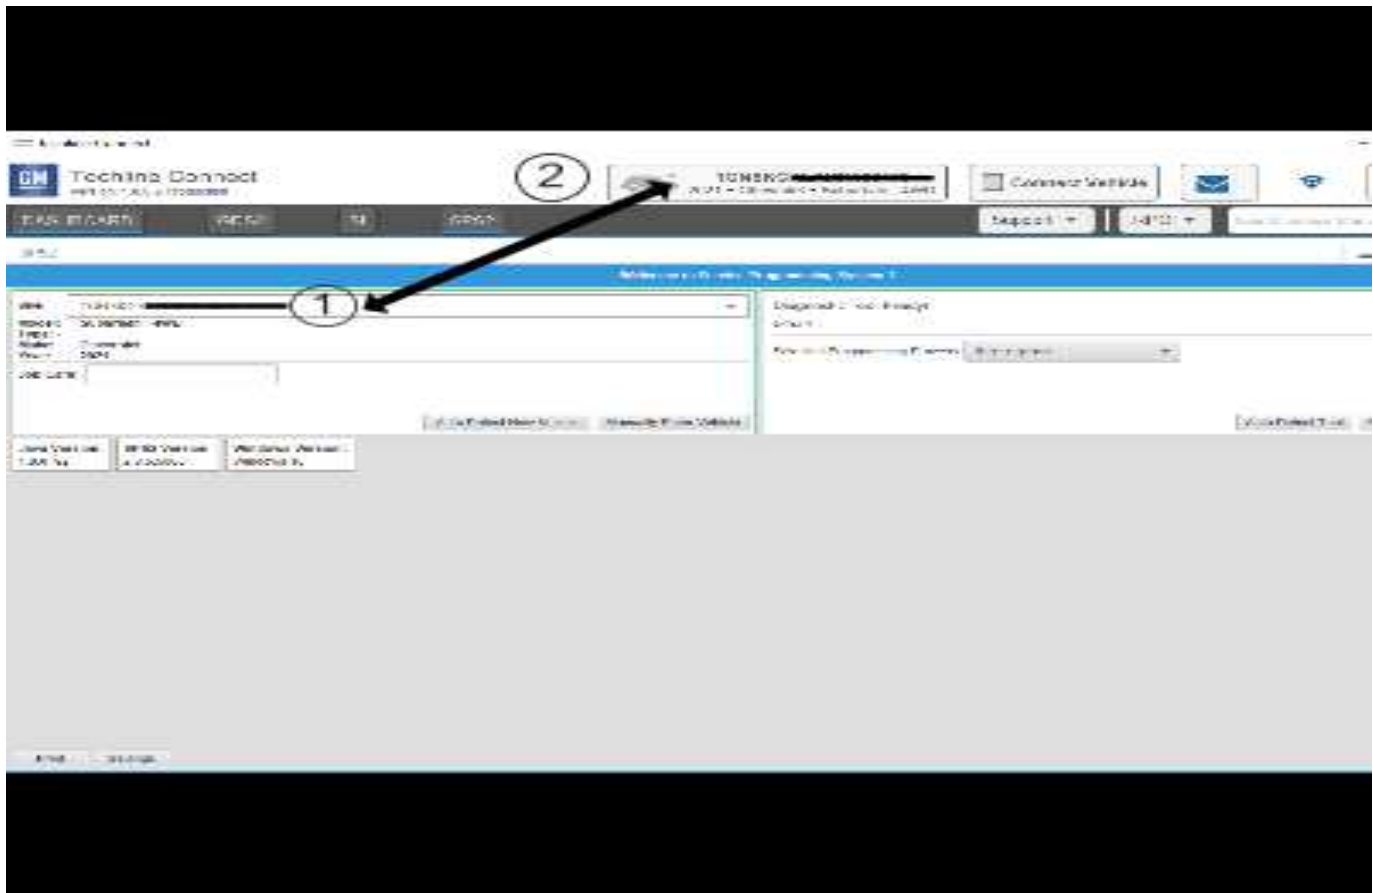
Caution: Be sure the VIN selected in the drop down menu (1) is the same as the vehicle connected (2) before beginning programming.

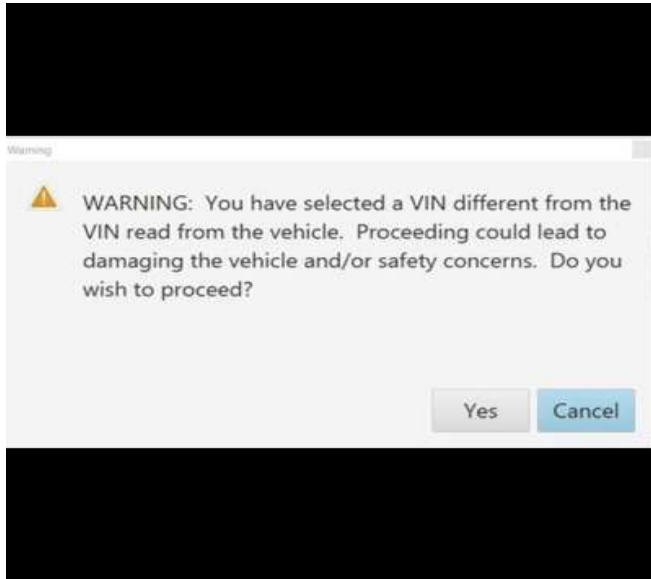
5877000

Important: If the vehicle VIN DOES NOT match, the message below will be shown

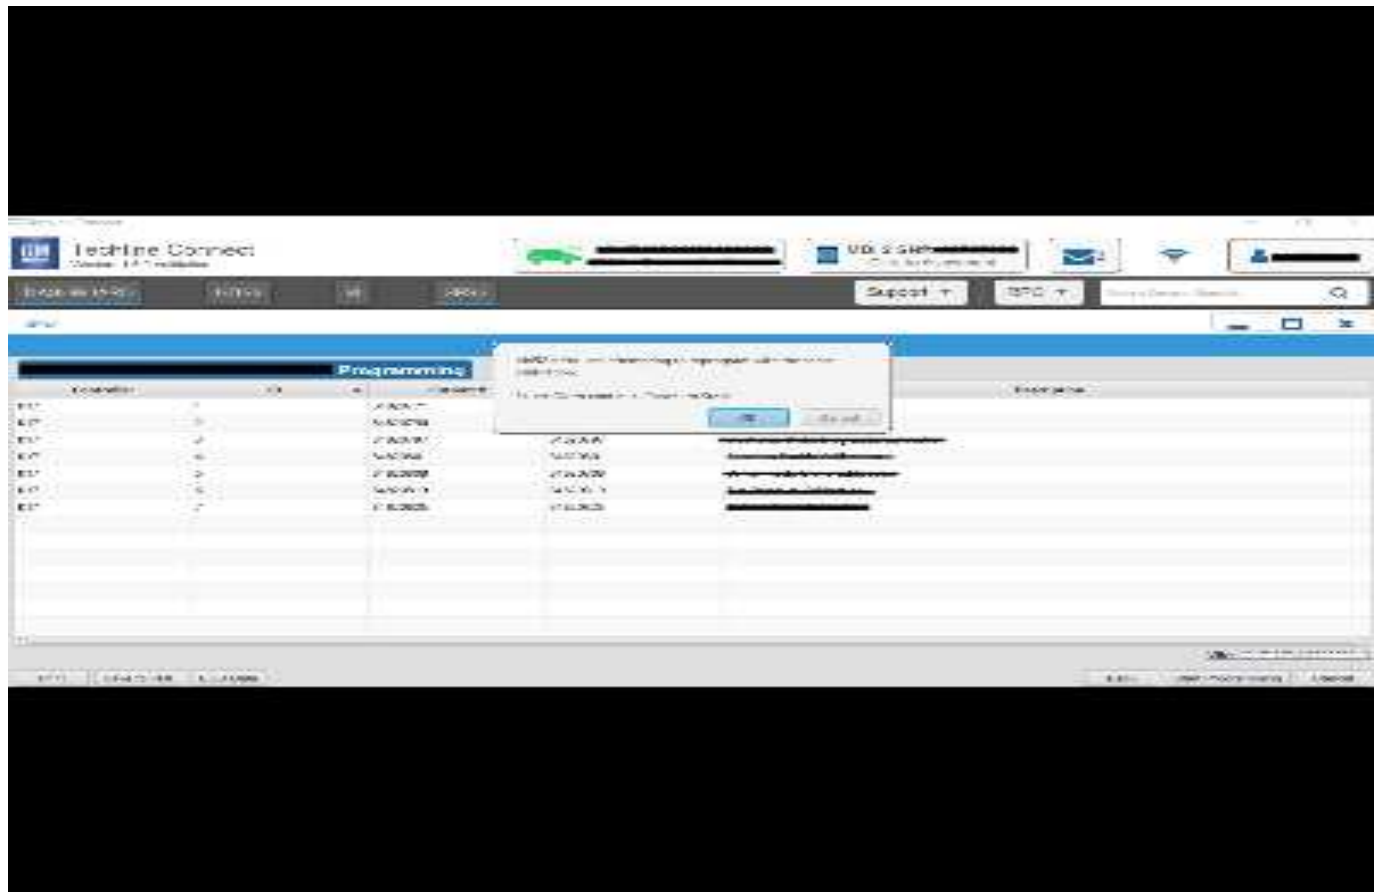
5644477

Important: Techline Connect and TIS2WEB screens shown above.
