# Service Bulletin

Bulletin No.: 21-NA-214

**Subject:** Service Engine Soon Lamp Illuminated, Harsh or Delayed Transmission Shifts Including Slip, Surge, Shudder, Noise, Whine, Growl, Shake and/or Vibration, DTCs P2002, P2463, P2459, P144E, P0421, P0422, P0106 P20EE, P129F, P16F3, P20FF, P226D, P249D, P249E, P11CC and / or P11D5 Set Current or in Recent History

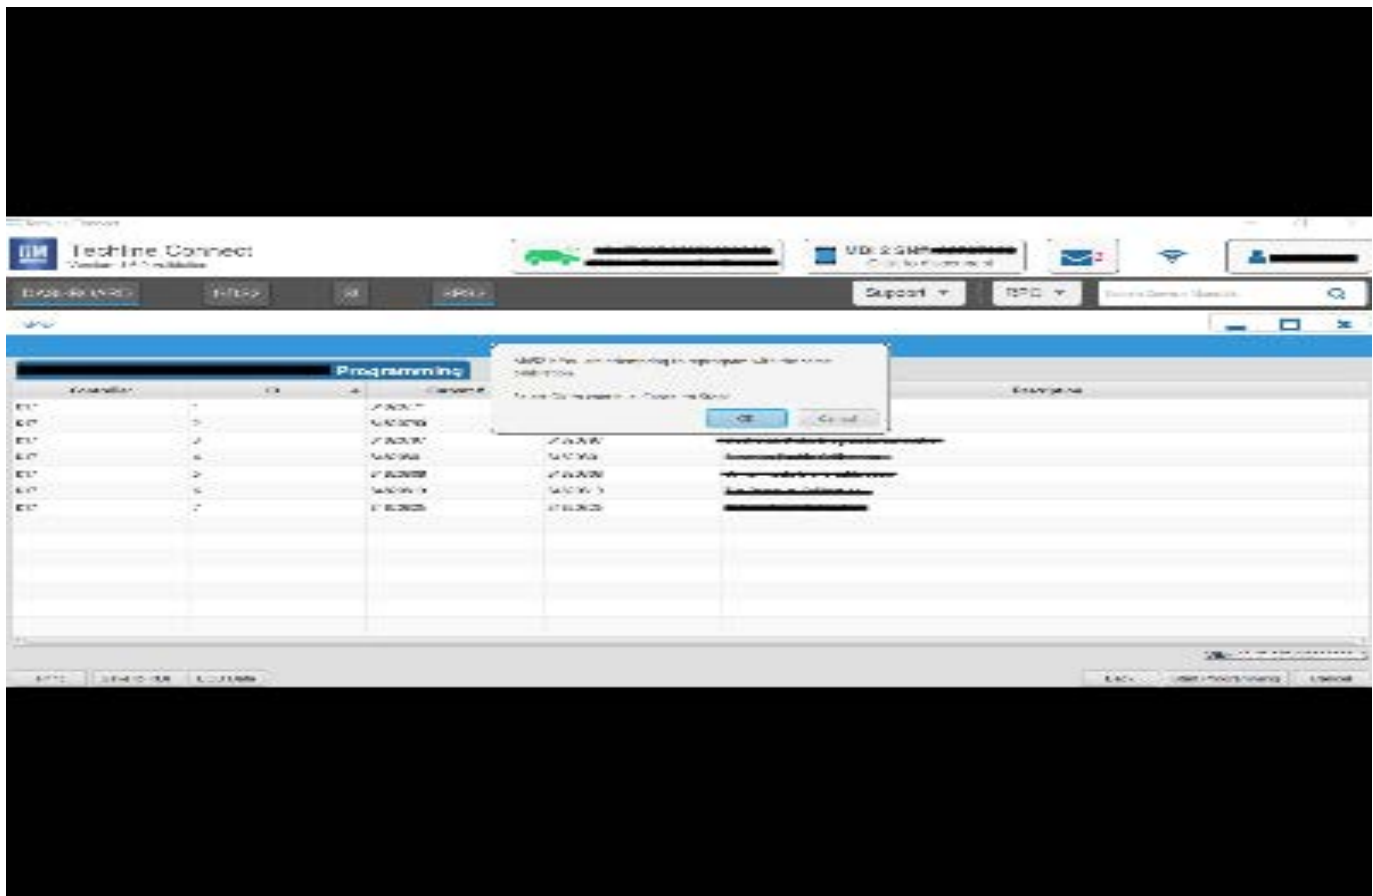
5644477

Important: Techline Connect and TIS2WEB screens shown above.

Important: If the same calibration/software warning is noted on the TLC or SPS Summary screen, select OK and follow screen instructions. After a successful programming event, the WCC is located in the Service Programming System dialogue box of the SPS Summary screen. No further action is required. Refer to the Warranty section of the bulletin.

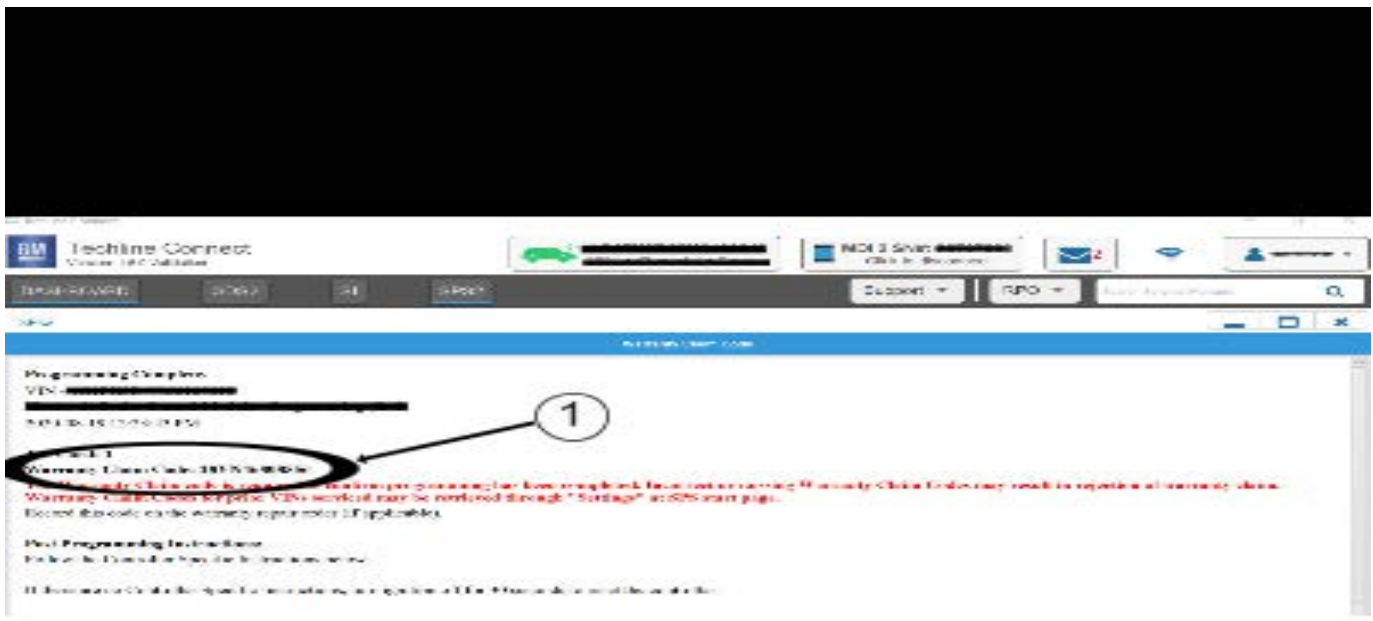
5644478

Note: The screenshots above are an example of module programming and may not be indicative of the specific module that is being programmed. Module selection and VIN information have been blacked out.

Important: To avoid warranty transaction rejections, you MUST record the warranty claim code provided on the SPS Warranty Claim Code (WCC) screen shown above on the job card. Refer to callout 1 above for the location of the WCC on the SPS screen
