Subject: N232421260 - Service Update  
False DTC Causing Unnecessary Battery Pack Replacements

Models: 2020 – 2022 Chevrolet Bolt EV  
2022 Chevrolet Bolt EUV

## Service Update

# N232421260 False DTC Causing Unnecessary Battery Pack Replacements

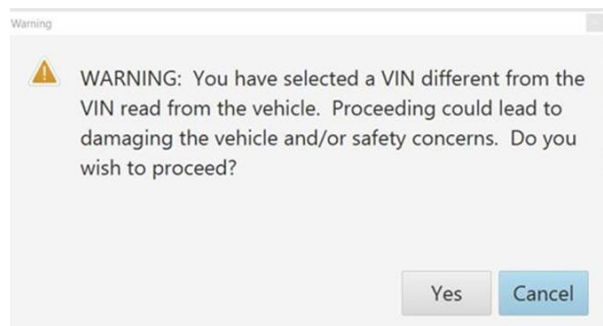
**Important:** If the vehicle VIN DOES NOT match, the message below will be shown.
