# Service Bulletin

Bulletin No.: 23-NA-193

**Subject:** Vehicles Setting DTCs P20EE, P22FE, P2C7A, P2EAD, P20FE, P2203, P22FB, P2459, P049D, P0300 and/or P1C30

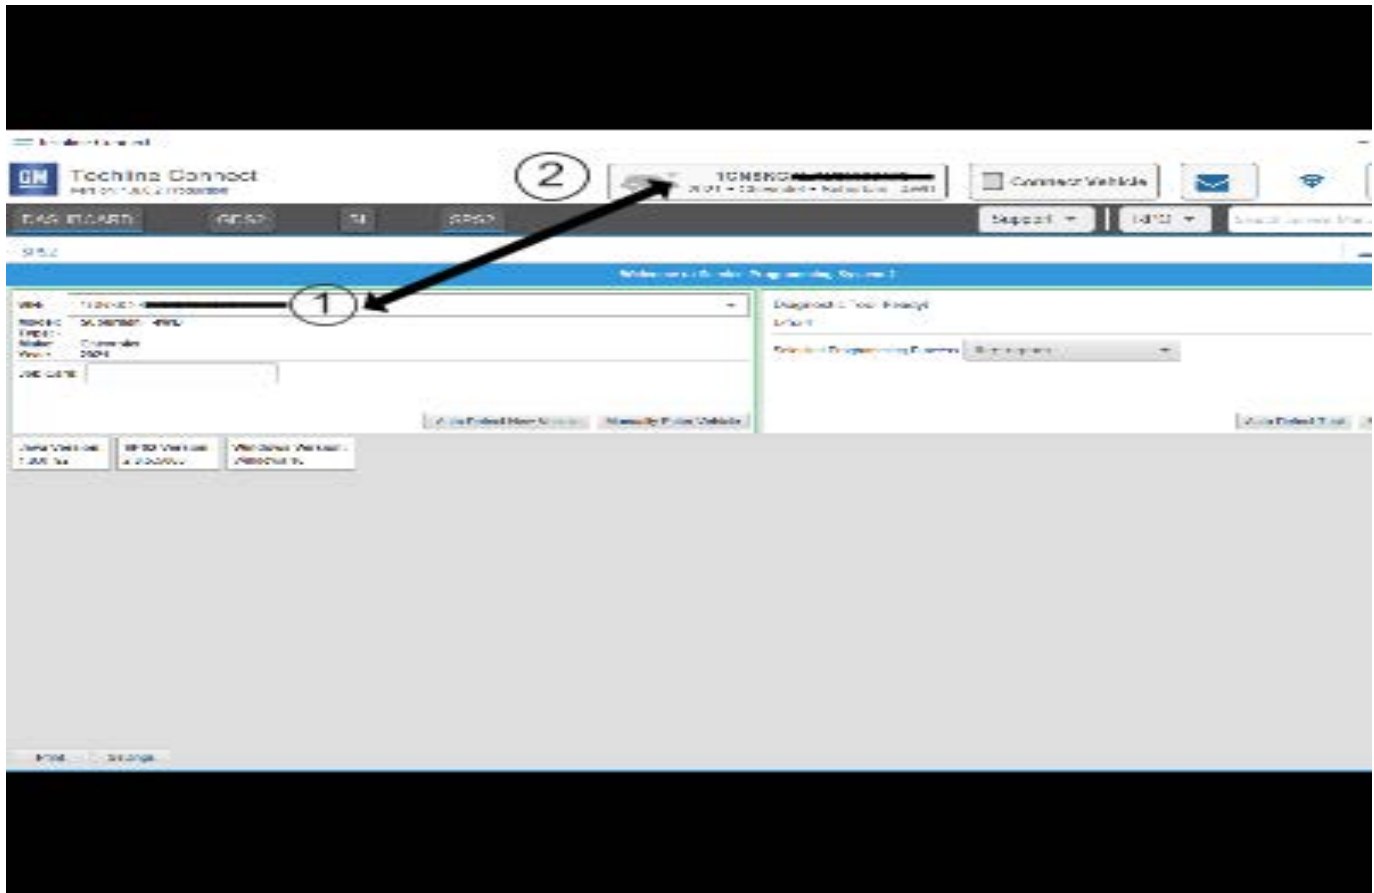
Caution: Be sure the VIN selected in the drop down menu (1) is the same as the vehicle connected (2) before beginning programming.

Important: Techline Connect screens shown above.
