# Service Bulletin

Bulletin No.: 23-NA-033

Subject: Rattle Noise During Cold Start, Malfunction Indicator Lamp (MIL) Illuminated - DTC P2261 Set

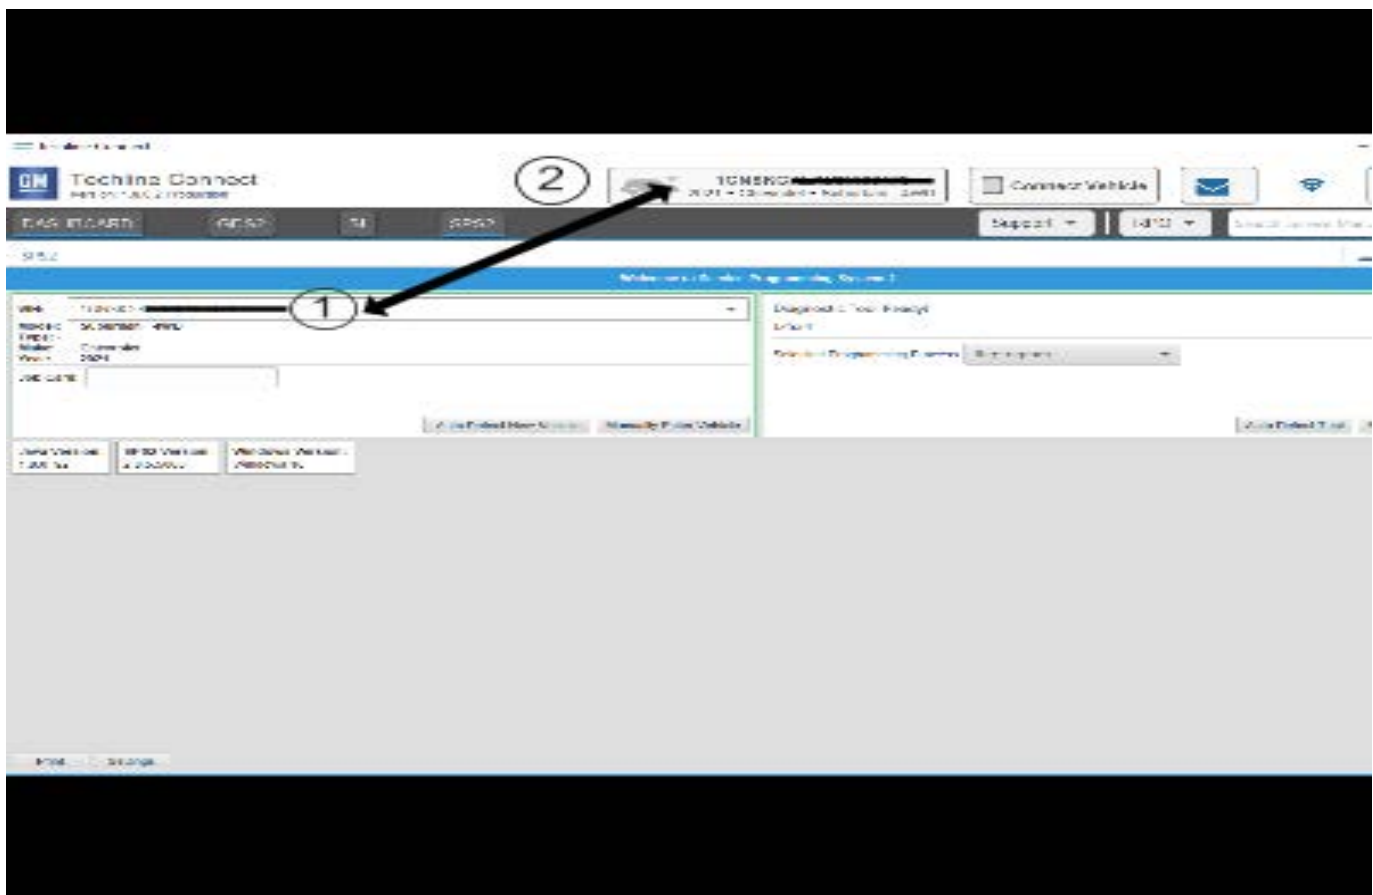
Caution: Be sure the VIN selected in the drop-down menu (1) is the same as the vehicle connected (2) before beginning programming.

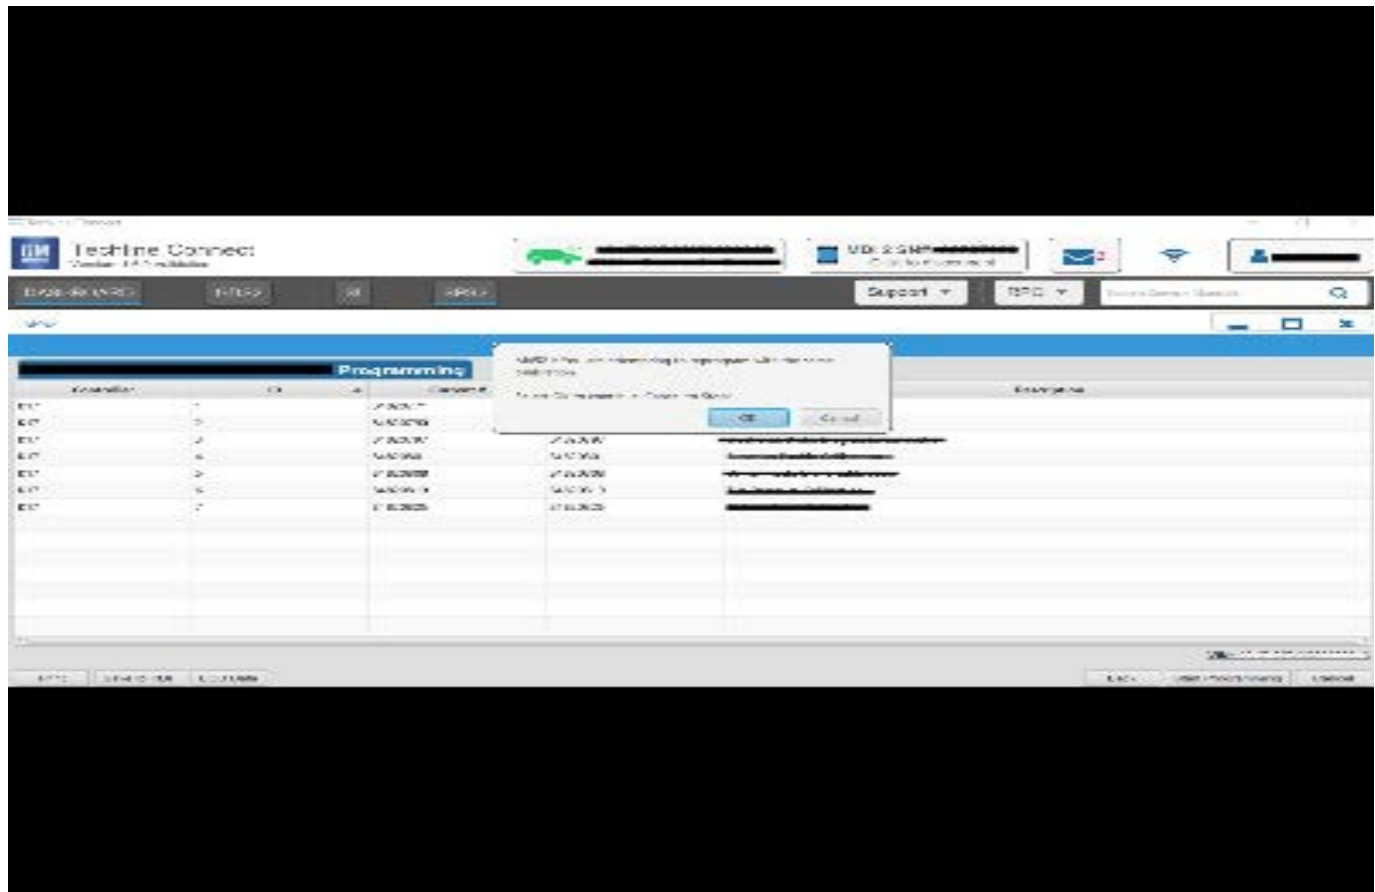
5644477

Important: Techline Connect screens shown above.
