# Service Bulletin

Bulletin No.: 22-NA-112

Subject: 2020 - 2022 Silverado and Sierra Equipped with Diesel Engine Setting DTCs P20BB or P20C3

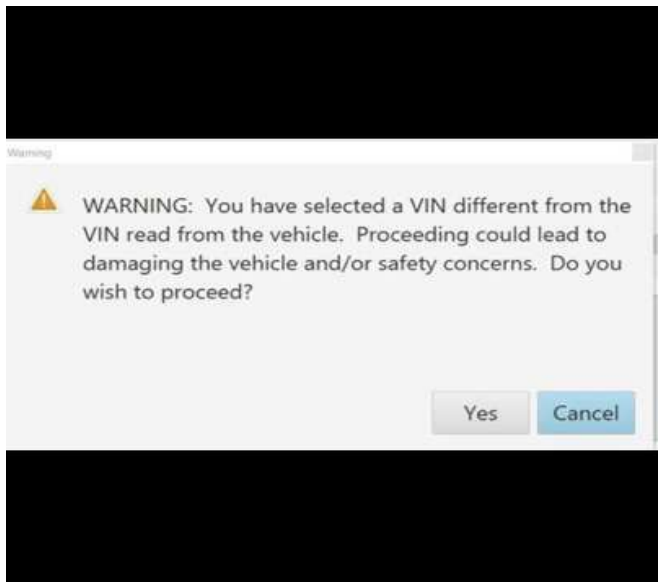
5877000

Important: If the vehicle VIN DOES NOT match, the message below will be shown
