Subject: N212350930 - Service Update  
Transmission Control Module Reports Incorrect DTC Permanent  
Status

Models: 2021 Chevrolet Corvette

## Service Update

# N212350930 Transmission Control Module Reports Incorrect DTC Permanent Status

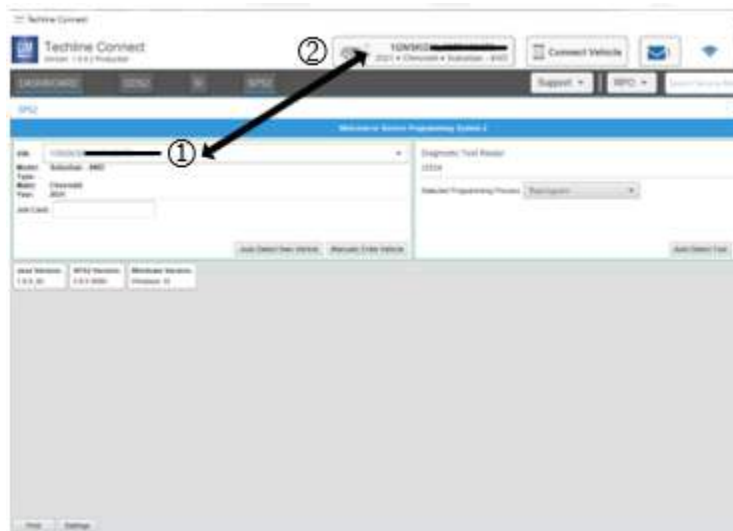
5743643

**Caution:** Be sure the VIN selected in the drop-down menu (1) is the same as the vehicle connected (2) before beginning programming.

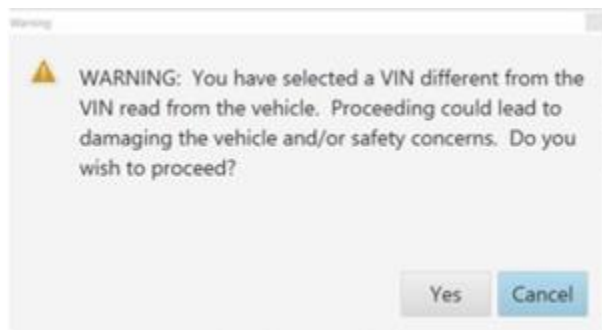
5877000

**Important:** If the vehicle VIN DOES NOT match, the message below will be shown.

**Important:** Techline Connect and TIS2WEB screens shown above.

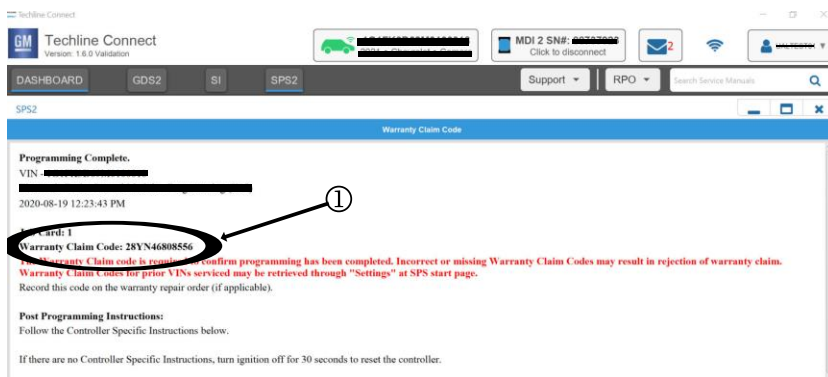
5644478

1. Reprogram the Transmission Control Module. Refer to *K71 Transmission Control Module: Programming and Setup 9T50 M3H* in SI.

**Note:** The screenshot above is an example of module programming and may not be indicative of the specific module that is being programmed. Module selection and VIN information have been blacked out.
