2022-2023MY  
Carnival (KA4)

062 (Rev 1, 02/22/2024)

SERVICE ACTION: ECM LOGIC UPDATE FOR DTC P2118  
AND THROTTLE BODY FREEZING (SA514)

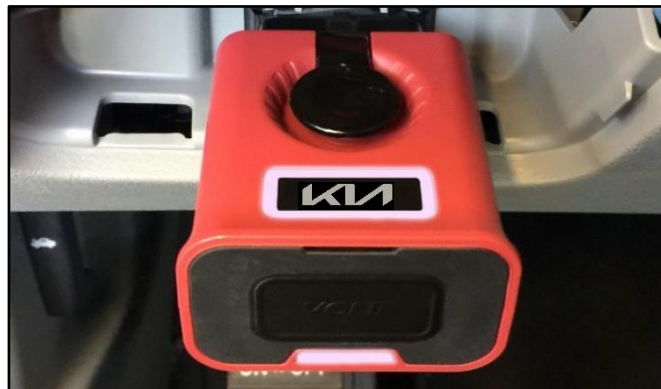
The ECU upgrade function on KDS operates wirelessly. It is not necessary to perform the upgrade via USB cable.

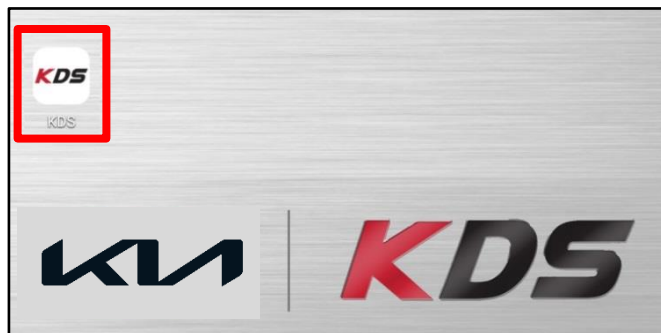
2. With the ignition ON, turn ON the KDS tablet. Select 'KDS' from the home screen.

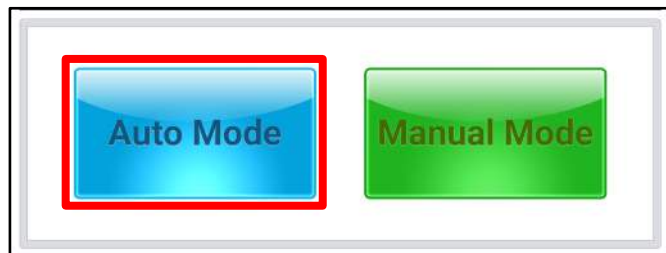
6. Select Auto Mode.

Do NOT attempt to perform a Manual Mode upgrade UNLESS Auto Mode fails. Always follow the instructions given on the KDS in either Auto or Manual mode.
