Technical Service Bulletin

| Subject:<br><br>"TELEMATICS MALFUNCTION" MESSAGE WITH DTC U3000:04-TCU | Bulletin No.: 09-001/24 |

Some customers may experience a "Telematics Malfunction" message in the instrument cluster with DTC U3000:04-TCU (Telematics communication unit internal malfunction) stored in memory. This is caused by improper control software of the telematics communication unit (TCU). To eliminate this concern, the control software of the TCU has been modified. Customers having this concern should have their vehicle repaired using the following repair procedure.

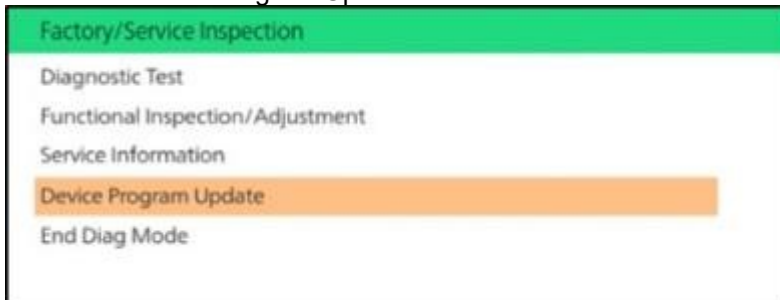
h. Select "Device Program Update" on the screen below.

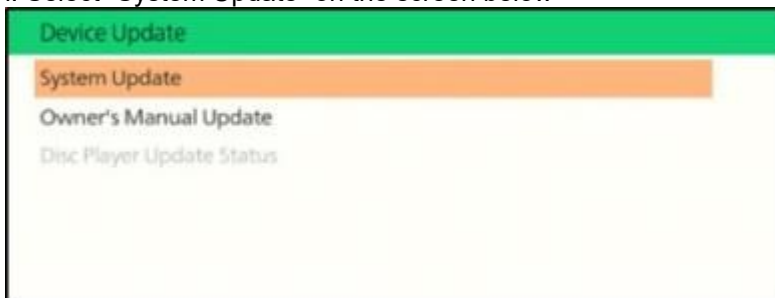
i. Select "System Update" on the screen below
