# Service Bulletin

Bulletin No.: 23-NA-008

Subject: DEF Pump Controller Update with DTCs P105A and/or P208A Set.

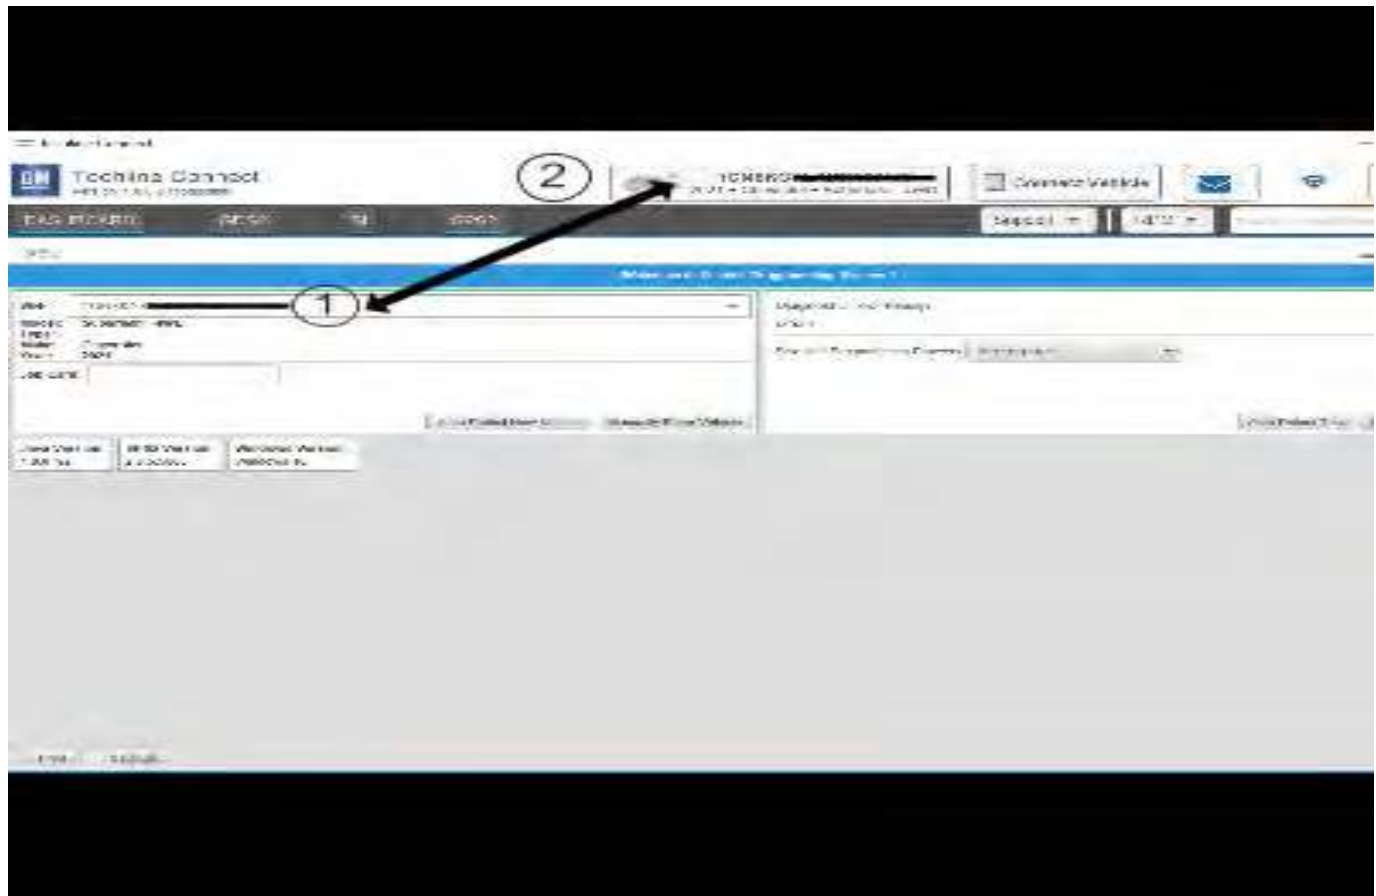
5743643

Caution: Be sure the VIN selected in the drop down menu (1) is the same as the vehicle connected (2) before beginning programming.

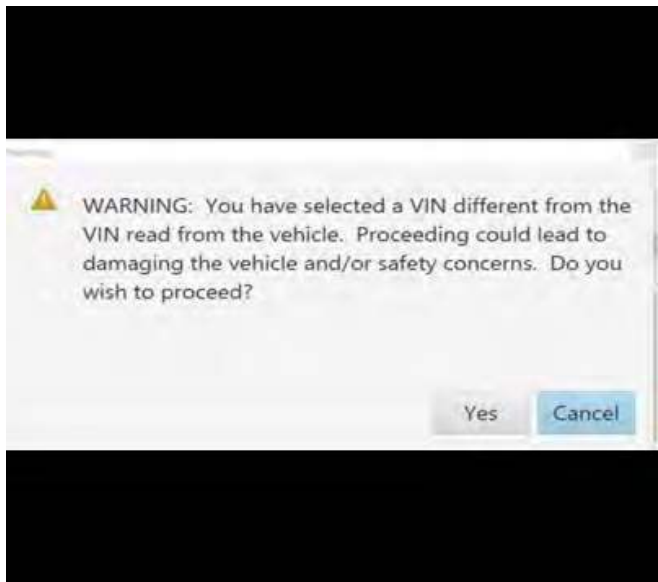
5877000

Important: If the vehicle VIN DOES NOT match, the message below will be shown

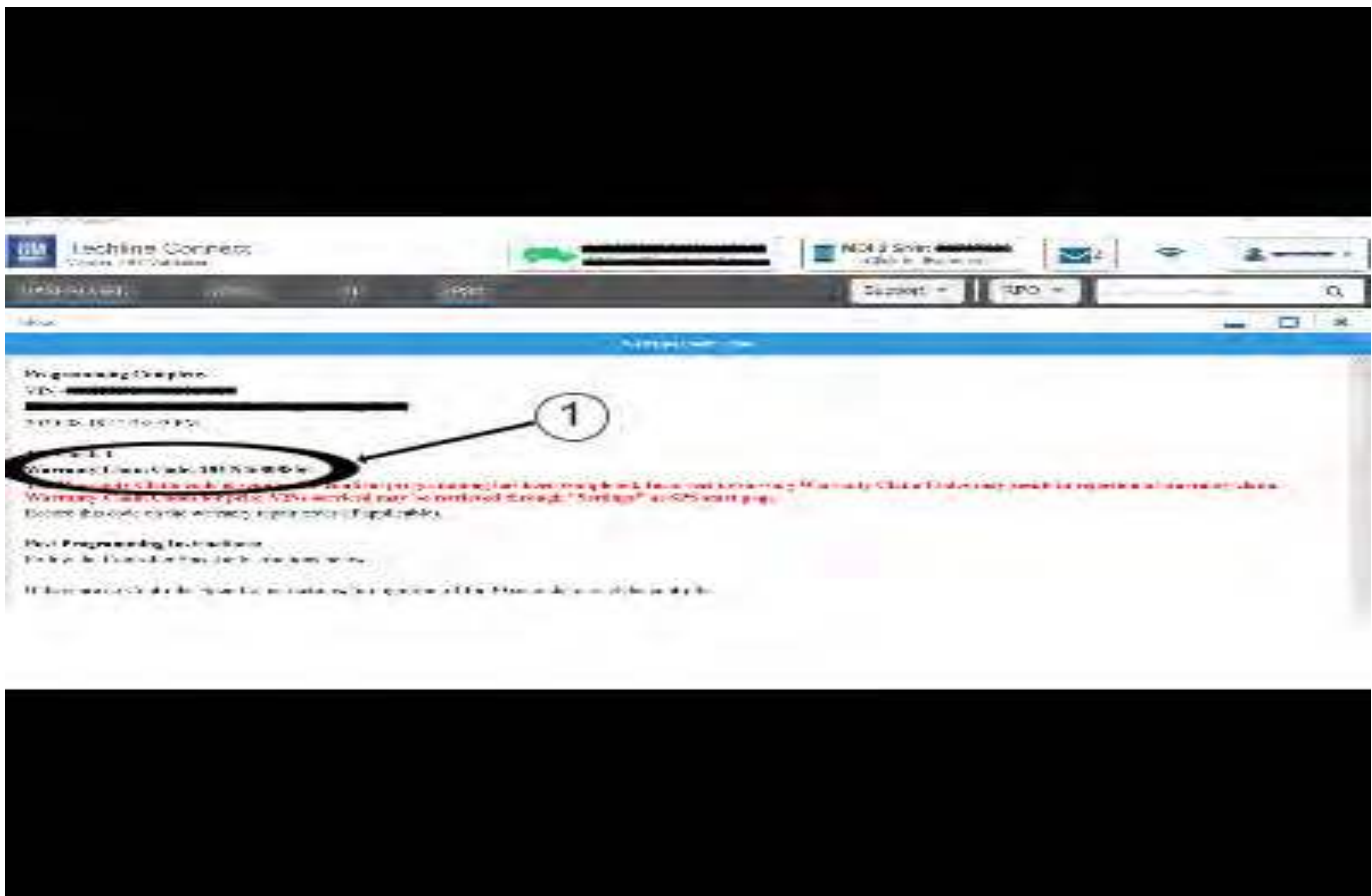
5644478

Note: The screenshot above is an example of module programming and may not be indicative of the specific module that is being programmed. Module selection and VIN information have been blacked out.

Important: To avoid warranty transaction rejections, you **MUST** record the warranty claim code provided on the Warranty Claim Code (WCC) screen shown above on the job card. Refer to callout 1 above for the location of the WCC on the screen.

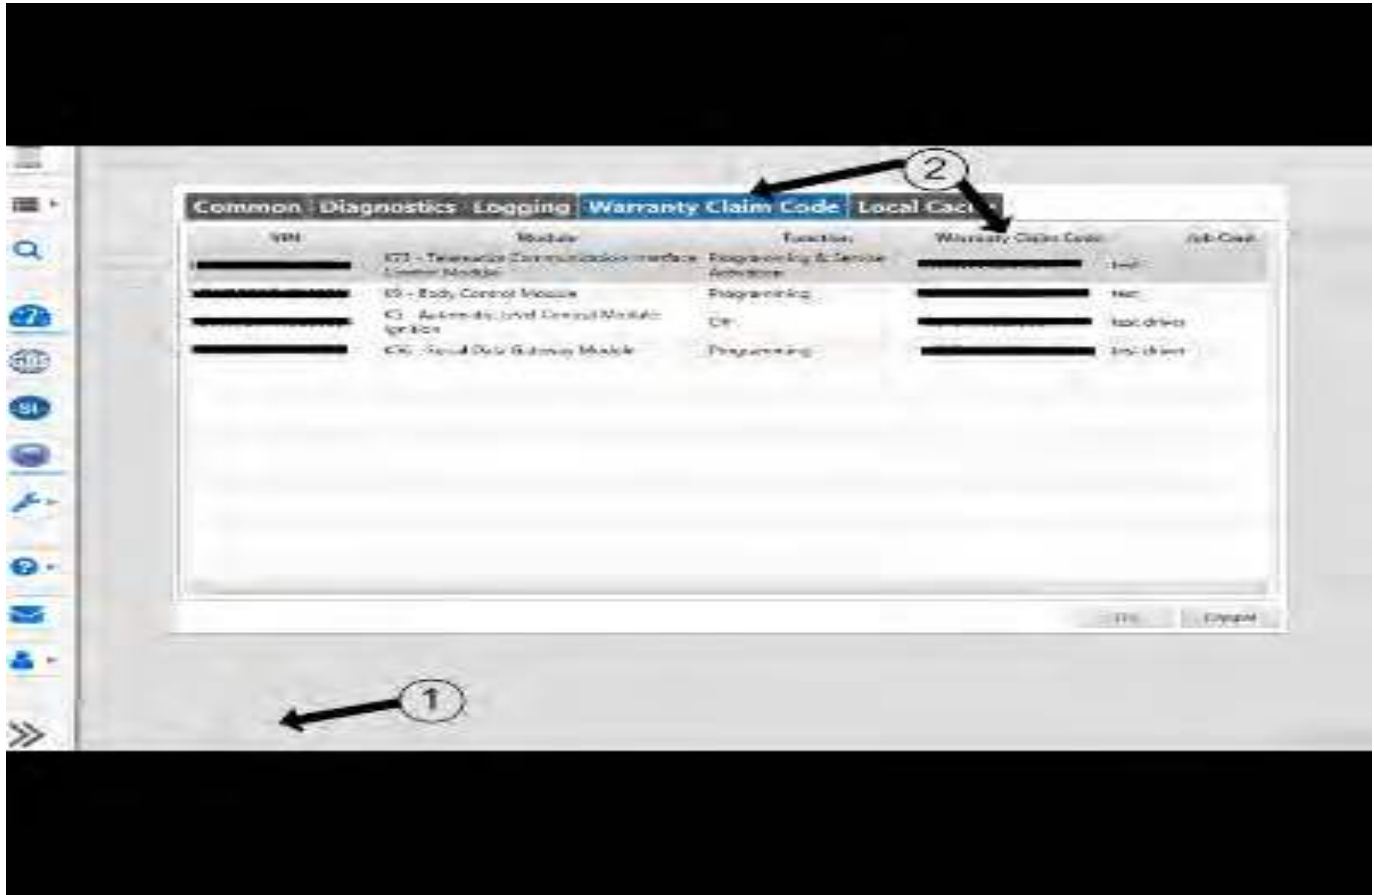
6125774

If the Warranty Claim Code was not recorded on the Job Card, the code can be retrieved in the SPS2 system as follows:

The VIN, Warranty Claim Code and Date/Time will be listed on a roster of recent programming events. If the code is retrievable, dealers should resubmit the transaction making sure to include the code in the SPS Warranty Claim Code field.
